Woolgoolga to Ballina Pacific Highway upgrade

**Construction and Operational Monitoring of
In-situ Threatened Flora Species (non-
rainforest)**

Annual Report 2019

Woolgoolga to Ballina Pacific Highway Upgrade
In-situ Threatened Flora (non-rainforest flora) Annual Monitoring Report 2019

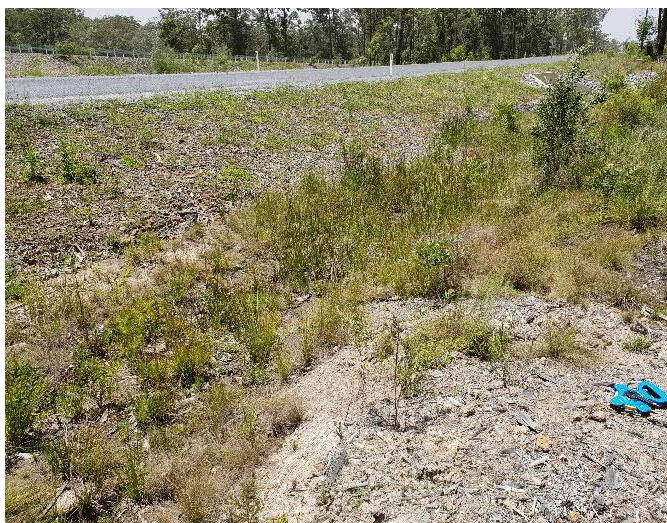
Photograph 1: *Lindernia alsinoides* sub-population at new site La-1.3a established in 2018 along roadside drainage (Simmons Flat Road) adjacent to old Site La-1.3.

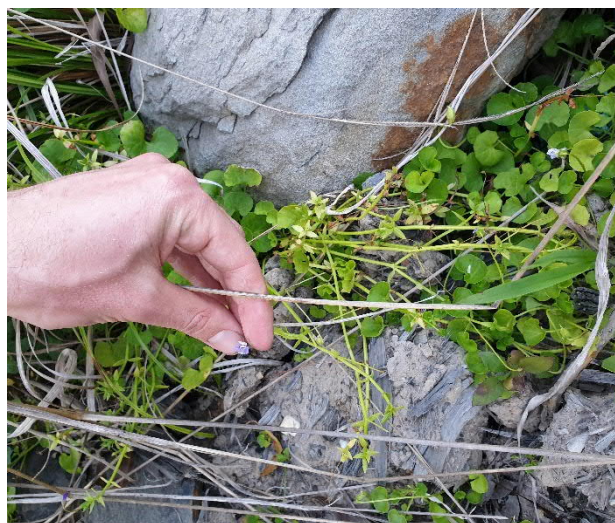
New individuals that were identified in 2018 along completed portions of section 1 (Corindi Beach) on seepage zones and on edge of constructed sedimentation basin near site La-1.2 were again observed alive during 2019 surveys. It is possible that soil in this location has better access to groundwater helping plants to persist.

Photograph 2: New *Lindernia alsinoides* identified in 2018 on edge of constructed sedimentation pond on rocky substrate near site La-1.2 present during 2019 surveys

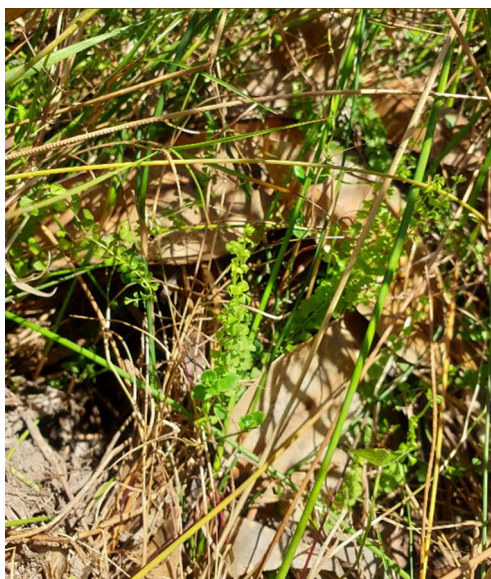
Photograph 3: *Lindsaea incisa* growing abundantly though showing some signs of wilting at site Li-2.1

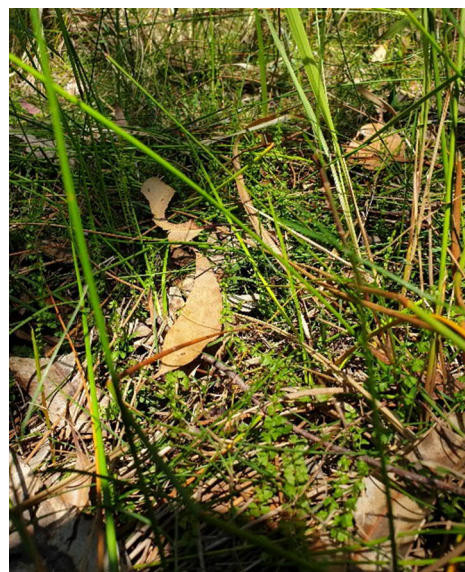
Photograph 4: High cover of *Lindsaea incisa* observed at site Li-C2.1

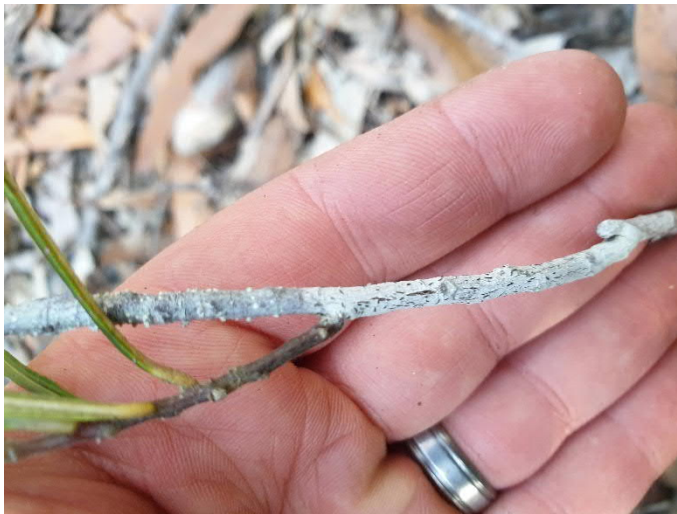
Photograph 5: Quassia sp. Moonee plant at Qm-2.1 showing white fungus-like substance on the stem

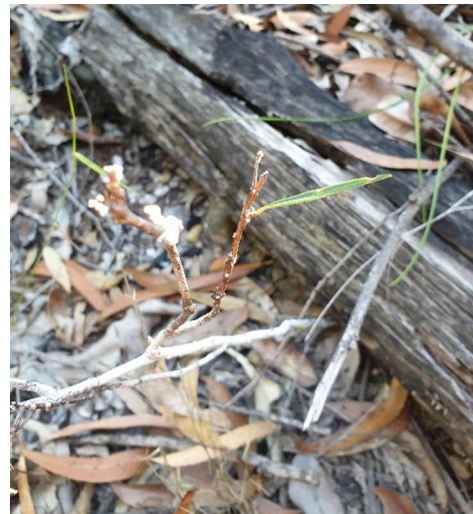
Photograph 6: Quassia sp. Moonee plant at Qm-2.1 showing missing leaves and white fungus-like substance on the stem.

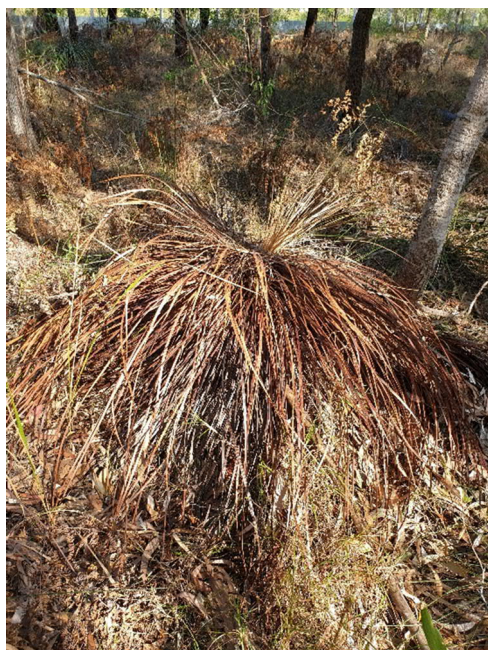
Heat related plant stress and/or plant dieback continues to be evident (since Year 1 construction monitoring) at sites Ar-3.4 and Ar-3.7. Plant species affected include *A. robur* seedlings, *Xanthorrhoea* sp., *Duboisia myoporoides*, *Banksia oblongifolia*, *Pteridium esculentum* and *Alphitonia excelsa*. Dieback of *Xanthorrhoea* sp. and *B. oblongifolia* at Ar-3.7 is suspected to be caused by the epidemic infection of the root-rot fungus Cinnamon Fungus (*Phytophthora cinnamomic*), but this would need to be confirmed (refer to Photograph 7). Most sites with mature *A. robur* trees generally show some level of dieback in branches, and it is unknown whether minor tree dieback and seedling mortality at site Ar-3.7 is associated with the potential pathogen. Low average annual rainfall in the region has resulted in very dry conditions effecting many species (Photograph 7).

Photograph 7: Xanthorrhoea sp. dieback at in-situ site Ar-3.7 in October 2019. The photo also shows lots of brown and yellow plants, a result of drought conditions in 2019.

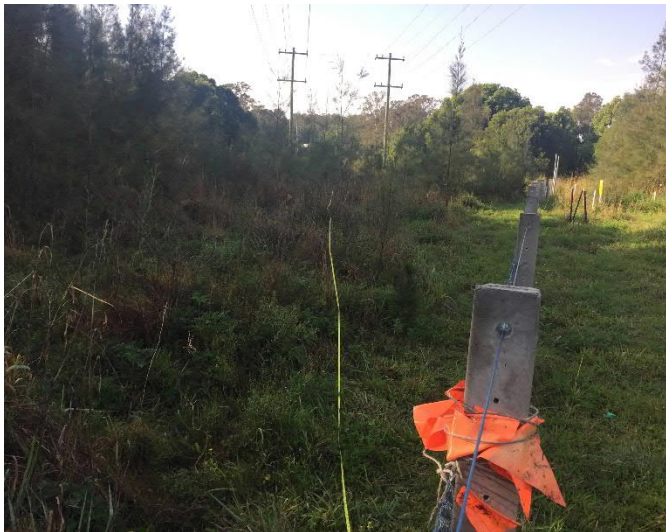
The only site that seemed unaffected by the dry conditions was Ah-8.1. Plants were healthy and up to 15cm, though mostly small and appeared to have just started shooting. However, this site was impacted by the construction of a new fence running north to south through the plot (see photographs 8 and 9). The concrete posts and associated clearing (approx. one metre either side) and disturbance has removed a large portion of the previous occurrence of *Arthraxon hispidus* in the plot (from 40 m² in 2018 to 9 m² in 2019).

Photograph 8: New concrete post fence constructed through plot Ah-8.1.

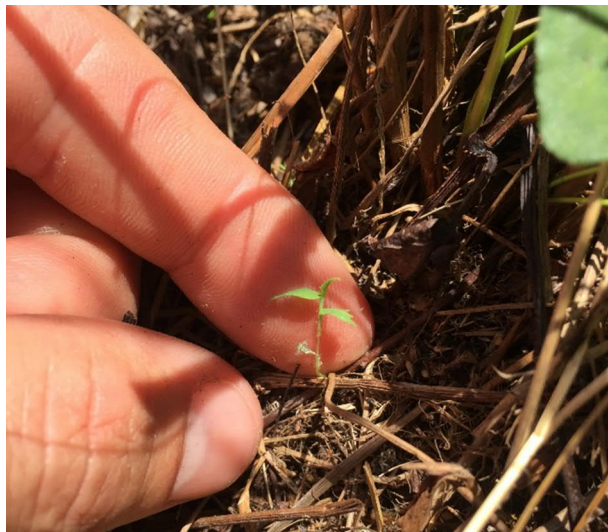
Photograph 9: New Arthraxon hispidus shoots observed at most sites.

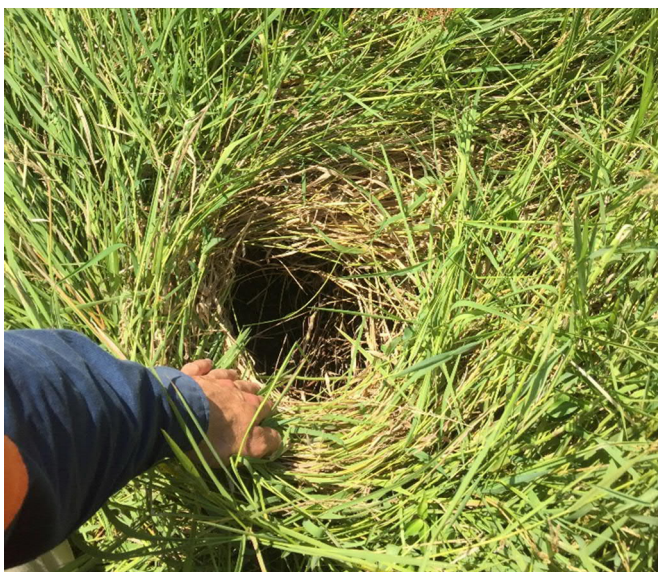
Photograph 10: Dense groundcover of *Leersia hexandra* at Ah-C10.1.

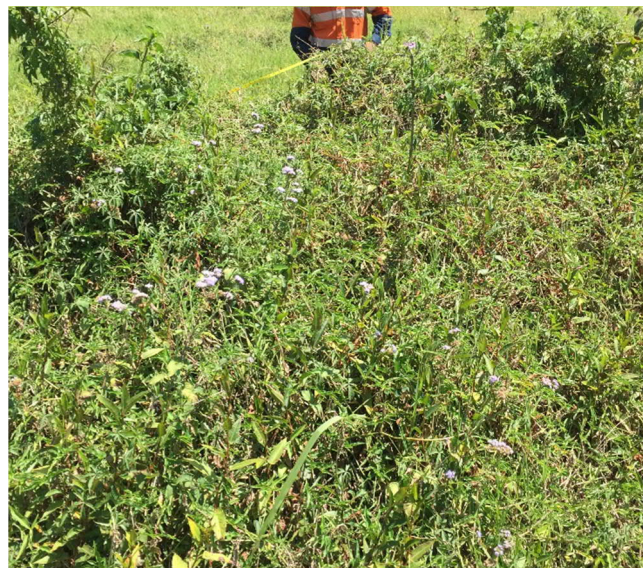
Competition with other plants continues to be a threat to *Arthraxon hispidus*. This is primarily by exotic species such as *Ageratum houstonianum* and *Commelina benghalensis* forming dense groundcover. This is particularly evident at sites Ah-C10.2 and Ah-10.4, where it appears *Arthraxon hispidus* plants are being out-competed. Similarly, this is also happening at Ah-C10.1 with the native grass *Leersia hexandra*. This is most likely occurring as the wetland around the upper reaches of Saltwater Creek is slowly drying out, a product of drought conditions in 2018-19. Though this problem may also be exacerbated by the removal of cattle from these properties, which have been previously managed through grazing. Cattle removal has occurred in some locations during the construction period. Table 3-1 shows the change in weed cover and number of weed species for all sites over all monitoring periods. This impact is not project related.

Photograph 11: Exotic species such as *Ageratum houstonianum* and *Commelina benghalensis* forming a dense groundcover at Ah-10.4.

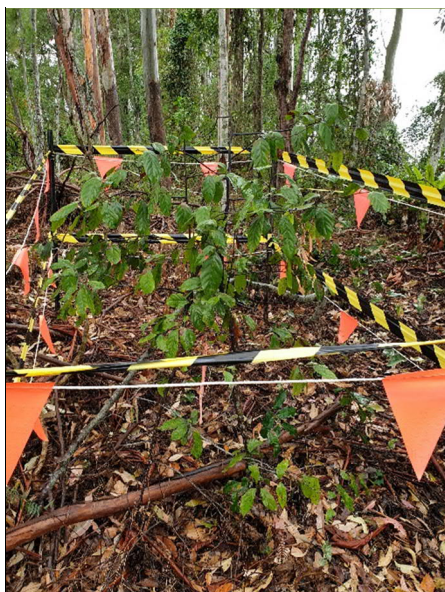
The single individual *E. muelleri* subsp. *bracteata* at site Emb-4.1 is in good health with new apical meristem shoots and has maintained a height of 1.6 metres since Year 1 construction. Insect activity on shrub continues to be observed including caterpillar, moth, ant and aphids. A termite trail up the stem was observed in 2019 (refer photograph 11). Leaf insect damage has been noted but hasn't caused detrimental harm to plant. The *E. muelleri* shrub was observed in 2018 being smothered by Dutchmen's Pipe (*Aristolochia elegans*) climber weed, however weeds works have been undertaken and flagging has been re-established around the shrub (refer photograph 10). The amount of sunlight entering this site has increased from vegetation clearing during construction to the south (inside the project boundary) and dieback of Flooded Gum (*Eucalyptus grandis*) tree canopy, suspected to be caused by irregular roosting of Flying Foxes. The increased sunlight to the groundcover was potentially the cause of increases in weed cover. No recruitment of *E. muelleri* subsp. *bracteata* was observed.

Photograph 10: *E. muelleri* subsp. *bracteata* at in-situ site Emb-4.1 showing protective flagging.

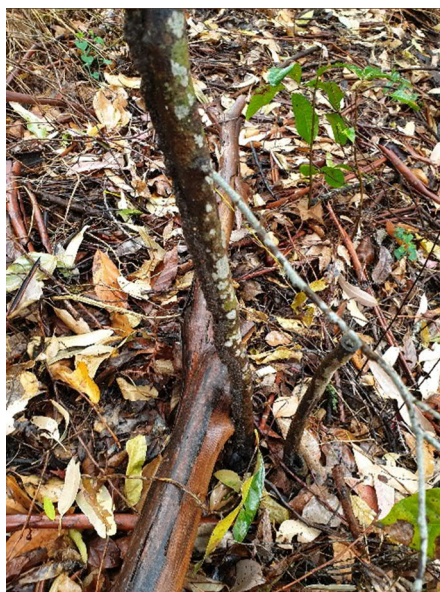
Photograph 11: Termite trail on *E. muelleri* subsp. *bracteata* at in-situ site Emb-4.1.

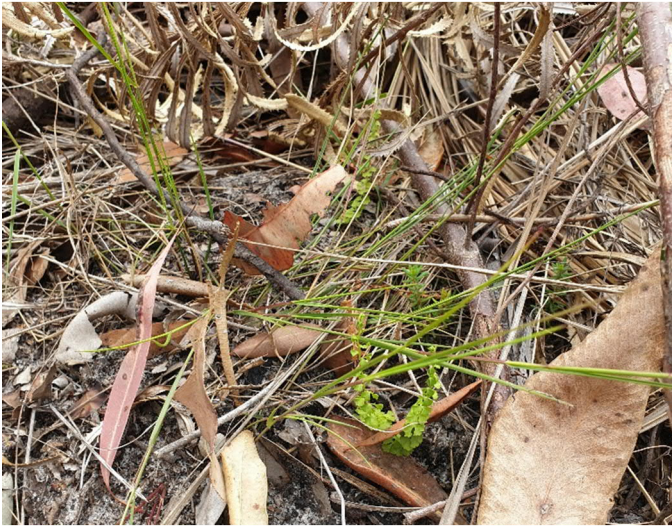
In-situ site Li-3.1 has continued to decline since 2018. This site was directly impacted by the approved detailed design work prior to autumn 2018 survey with the construction of a man-made drainage line in the middle of the site, which resulted in some loss of ferns, however many were observed in good health growing on edge of cleared space (refer to Photograph 12). The decrease in areas of occupancy to just 0.5 m² observed during 2019 surveys is possibly a result of a combination of this impact plus the dry conditions.

Photograph 12: Continue plant growth in 2019 at in-situ Site Li-3.1 despite extensive modification of the site in 2018 for a drainage line.

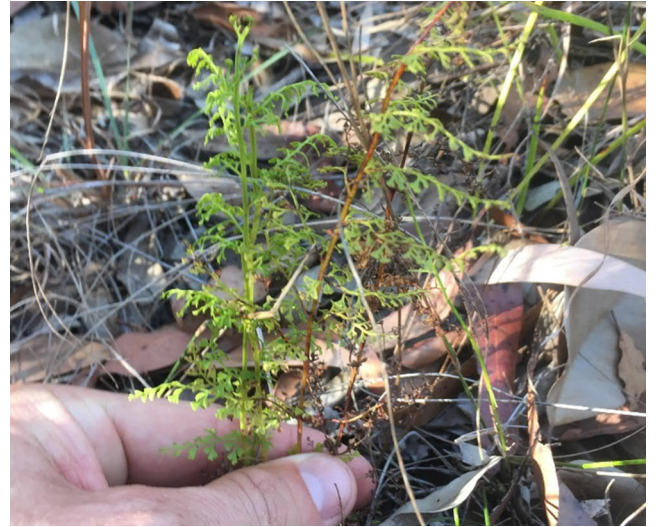
No plants were observed at any of the monitoring locations in Section 6 during 2019 surveys. This follows from 2018 where *L. incisa* was absent at in-situ site Li-6.2 and control site Li-C6.1, and ferns were scarce and in bad health at in-situ site Li-6.1. These observations are expected to be a result of lower than average rainfall in the region in both 2018 and 2019. The dry and unfavourable conditions were evidenced by wilted and dying *L. microphylla* observed along the track near in-situ site Li-6.1 (refer to Photograph 13). During spring 2018 surveys, healthy *L. incisa* ferns were observed along edge of track adjacent to in-situ sites Li-6.1 and Li-6.2 where ferns are exposed to track runoff, however no plants were identified anywhere in habitat surrounding these sites in 2019. This species is likely to be sensitive to the very low rainfall trends and these observations are unlikely to be a project-related impact.

Photograph 13: Wilted and dying related *Lindsaea* microphylla observed along the track near in-situ site Li-6.1 evidence of the dry conditions likely responsible for the absence of plants in Section 6.

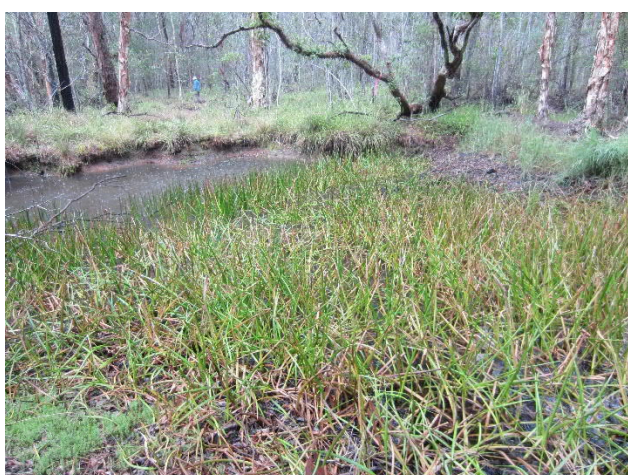
Photograph 14: Pre-construction phase at in-situ site Mt-7.2 showing healthy population of *M. triglochinoides* (May 2014)

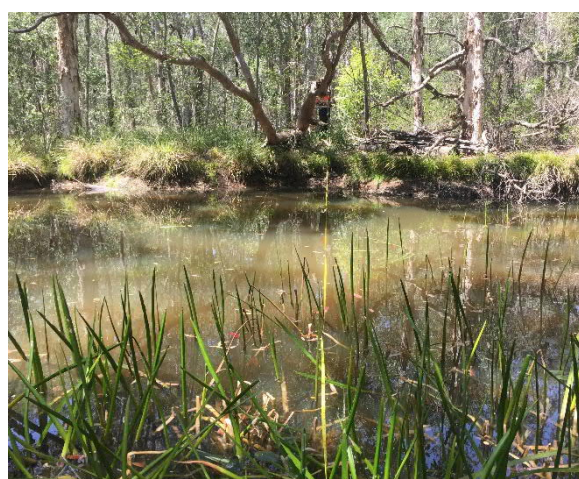
Photograph 15: Year 3 construction phase at in-situ site Mt-7.2 showing gradual recovery of *M. triglochinoides* core population (October 2019)

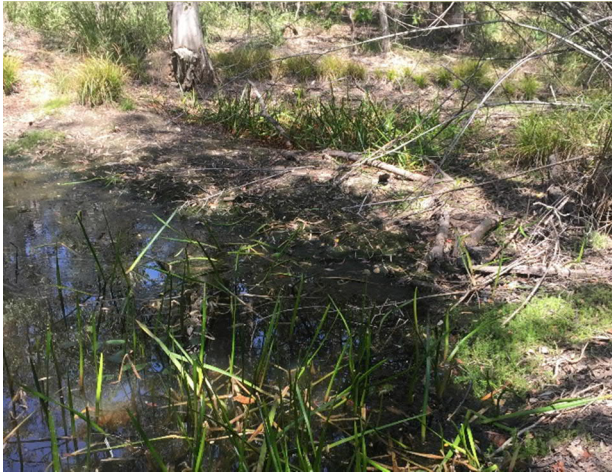
Photograph 16: Year 3 construction phase at in-situ site Mt-7.2 showing gradual recovery of *M. triglochinos* core population (October 2019). Photograph also shows how the sediment bar deposited during 2017 floods has isolated a pool of plants as the water level drops.

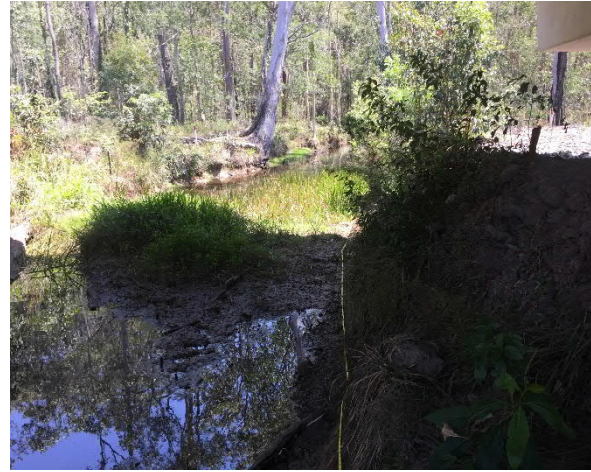
Photograph 17: Year 3 construction phase at in-situ site Mt-7.3 showing major dieback of *M. triglochinos* under the bridge due to shading (October 2018)
