Pacific Highway Upgrade: Woolgoolga to Ballina, Sections 1 and 2

Microbat and Nest box Monitoring –
Operational Phase, (2020-2021)

Sandpiper Ecological

8 November 2021

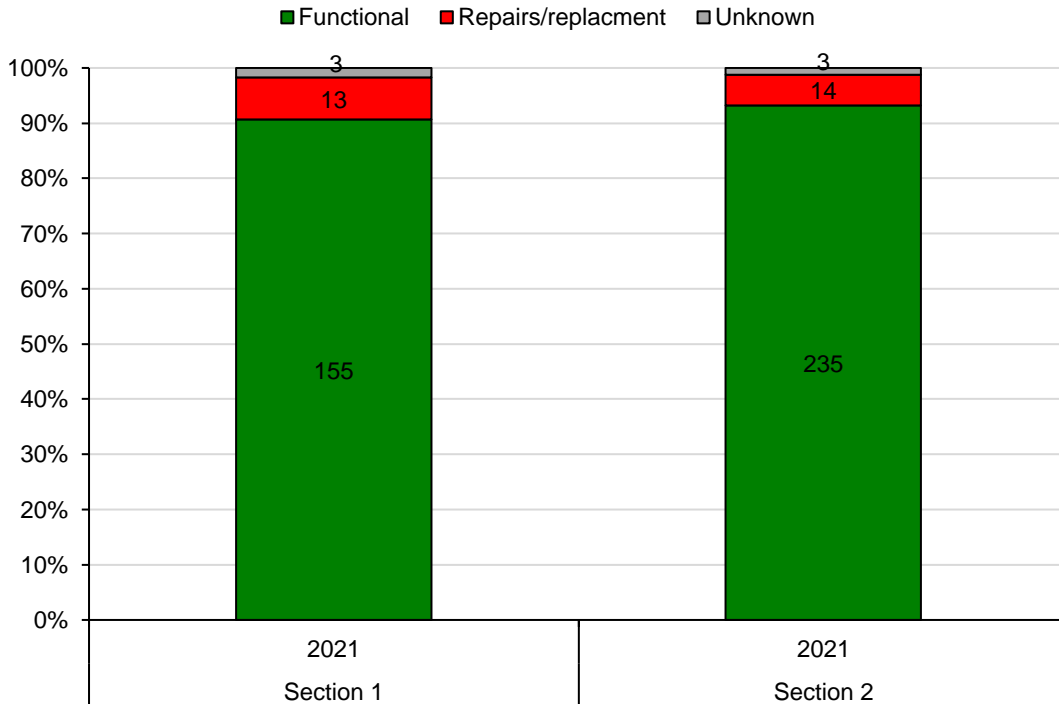
Figure 11: Nest boxes requiring repair or replacement during operational phase monitoring at W2HC (Section 1) and HC2G/WC2G (Section 2), 2020-2021.

A total of 13 (7.6%) boxes in section 1 and 14 (5.5%) in section 2 required maintenance or replacement during the 2020-21 operational monitoring (Figure 10). The “unknown” nest boxes in Figure 10 include three boxes on inaccessible private property in Section 1, and three boxes unable to be found due to co-ordinate error or burnt in section 2. Causes for repair included burnt (S1 = seven boxes, S2=nine boxes), wire/spring failure (S1 = three boxes, S2 = one box), lid/hinge reattachment (S1=two boxes, S2=four boxes) and wire growing into tree (S1 = one box) (see Appendix A, Table A1 and Appendix B, Table B1). A total of 21 repairs were undertaken in July 2021 including replacement of burnt boxes (n=16) with Cyplas designs, box reinstatement at section 1 (n=2), lid reattachment at section 1 (n=2) and wire repaired on hanging scansorial mammal box at section 1 (n=1) (see Appendix A, Table A1, and Appendix B, Table B1). A further six boxes had deteriorated (i.e. missing one hinge with lid still attached, or partial lid deterioration) yet were deemed functional.

Aside from nest box damage due to fire (S1 = seven boxes, and S2 = 9 boxes), the majority of nest boxes remain in fair condition. The number of boxes requiring repair or replacement will increase over time, although, considering they have been installed for 5-6 years boxes in sections 1 and 2 have fared better than many other sites. For example, all 79 boxes installed for the Cooperook to Herons Creek upgrade required maintenance or replacement seven years after installation (Sandpiper Ecological 2015), with a similar result recorded at Sapphire to Woolgoolga (Sandpiper, 2016). Beyer and Goldingay (2006) suggested that most plywood boxes would persist for ~5 years but conceded that box design and site features influenced longevity. The increased longevity of boxes in sections 1 and 2 may be due to the predominance of drier forest types and lower rainfall than other monitoring sites.

Nest boxes that had moderate or severe deterioration were assessed to determine the best ameliorative approach. Maintenance was undertaken on 5 and 6 July 2021 with several boxes replaced in section 1 and 2 due to bush fires and damage from wire/spring failure. Replacement Cyplas boxes were reinstalled via ladder with an ecologist present. Other repairs accessible via ladder were also undertaken such as wire replacement, lid reattachment and box reinstallation.
