**Green-leaved Rose Walnut Rehabilitation Plan – W2B Project,
Section 4. Monitoring Report (August 2021- May 2023)**

**Ecos Environmental (Dr Andrew Benwell)
PO Box 641, Mullumbimby NSW 2482**

2/6/2023

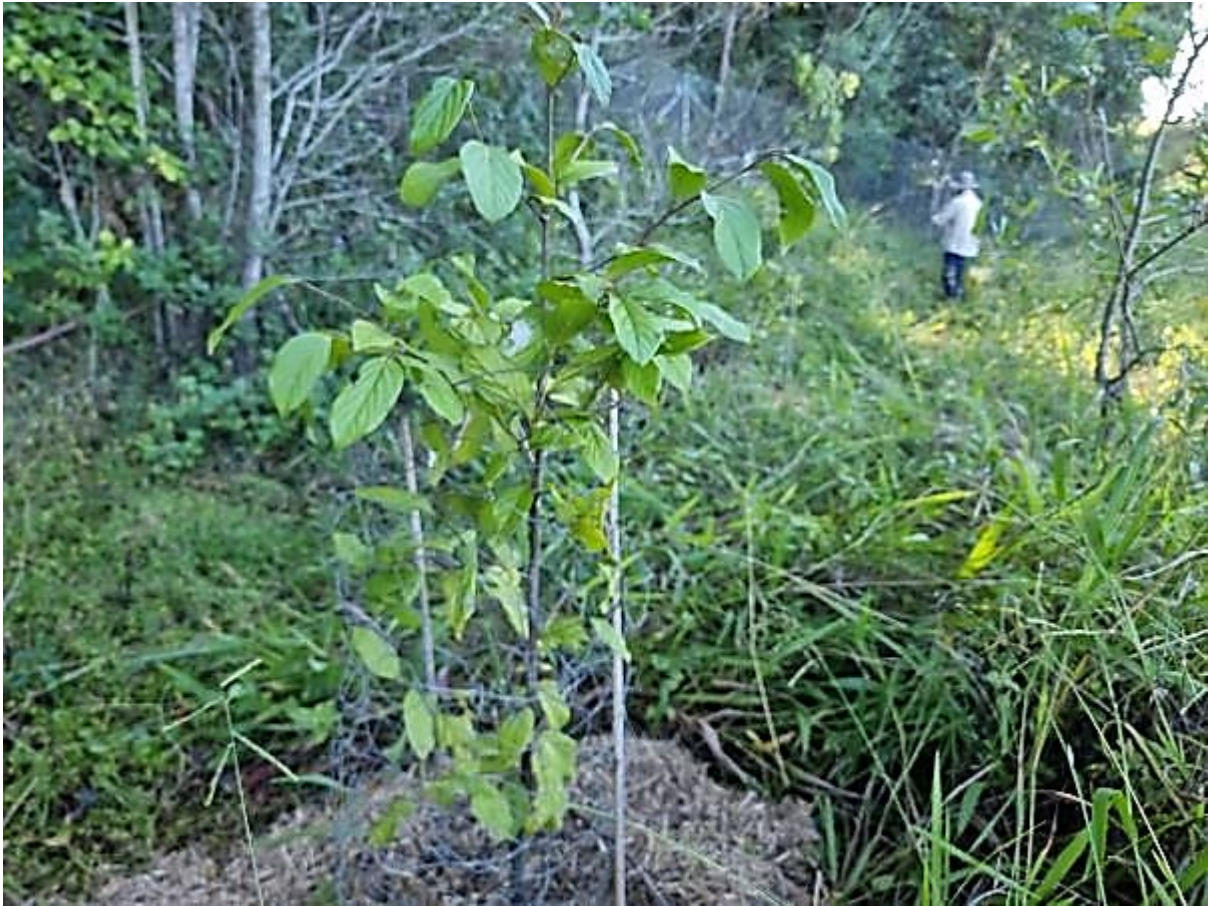
Plate 1: Rusty Green-leaved Rose Walnut inside a chicken wire tree guard showing growth 2 years and 9 months after planting out. May 2023.

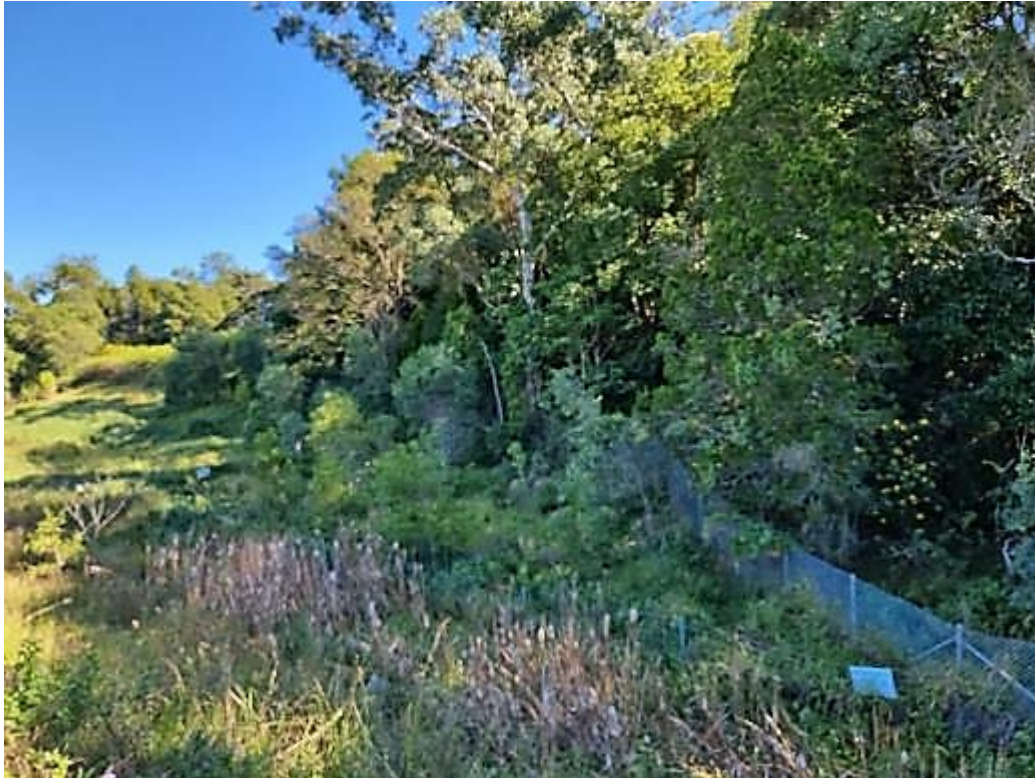
Plate 2: Translocation recipient site for RGRW adjacent to the Maclean interchange. Twelve RGRW were planted near the tall fence on the uphill side of the site. May 2023.

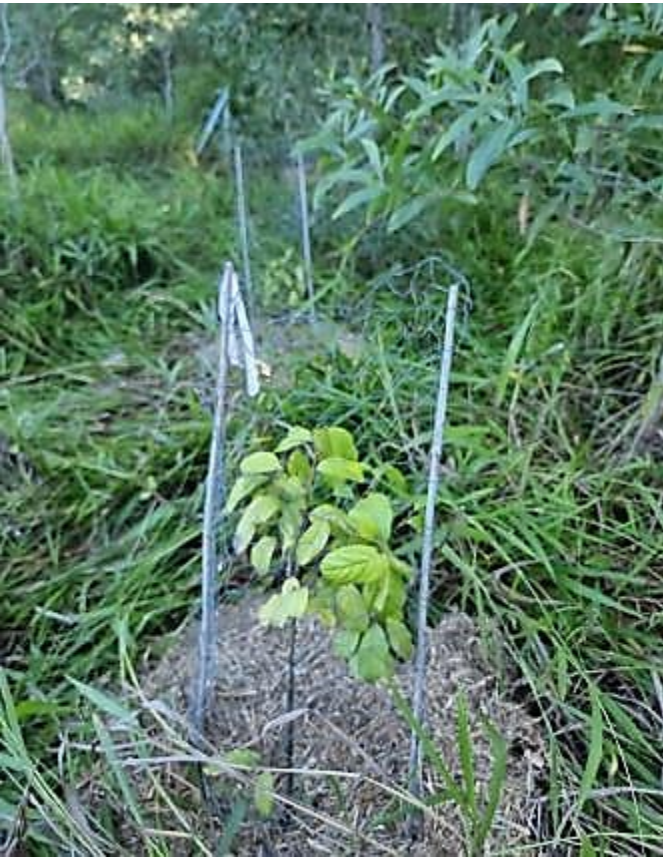
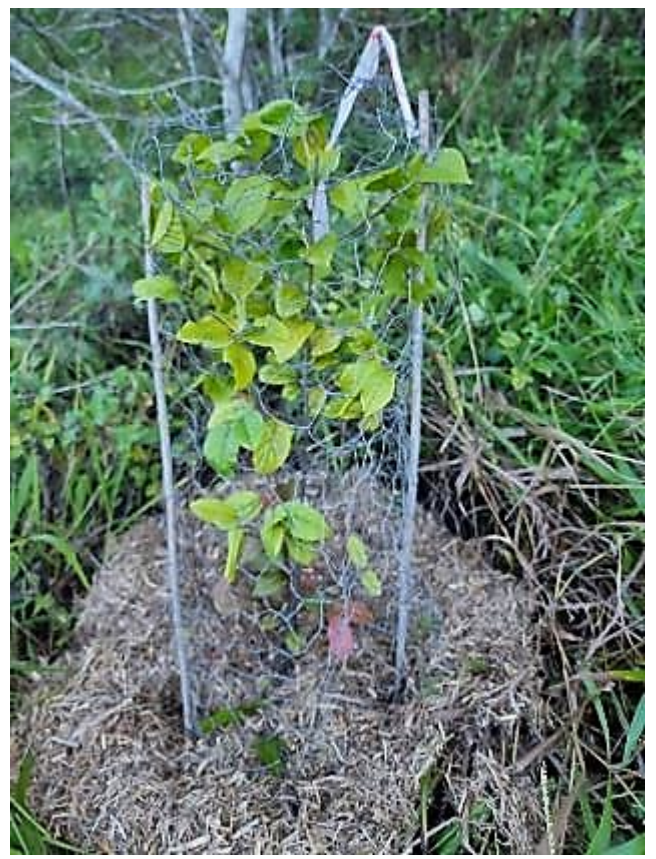
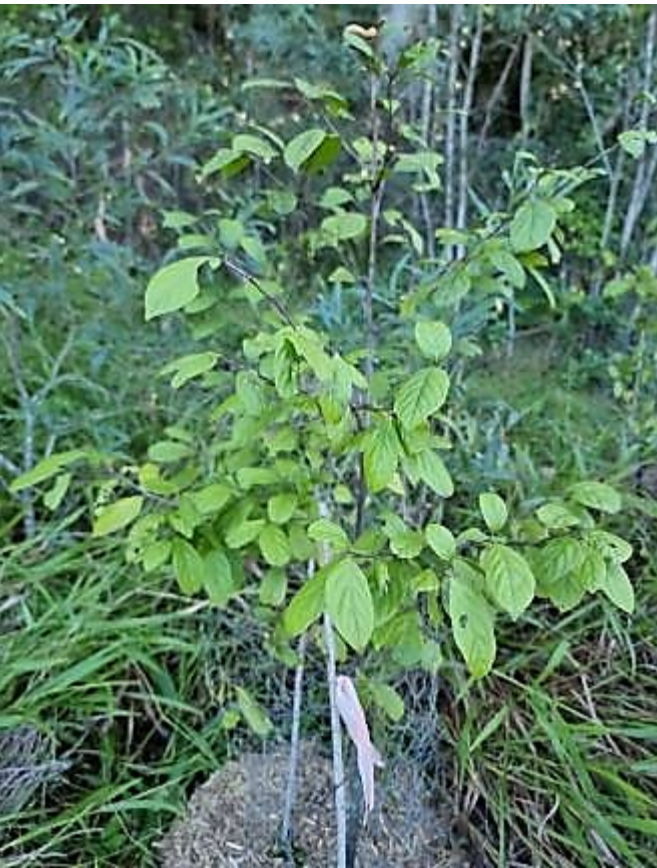
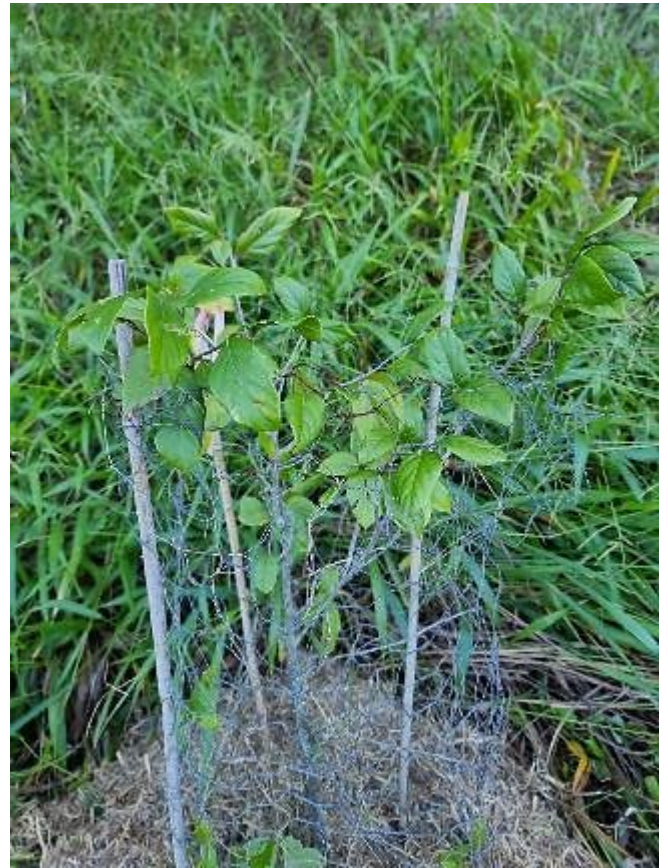
By May 2023, two years and four months after introduction, survival rate of RGRW was 100% and plants were in reasonable condition, although yellowing of leaves was common, indicating nutrient deficiency due to low soil nutrient levels and stressful growing conditions. Seedlings increased in height from a mean of 0.72 ± 0.05 cm in August 2021 (the last monitoring) to 0.94 ± 0.08 cm in May 2023 (Table 1), an average increase in height of 22 cm over a period of one year and 9 months. This difference is statistically significant ($t = -2.175$; $p=0.020$).

The yellowing of leaves is an indicator of stress likely from weeds and lack of nutrients. The weed control, mulching and addition of slow-release fertiliser in May 2023 should improve the plant health.

The soil in the recipient site, formed on sedimentary geology, is very low in nutrient and maintenance is essential if the RGRW seedlings are to have any chance of establishing successfully.

Plates 3-6: RGRW showing yellowish foliage, indicative of nutrient deficiency and low soil nutrient status. Slow release fertiliser and cane mulch were applied in May 2023.

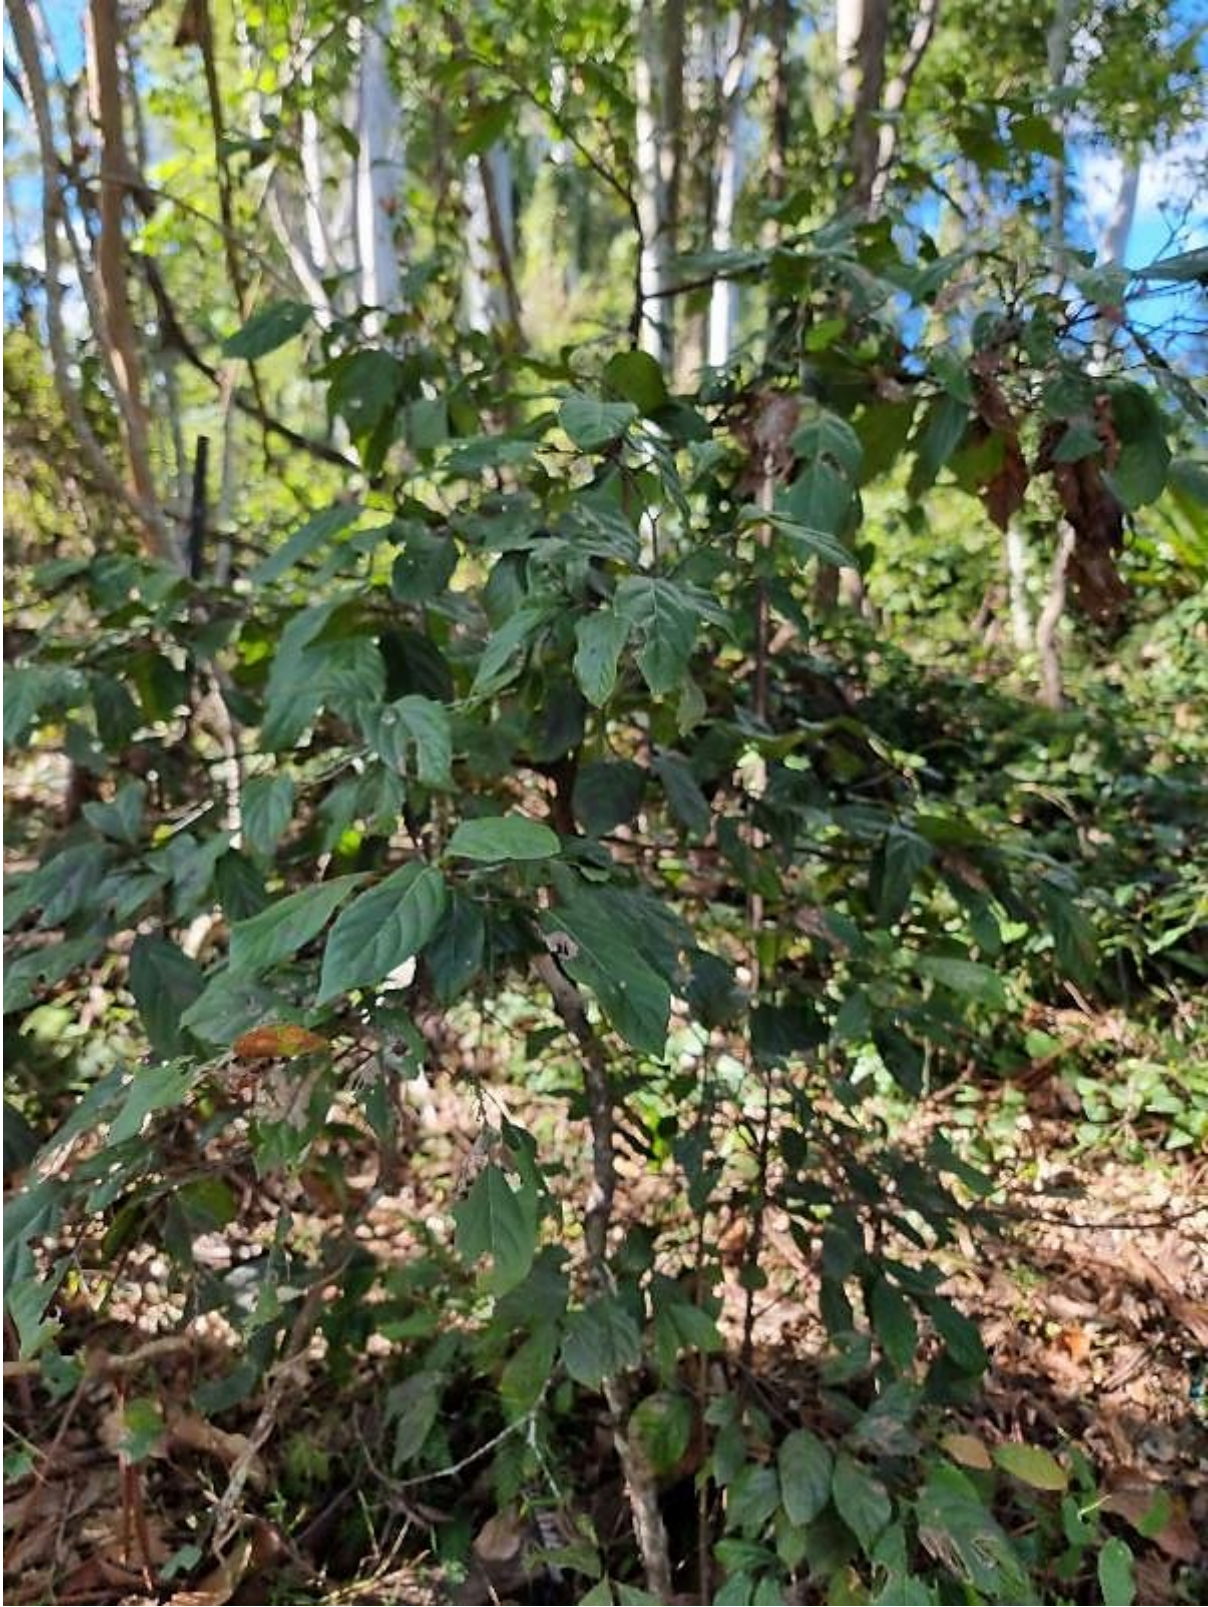
A dense infestation of the exotic vine Dutchmans Pipe (*Aristolochia elegans*) poses a significant threaten to the RGRW sapling by smothering it. Weed control carried out by Ecos Environmental involved spraying Dutchmans Pipe with glyphosate and metsulfuron (Brush-off). The cut-and-paint method was not applied as copious white sap exuded by cut stems of the vine is reported to be highly toxic and a serious health hazard.

Weed control work has substantially reduced the density of Dutchmans Pipe within 10-15 m of the RGRW sapling, however, a large area of the vine extends out 20-30 m, possibly more as it is spreading. The RGRW sapling is in good condition and has increased in height since management began.

Plate 7: In situ RGRW in the road reserve about 400 m north of the recipient site, May 2023.

Action	2023-2024 Year 3 since introduction
Maintenance	
Management Zone 1 <ul style="list-style-type: none"> Control grass and weed growth, apply mulch and slow-release fertiliser to plantings 	Oct-Nov/23 & May/24
Management Zone 2 <ul style="list-style-type: none"> Spray Dutchmans Pipe 	Oct/Nov/23 & May/24
Annual Monitoring and Report	May 2024
