***Green-leaved Rose Walnut Rehabilitation Plan – W2B Project,
Section 4. Monitoring Report (June 2023 - May 2024)***

**Ecos Environmental (Dr Andrew Benwell)
PO Box 641, Mullumbimby NSW 2482**

2/5/2024

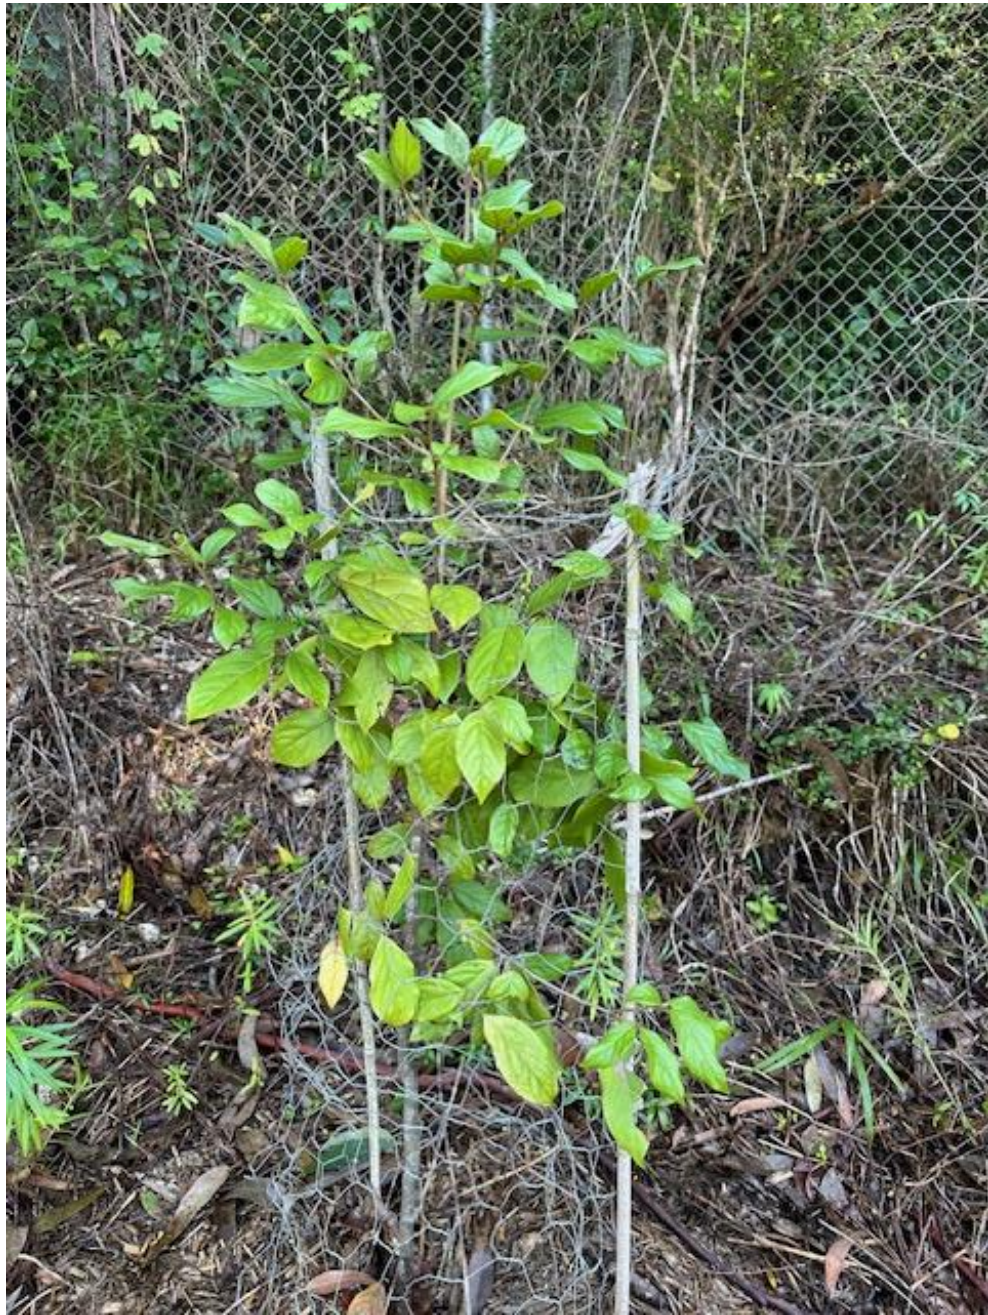
Plate 1: Rusty Green-leaved Rose Walnut 1.2 m high, May 2024, 3 years and 4 months after introduction and approximately 5 years since seed collection

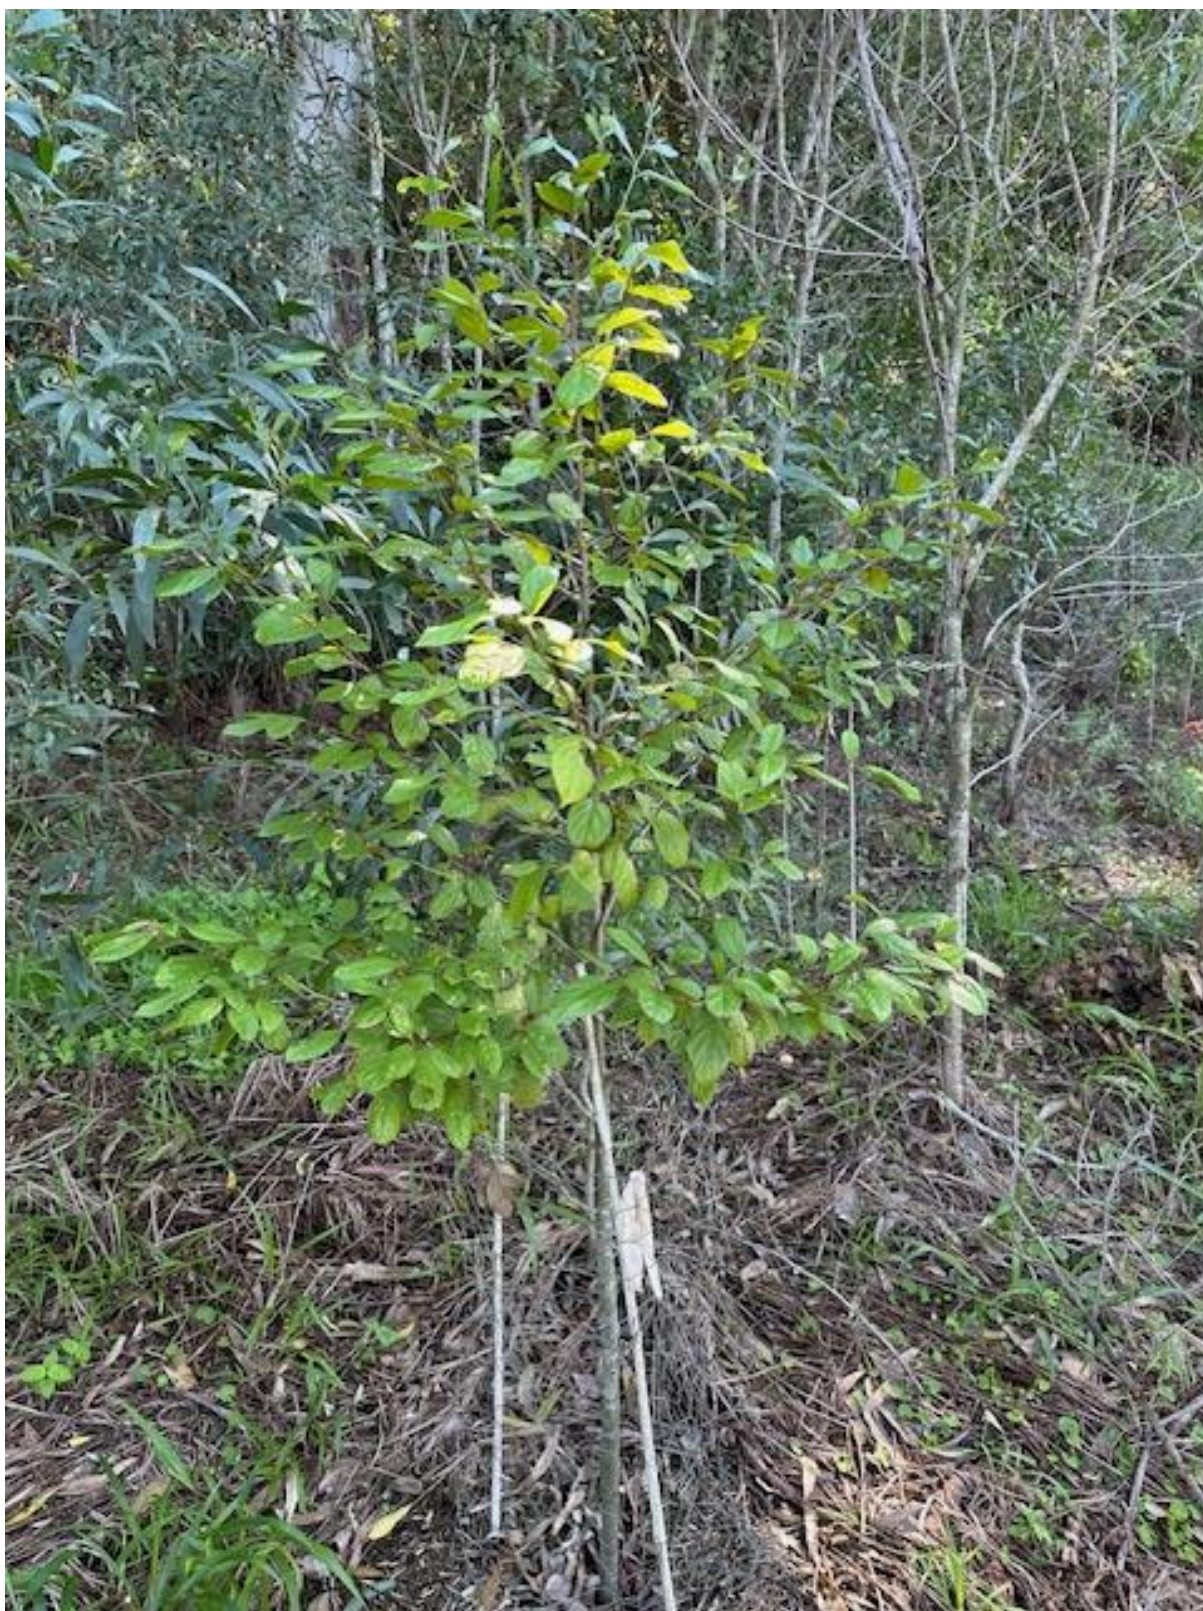
Plate 2: Rusty Green-leaved Rose Walnut 1.6 m high, May 2024, 3 years and 4 months after introduction and approximately 5 years since seed collection.

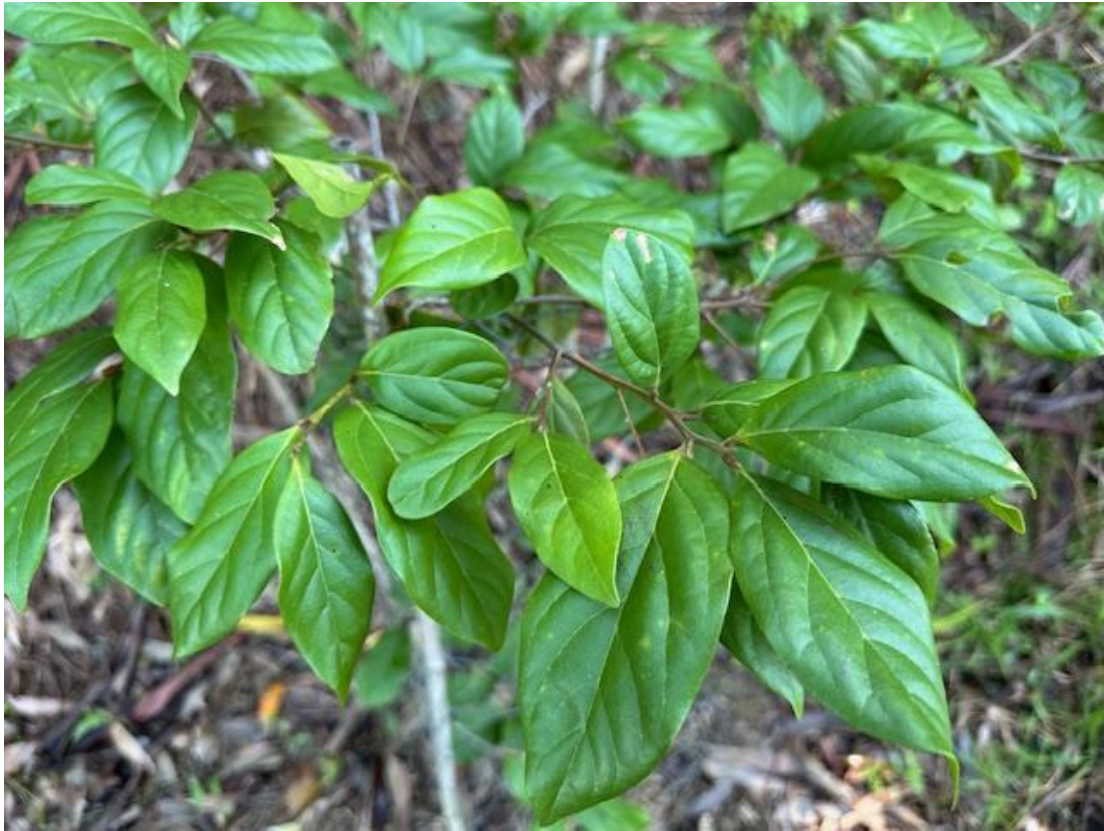
Plate 3: Foliage of Rusty Green-leaved Rose Walnut May 2024. Leaves on most plants were a healthy green colour and yellowing was uncommon.

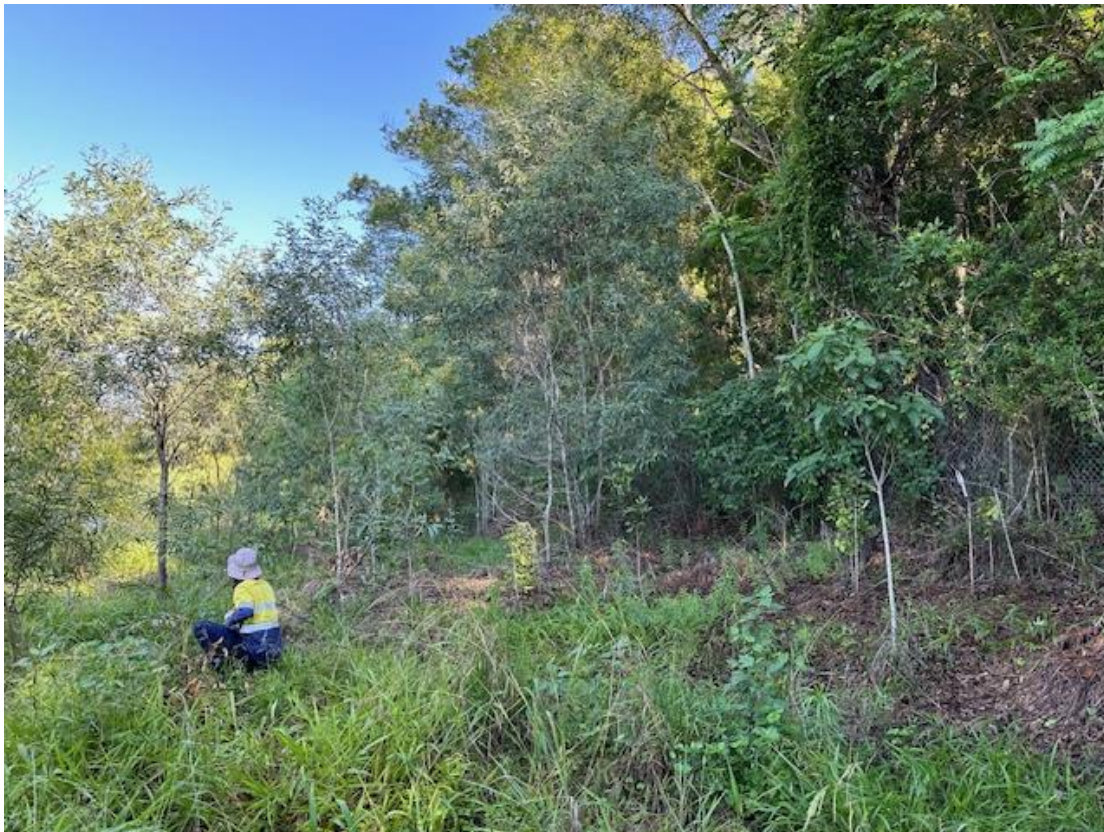
Plate 4: Rusty Green-leaved Rose Walnut recipient site, May 2024. Wire cylinder with RGRW in background. Sheltering regrowth mostly 1.5-3 m high and open so as not to inhibit RGRW growth on the poor soil. Three years and four months after introduction and approximately 5 years since seed collection.

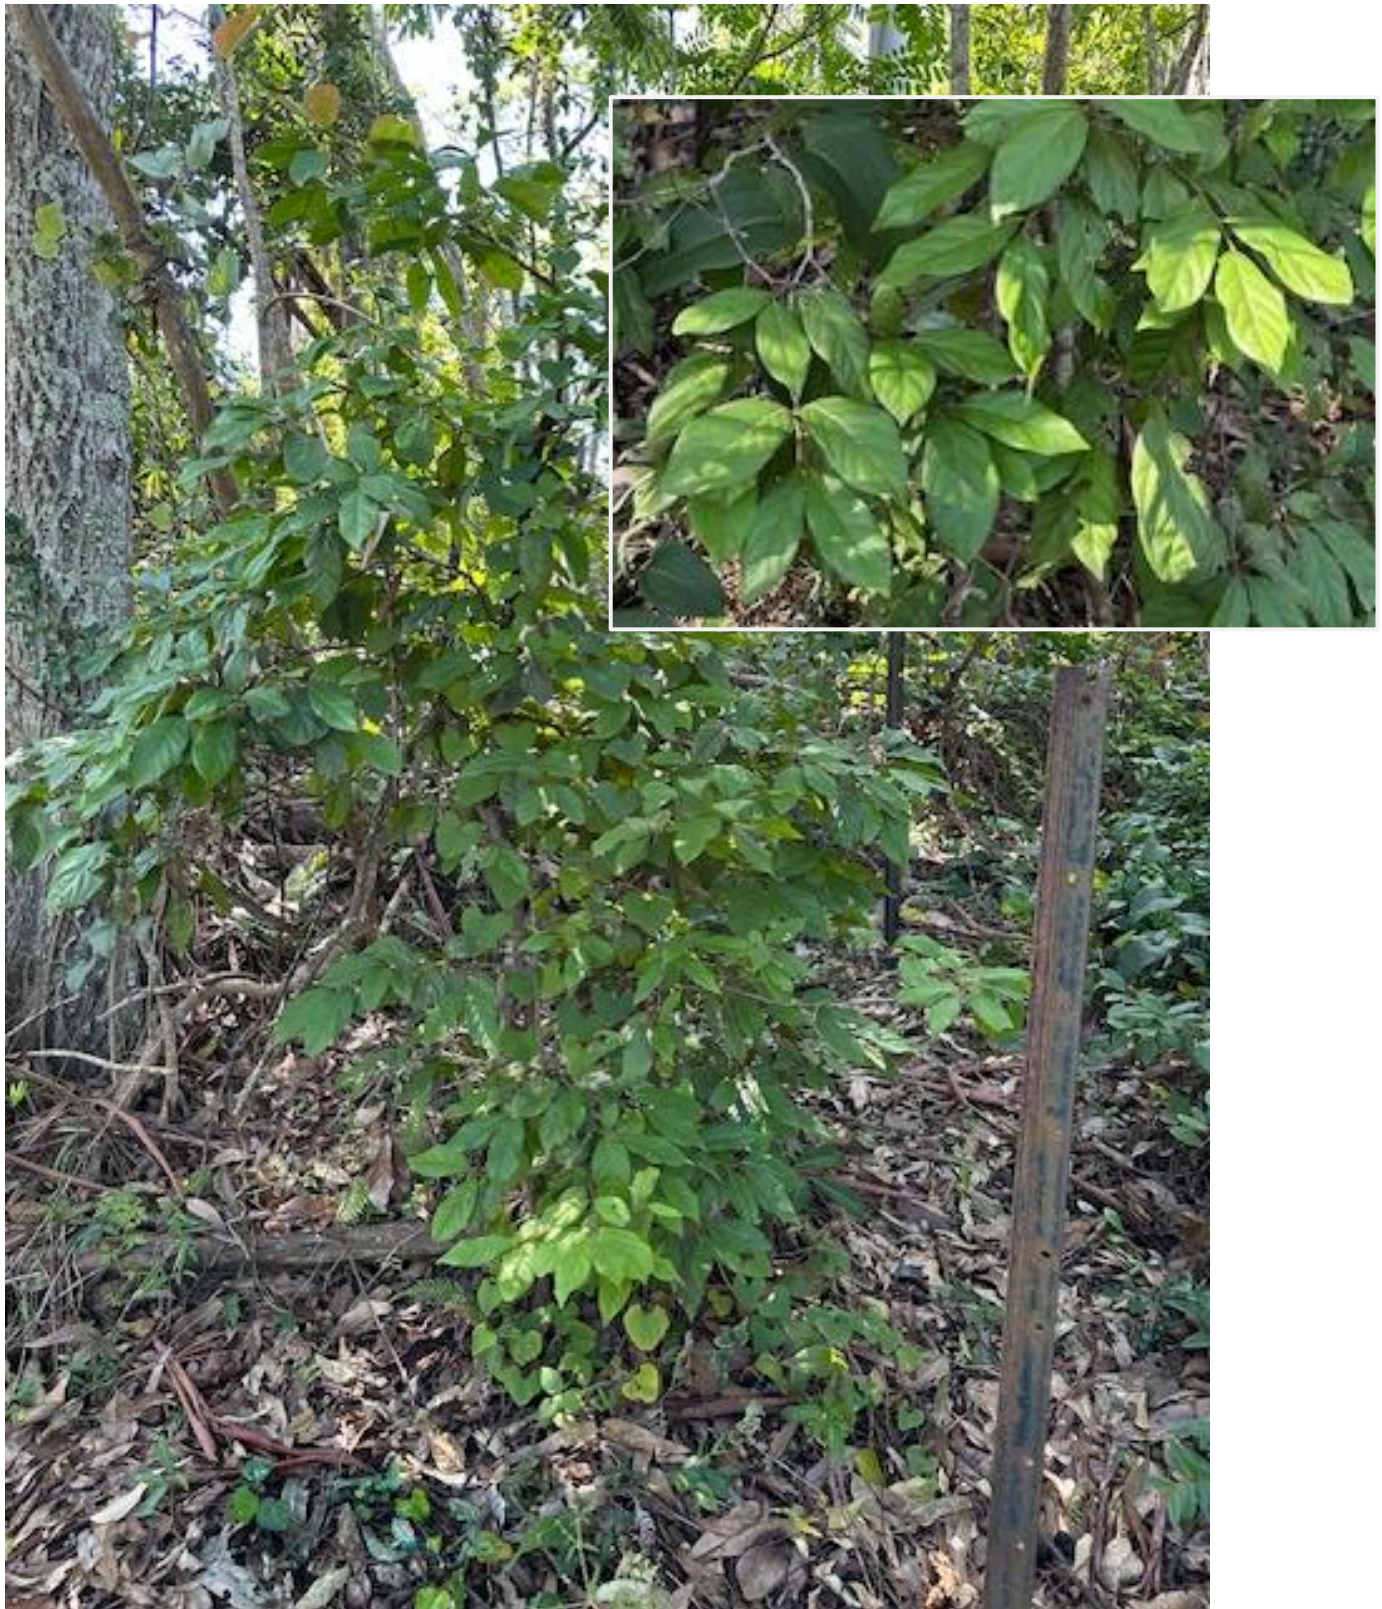
A dense infestation of the exotic vine Dutchmans Pipe (*Aristolochia elegans*) at this site poses a significant threat to the RGRW sapling by smothering. Weed control carried out by Ecos Environmental involved spraying Dutchmans Pipe with glyphosate and metsulfuron (Brush-off). The cut-and-paint method was not applied as copious white sap exuded by cut stems of the vine is reported to be highly toxic and a serious health hazard. Other exotics including three species of Asparagus Fern and Lantana were also sprayed.

Weed control work has substantially reduced the density of Dutchmans Pipe within 10-15 m of the RGRW sapling, however, a large area of the vine extends out 20-30 m, possibly more as it is spreading. The RGRW sapling is in good condition and has increased in height since management began.

Plate 5: In situ Rusty Green-leaved Rose Walnut in the road reserve north of the translocation area, May 2024. Plant healthy and showing growth after treating Dutchmans Pipe (*Aristolochia elegans*), a densely growing exotic vine, for three years. Inset - close-up of RGLW leaves, May/2024.

Action	Dates 2024-2025
Maintenance	
Management Zone 1 <ul style="list-style-type: none">Control grass and weed growth, apply mulch and slow-release fertiliser to plantings	Oct-Nov/24 & May/25
Management Zone 2 <ul style="list-style-type: none">Spray Dutchmans Pipe	Oct/Nov/24 & May/25
Annual Monitoring and Report	May 2025
