Corindi River Flood Assessments

DRAFT REPORT

4 December 2013

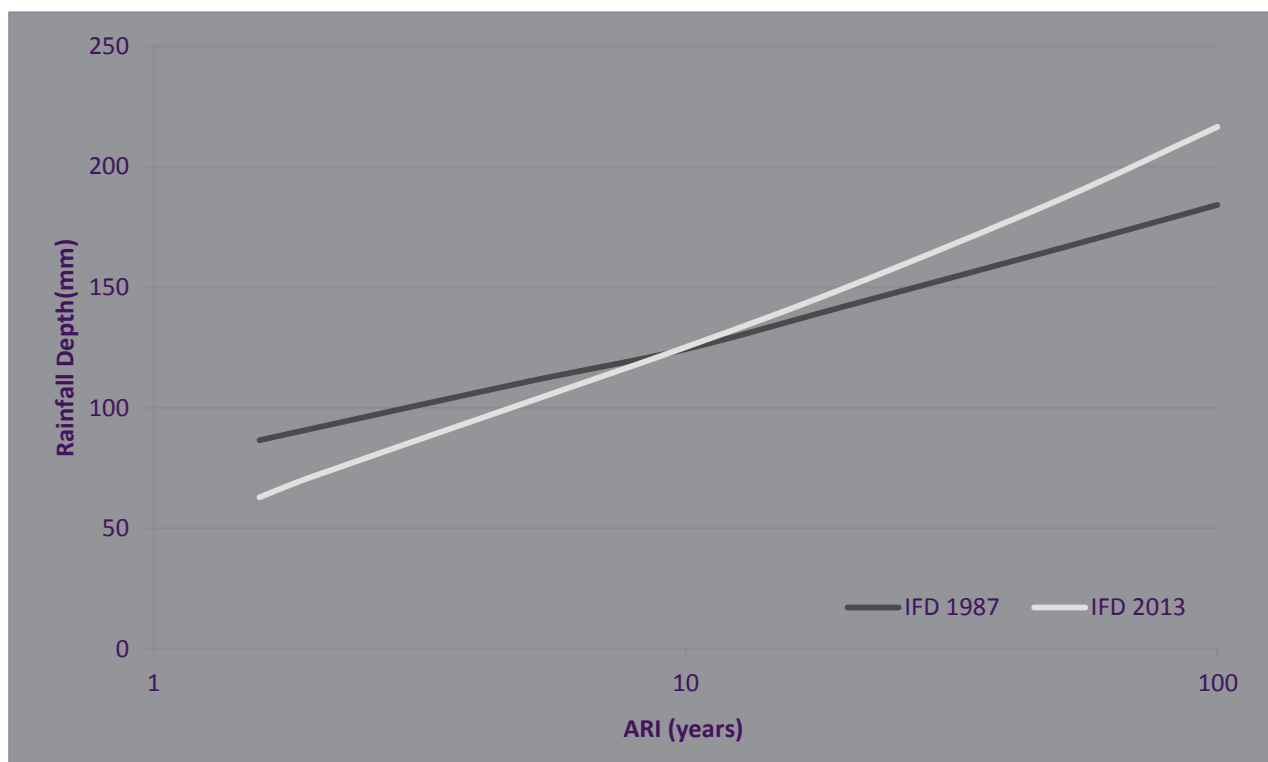
Figure 7.1 : Comparison of 1987 and 2013 point rainfall for Corindi for a 9 hour storm

It should be noted that the values above in **Table 7.1** are catchment-wide average rainfalls whereas the values shown in **Figure 7.1** are for a particular point in the catchment (Corindi). Hence, a direct comparison cannot be made between these two sets of data.

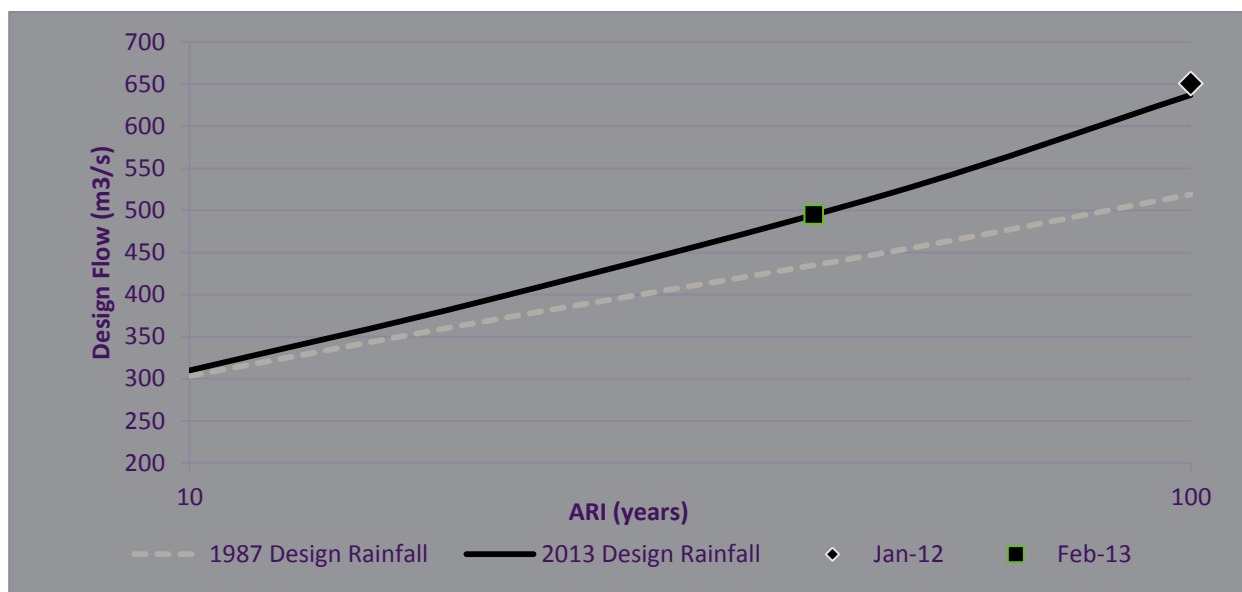
Figure 7.4 : Design flood frequency curve produced from the RORB model (including event peak flows)

This exercise resulted in identifying the rarity of the January 2012 event as about a 100 year ARI event and the February 2013 as about a 40 year ARI event.

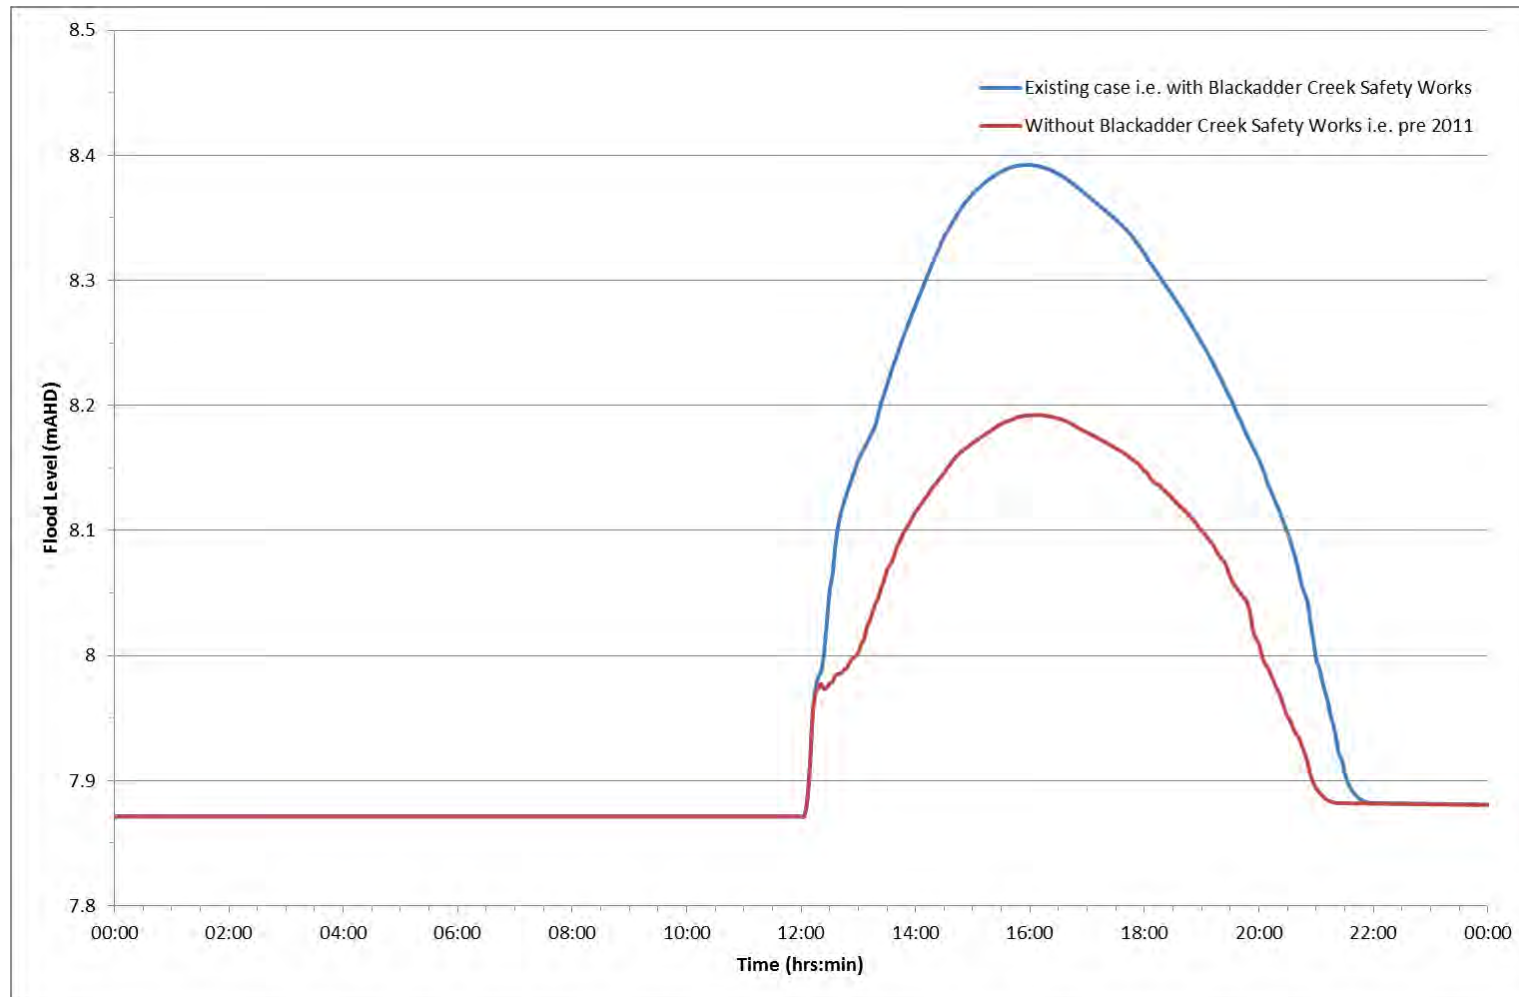
Figure 8.7 : Modelled January 2012 flood levels at Cox Lane: comparison of existing case and pre-BCSW

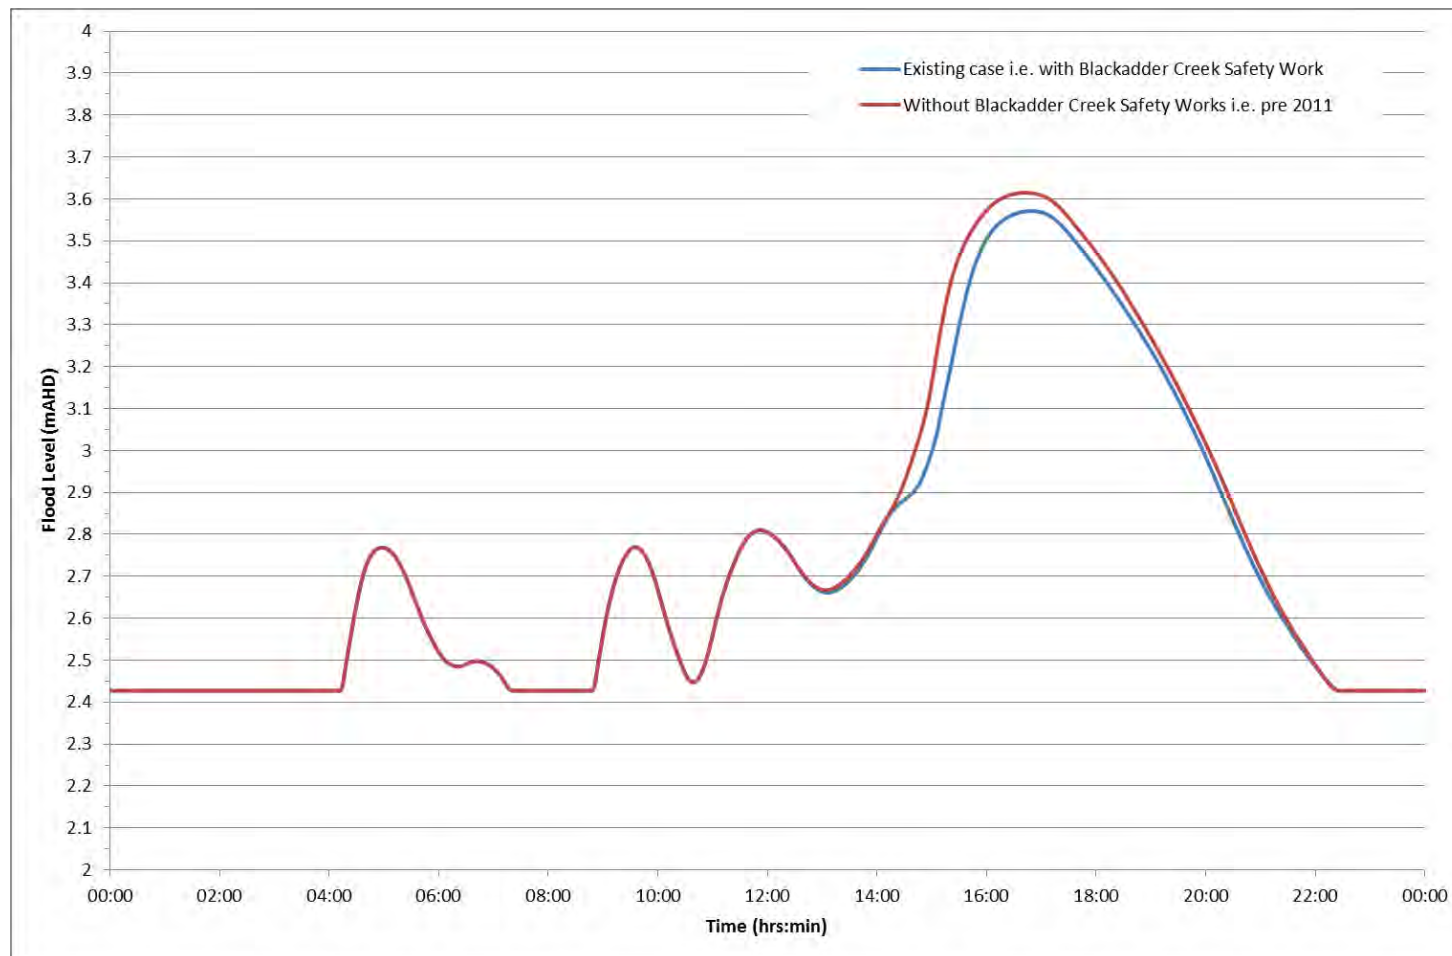
Figure 8.9 : Modelled January 2012 flood levels at NE Corindi Park Drive : comparison of existing case and pre-BCSW

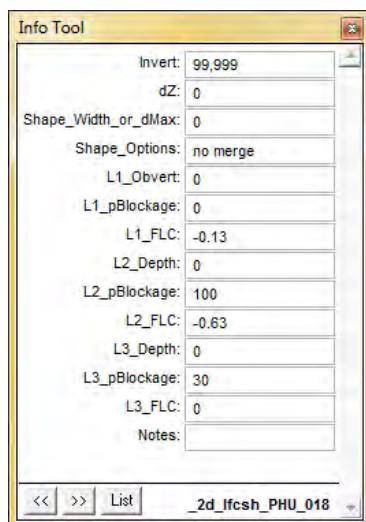
Although a detailed review of the adopted modelling parameters is beyond the scope of this preliminary review, WMAwater identified that the bridge form loss coefficients, used to model the influence of sub-grid scale energy losses such as turbulence at piers, have been set to negative values in the preliminary modelling of the proposed new Pacific Highway alignment (Diagram 4).

Diagram 4: Bridge form loss coefficients

The screenshot shows a software window titled "Info Tool" with a list of parameters and their values. The parameters are: Invert (99,999), dZ (0), Shape_Width_or_dMax (0), Shape_Options (no merge), L1_Obvert (0), L1_pBlockage (0), L1_FLC (-0.13), L2_Depth (0), L2_pBlockage (100), L2_FLC (-0.63), L3_Depth (0), L3_pBlockage (30), L3_FLC (0), and Notes (empty). At the bottom, there are navigation buttons: <<, >>, List, and a dropdown menu showing "_2d_ifcsh_PHU_018".

Parameter	Value
Invert	99,999
dZ	0
Shape_Width_or_dMax	0
Shape_Options	no merge
L1_Obvert	0
L1_pBlockage	0
L1_FLC	-0.13
L2_Depth	0
L2_pBlockage	100
L2_FLC	-0.63
L3_Depth	0
L3_pBlockage	30
L3_FLC	0
Notes

It is recommended that the implementation of these form losses be reviewed and if possible verified by alternative methods (e.g. Bradleys method or HEC-RAS) during the next modelling phase.
