# Nambucca Heads to Urunga

Low Noise Diamond Grinding  
Pavement Noise Monitoring

Roads and Maritime Services | July 2019

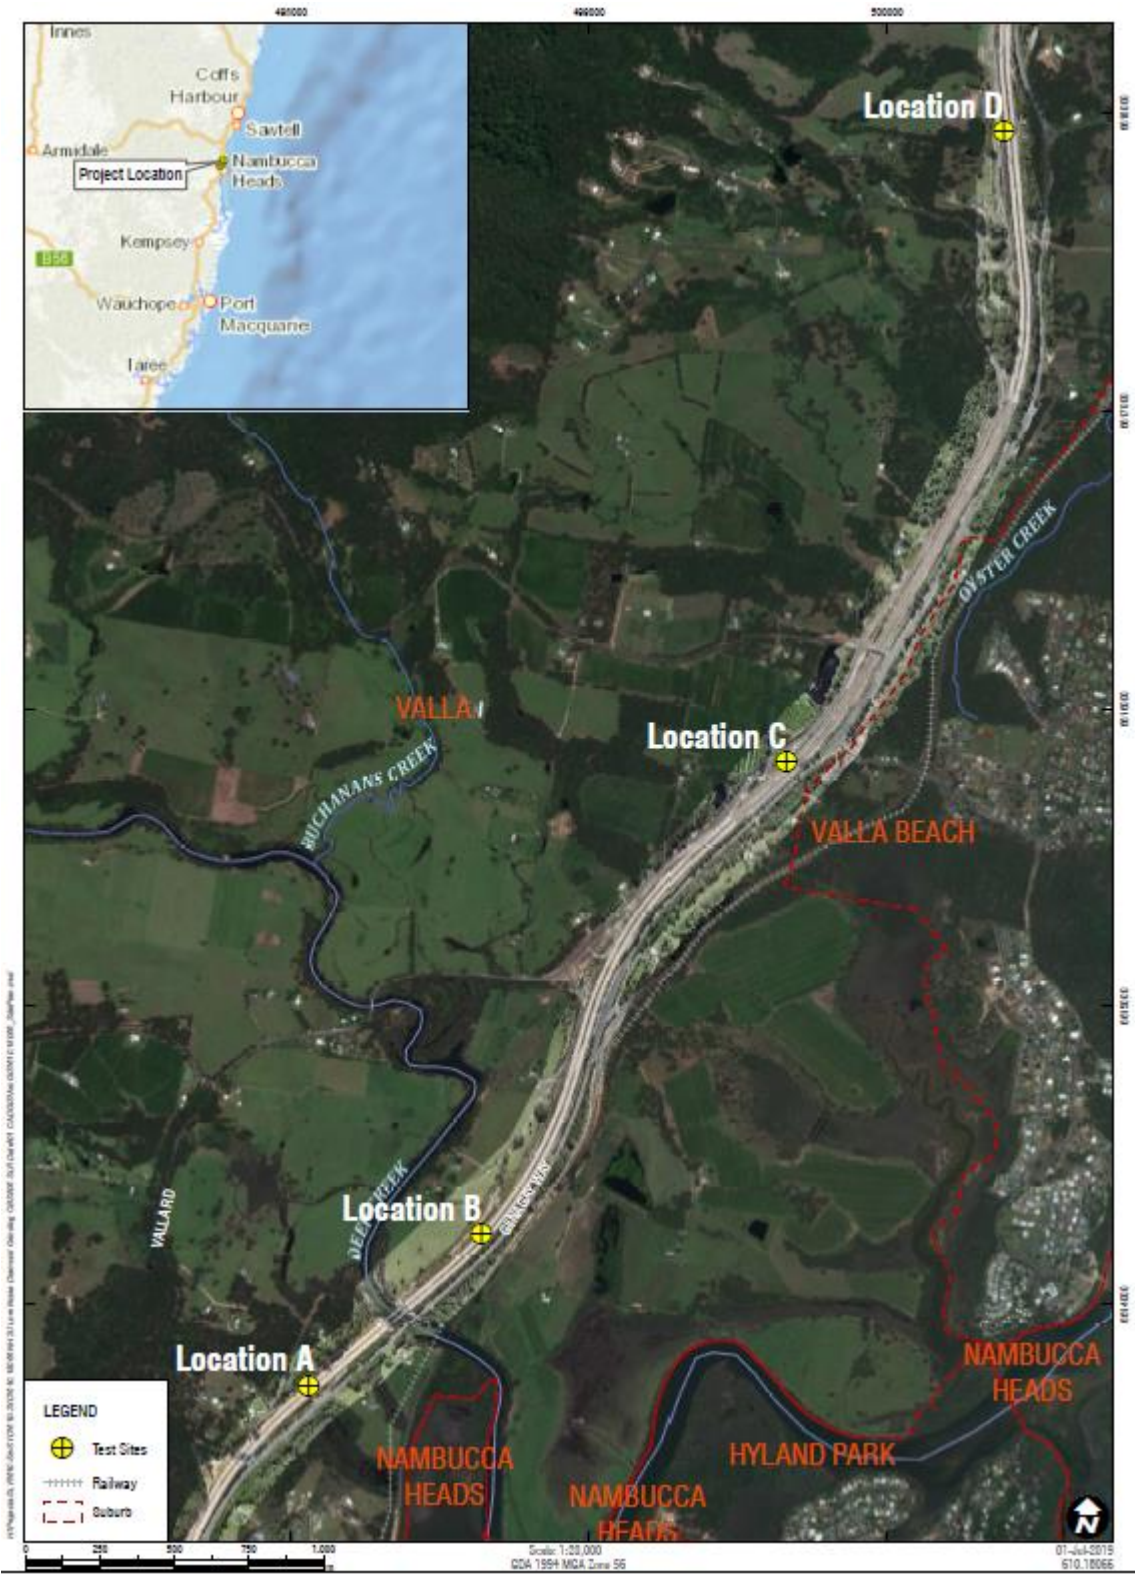
Figure 1 Test Locations

Details of the four test sites are provided in **Table 1** and are shown in **Figure 1**.

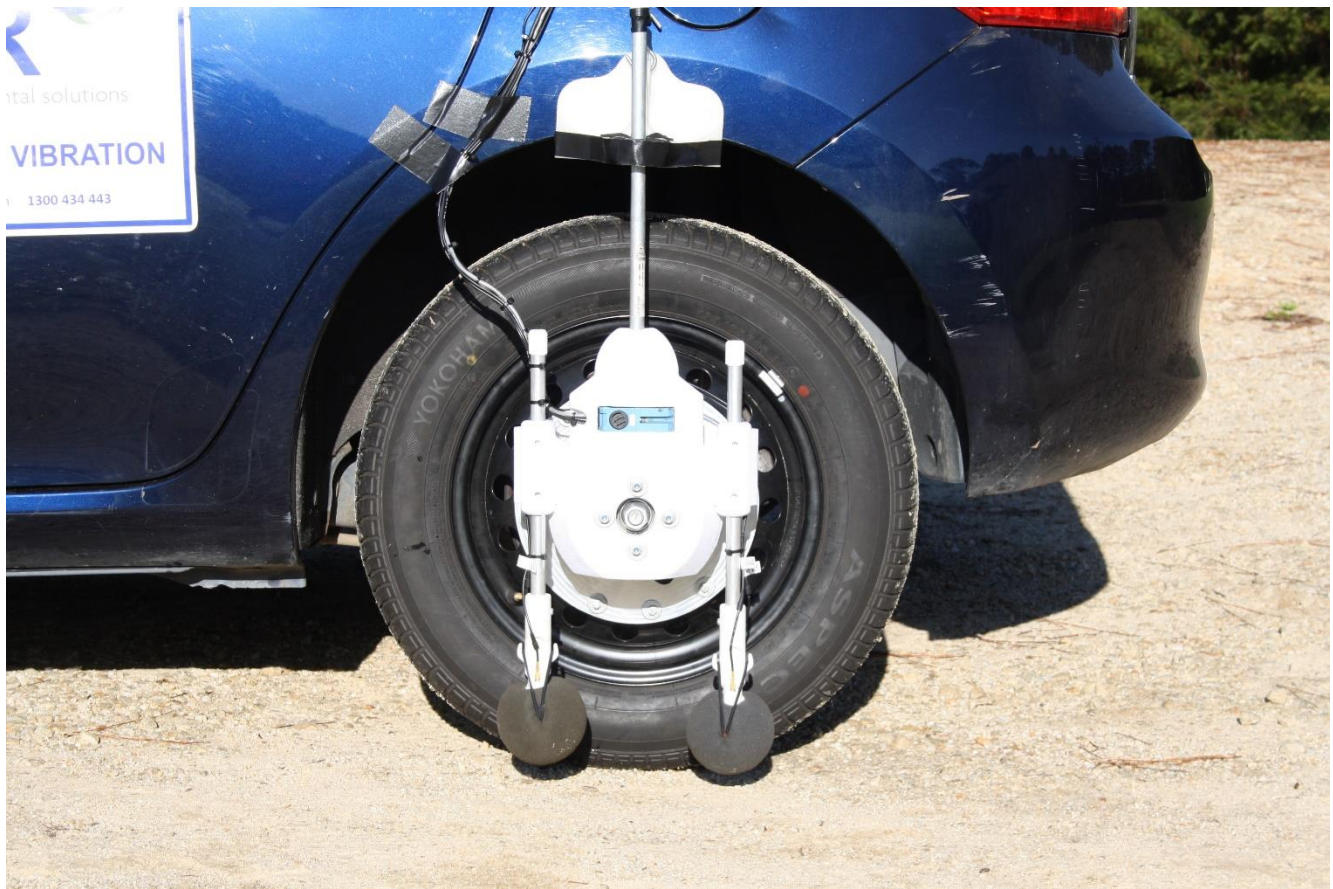
**Figure 3 OBSI System**

The OBSI system is shown below in **Figure 3**.

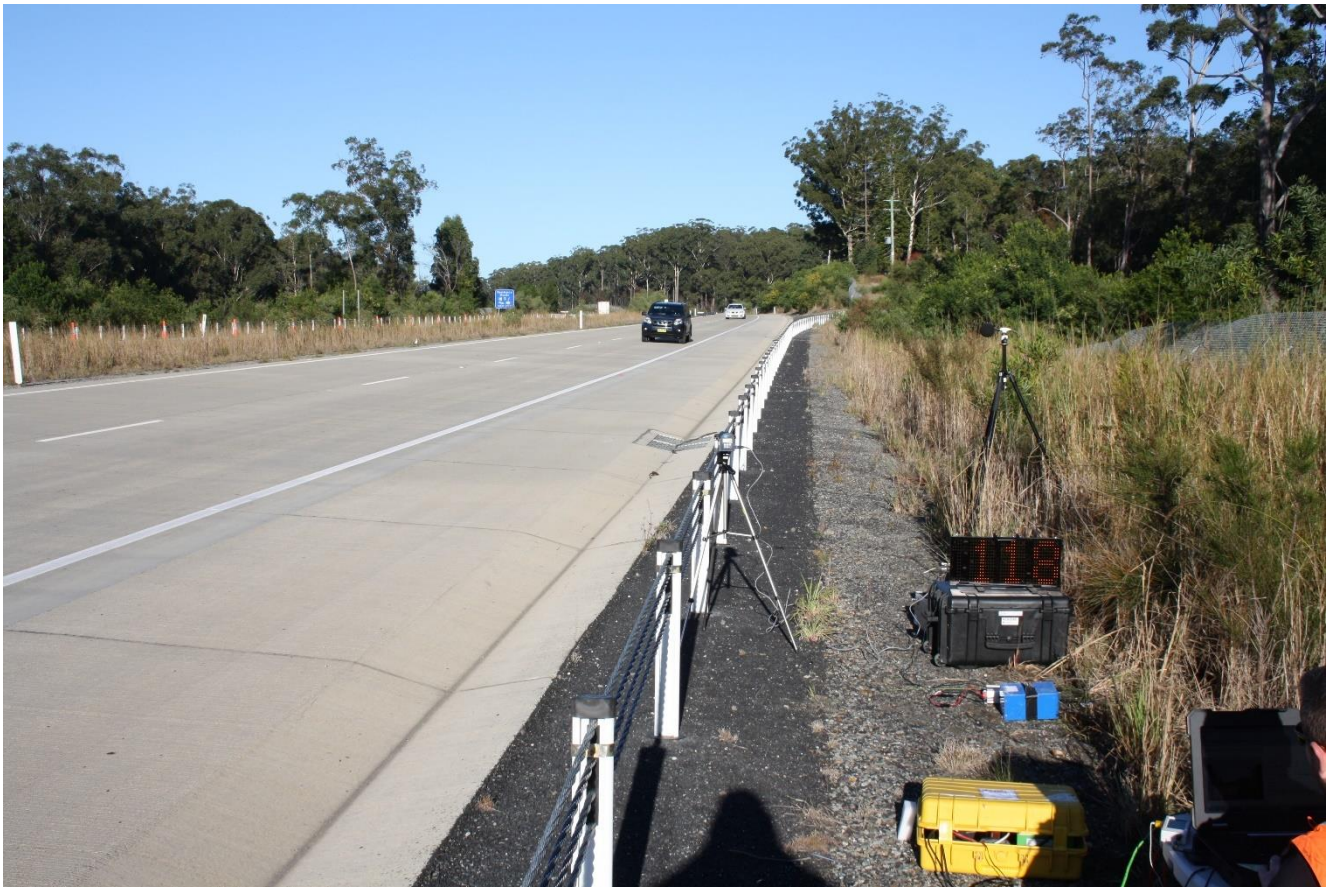
Figure C9 Typical SPBI Measurement Setup – Location A (LNDG 3 Pass) Pre-Grind

| Item | Details |
|---|--|
| Location | At a distance of 7.5 m from the centre of the test lane and at a height of 1.2 m above the road surface. |
