Woolgoolga to Ballina Pacific Highway Upgrade

Threatened Glider Monitoring for Sections 1 & 2: Year 1

November 2018

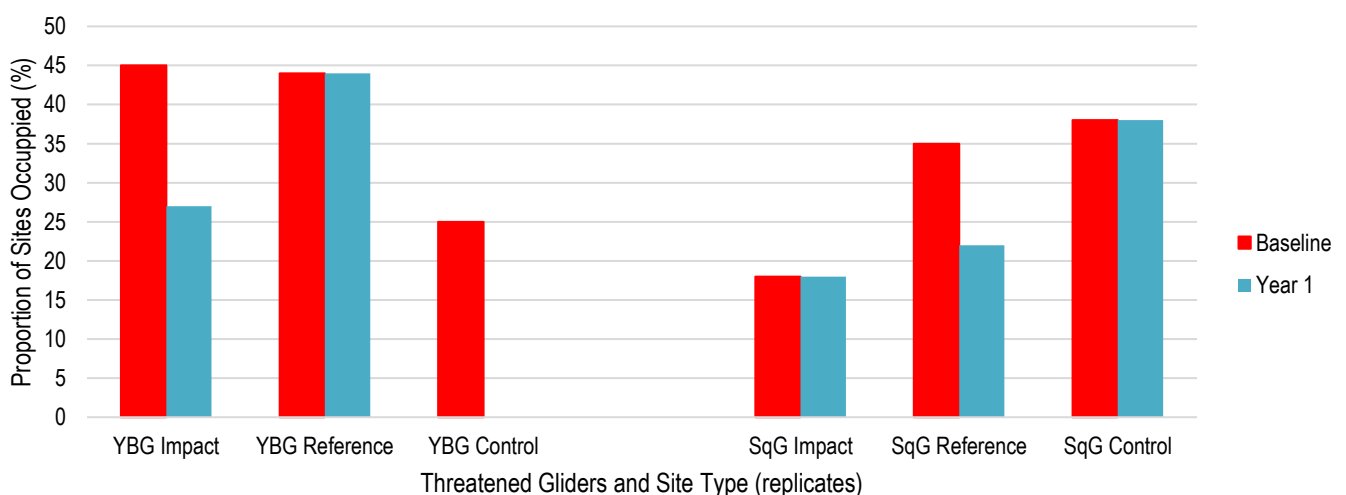
Figure 3-1. Comparison of site occupation rates for threatened gliders between the baseline survey and year 1.

To accord with previous baseline surveys (SES 2014), site occupancy for threatened gliders (YbG, SqG) has been calculated using “occupied” versus “absent” with the survey data pooled for the four seasonal surveys (see Goldingay 2014 and SES 2014). Year 1 sampling recorded YbG at 44% of the reference sites compared with 27% at the impact sites (Figure 3-1; Figure 3-2). No YbG occupation was recorded at the control sites. In the case of SqG, occupation rate was highest at the control sites (38%) which is close to double that of the impact (18%) and reference sites (22%; Figure 3-1; Figure 3-2).

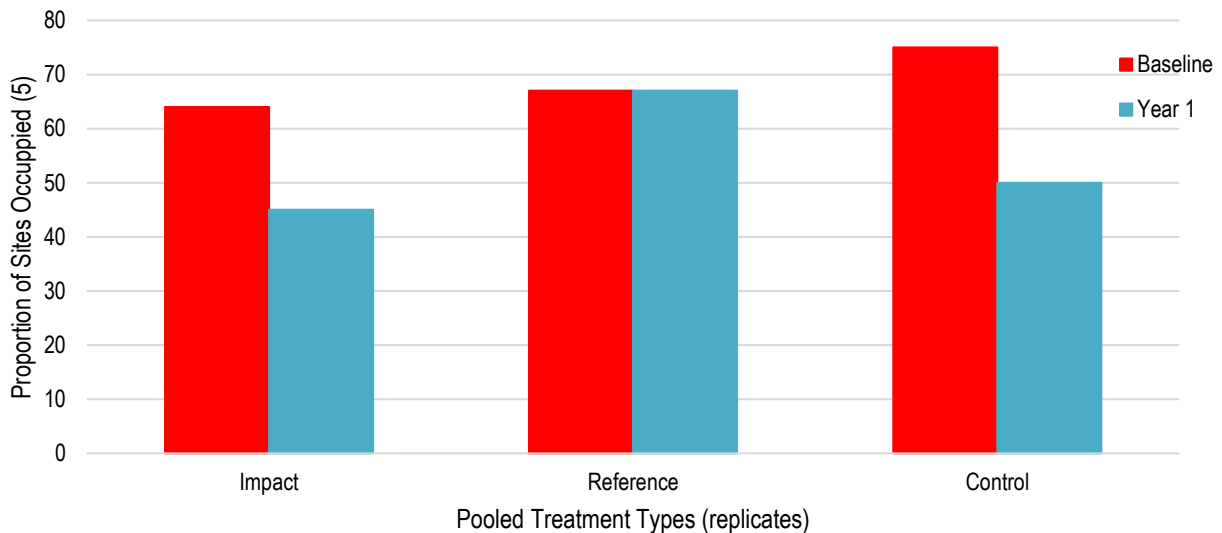
Figure 3-2. Comparison of site occupation rates for pooled threatened gliders between the baseline survey and year 1.
