PACIFIC HIGHWAY UPGRADE: WOOLGOOLGA TO BALLINA

Sections 1 and 2 Green-thighed Frog Construction Monitoring: Year 2

November 2018

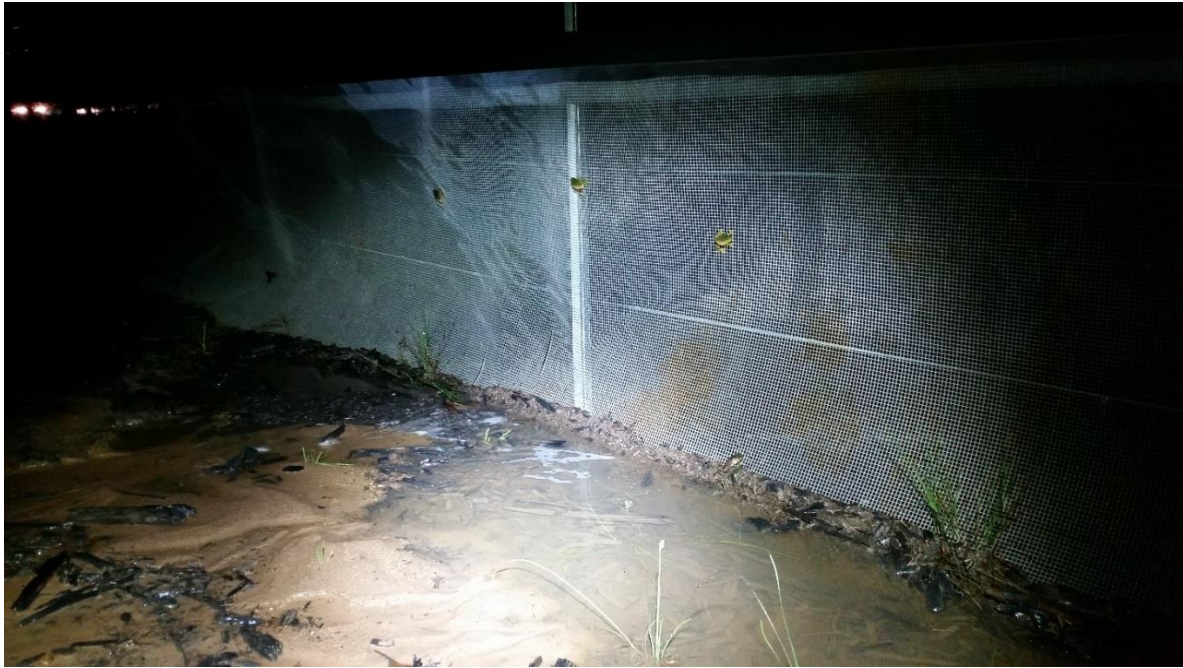
Although no Green-thighed Frogs were found in close proximity to the frog exclusion fence, numerous other species of frog were recorded on both the habitat and road side of this fence (Table 3-3). Numbers of frogs were generally four to seven times higher on the habitat side of the fence indicating the fence design is effective at reducing frogs accessing the carriageway. Observations included both ground dwelling and tree frogs, the latter of which often choose to use the fence as a calling site adjacent to flooded ponds. At Site 4A, an equal number of frogs were recorded on either side of the fence.

Plate 3-1. Hylid tree frogs (*Litoria gracilentia*) using the habitat side of the frog exclusion fence as calling sites at Halfway Creek (Site 2A).

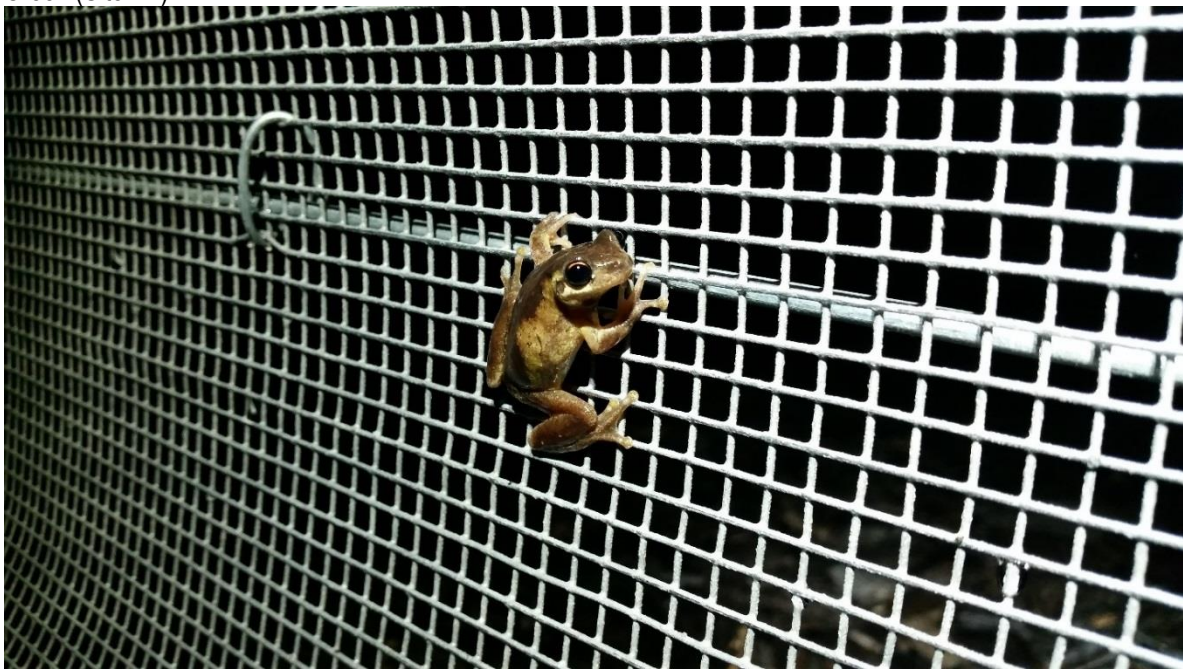
Plate 3-2. Example of other hylid frogs (i.e. *Litoria dentata*) using the habitat side of the frog exclusion fence at Site 5A.
