Woolgoolga to Ballina Pacific Highway upgrade

Threatened Rainforest Communities and Rainforest Plants Monitoring Program Annual Report 2018

Construction Phase Report

Woolgoolga to Ballina Pacific Highway Upgrade, Sections 10 & 11, Threatened Rainforest Communities and Rainforest Plants, Annual Monitoring Report # 2 (2018)

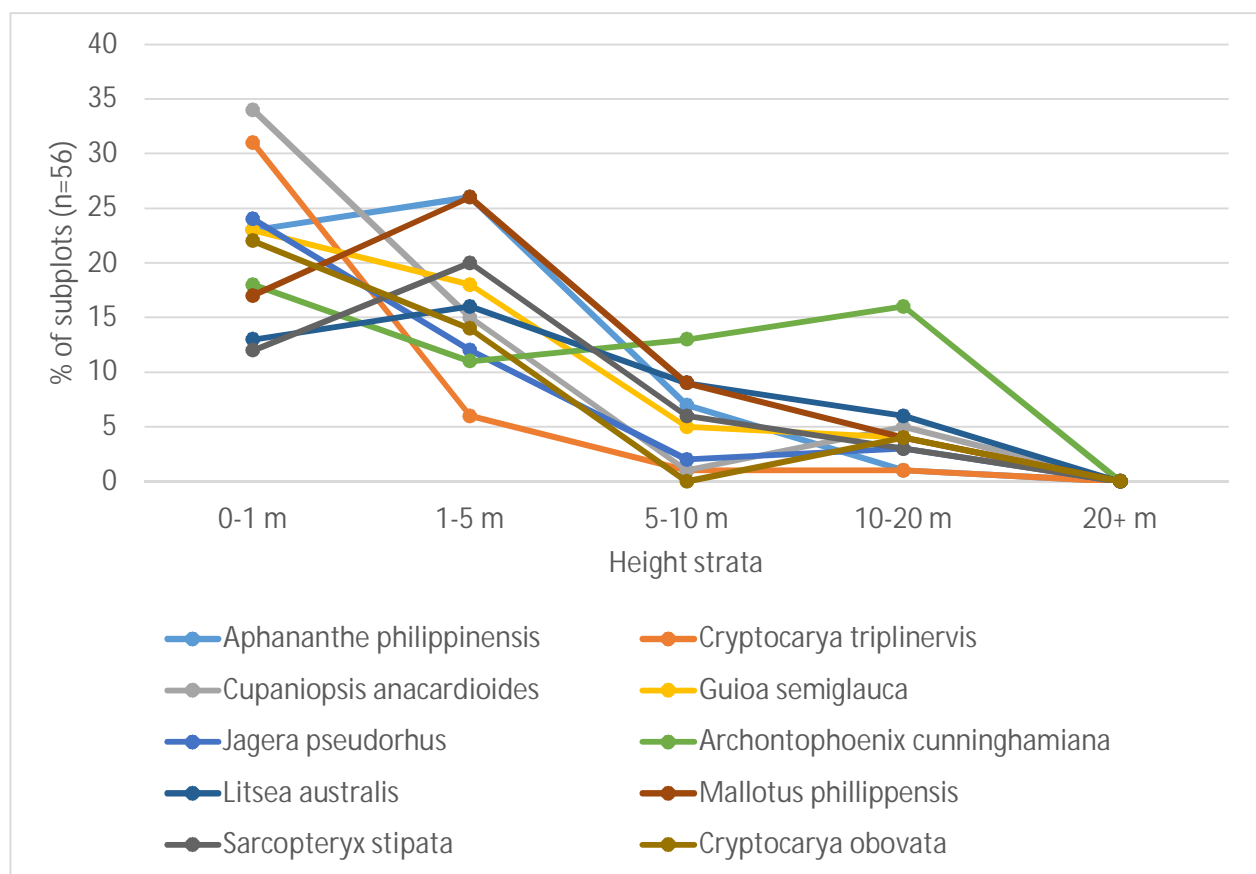
Figure 6. Frequency of the ten most actively recruiting native tree species in each height stratum. Data recorded Spring 2018.

Figure 6 shows the frequency of these ten native tree species in each stratum. All species except *A. cunninghamiana* appear to be common in the lower two strata but progressively less frequent in the mid and high strata. From this we can infer that either there has been a relatively recent burst of recruitment in the rainforest communities or saplings are not surviving to reach the mid and high stratum, which . We can also infer that either reproductively mature individuals in the 1-5 m stratum are mostly the source of seedlings in the 0-1 m stratum, or seed is coming from larger trees outside the monitoring plots. As there are no mature stands of rainforest in the study area, the latter explanation seems unlikely so young trees in the 1-5 m stratum, just reaching maturity, must be the source. As stands of *A. cunninghamiana* (Bangalow Palm) were rarely harvested for timber, it is not surprising that this species is still common in the 10-20 stratum in swamp rainforest plots.

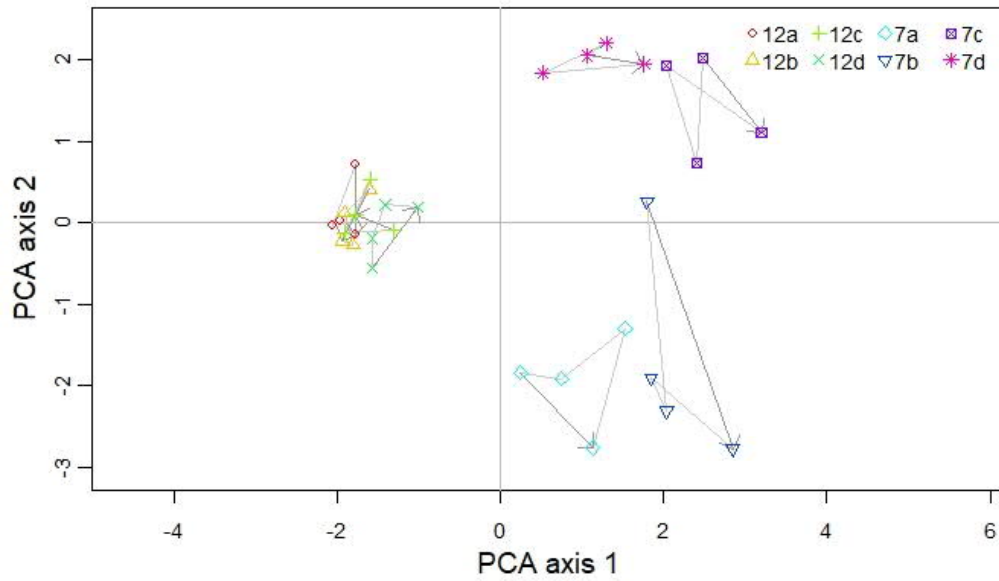
Figure 3. Principal Component Analysis (PCA) of subplots of Plot 7 (impact) and Plot 12 (control), sampled February 2014, autumn 2017, spring 2017 and spring 2018. Lines connect points of the same time series and an arrow points from the initial state (February 2014) to the final state (spring 2018).

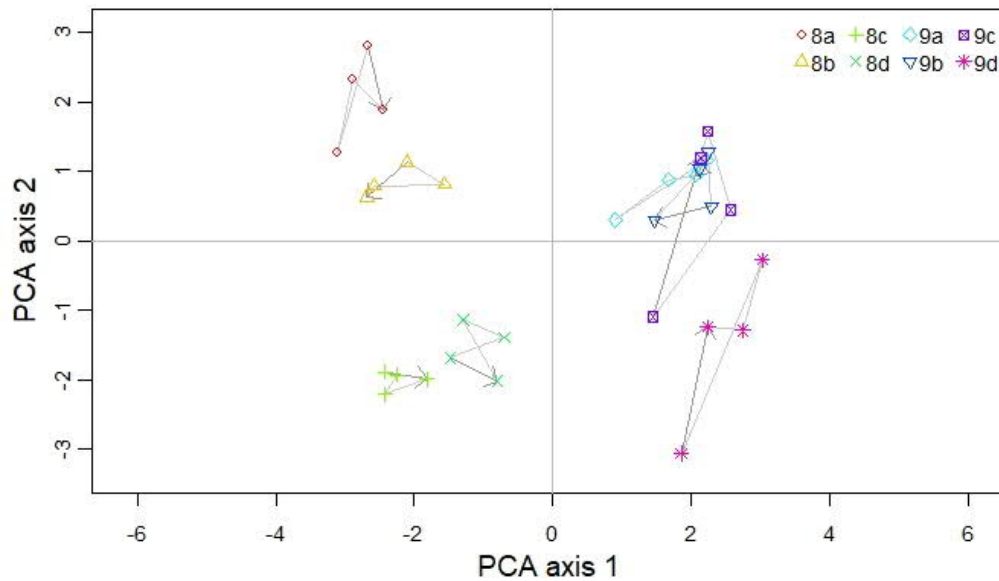
Figure 4. Principal Component Analysis (PCA) of subplots of Plot 8 (impact) and Plot 9 (control), sampled February 2014, autumn 2017, spring 2017 and spring 2018. Lines connect points of the same time series and an arrow points from the initial state (February 2014) to the final state (spring 2018).
