Woolgoolga to Ballina Pacific Highway upgrade

Threatened Frog Monitoring Annual Report 2018/19

Version 3.0

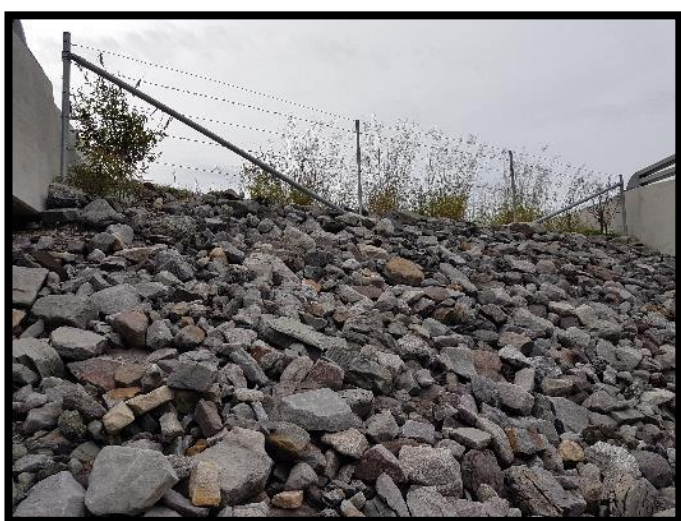
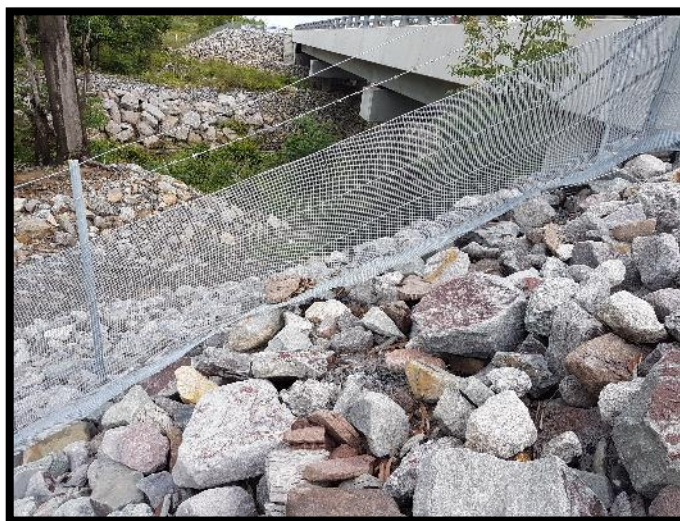
Surveys of the permanent frog fence found no Giant Barred Frogs on the carriageway side of the fence. There were a number of potential breach points for frogs to move up onto the highway, namely no frog fence installed between the bridges, numerous gaps at the bottom of the frog fence along with the fence return installed the opposite way (Plate 3-2).

Plate 3-2. Missing frog exclusion fence at Corindi Creek on the northern abutment (left) and frog fence return facing the opposite way along with numerous holes at the bottom of the fence (right).

Corindi Creek - One adult female (735D21B) was recorded moving from approximately 80m downstream to approximately 70m upstream side of bridge between Year 3 and Year 4. As the population is likely to contain less than 100 frogs over this 500m section of creek, this is considered a demonstrated success of the habitat connectivity mitigation measures used at this site. Surveys along the permanent frog exclusion fence found no barred frogs on the road side, however, there were a number of potential breach points, namely where the fence travels over uneven ground such as the bridge abutments covered with large aggregate along with the fact it has been recessed along the ground in the opposite and incorrect way (Plate 3-2). Furthermore, the frog fence between the two carriageways is missing thus enabling frogs to access the carriageway (Plate 3-2).

Recommendation No	Recommendation	Transport for NSW
1.	Revert to transect length of 500m at Pigeon Gully and Dirty Creek.	Adopted - Increasing transect length confirmed the site is a constant state of fluctuation. Agree to revert back to original transect length.
2.	Transport for NSW review the frog fencing design and perform a site inspection to assess fence extents and design for adequacy at Corindi Creek between ch. 3500-3800 with particular attention given around the bridge abutments, Boneys Creek between ch.13250-13350 focusing around the tie in points of the culvert and Halfway Creek between ch. 20700-20900 focusing on the bridge abutments.	Adopted - Transport for NSW will inspect and undertake fencing rectification as required.

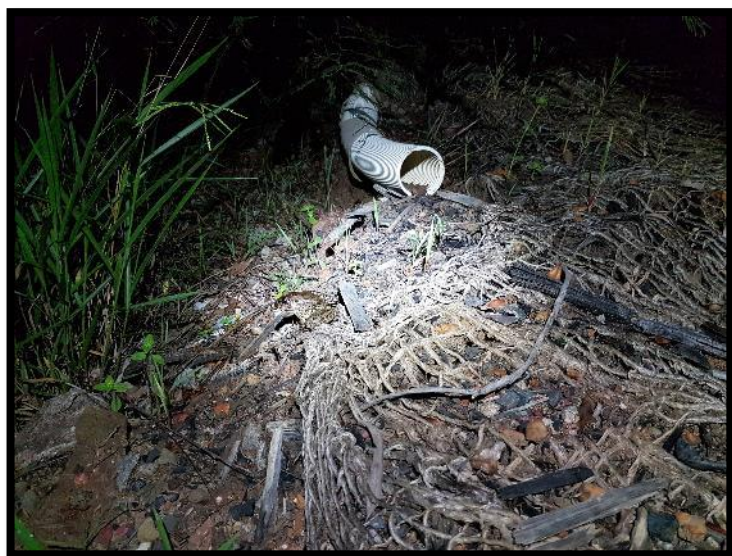
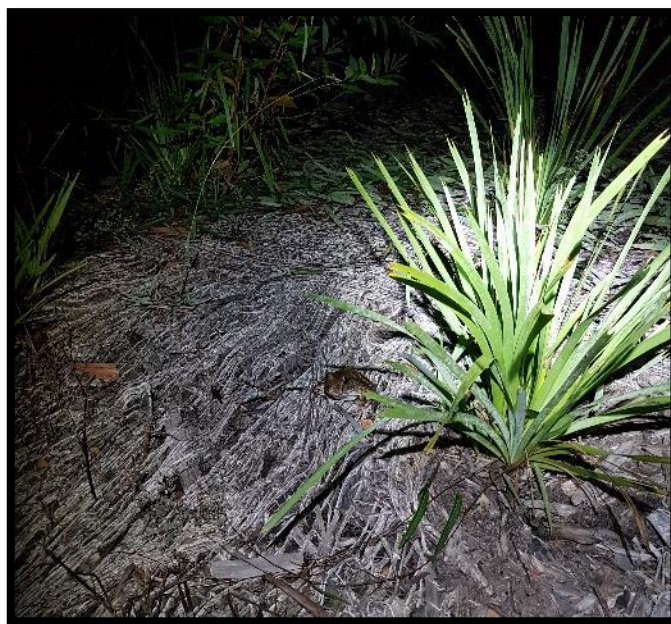
Halfway Creek (Site 3A) – Six of the captures were from previous monitoring events and there was no evidence to suggest any of these have crossed beneath the bridge. Five frogs have been recorded using the rehabilitated areas and this includes both the northern and southern banks on both the upstream and downstream sides of the bridge (Plate 3-3).

Plate 3-3. Adult male frog using the southern bank rehabilitated area and female using the northern bank planting bed.

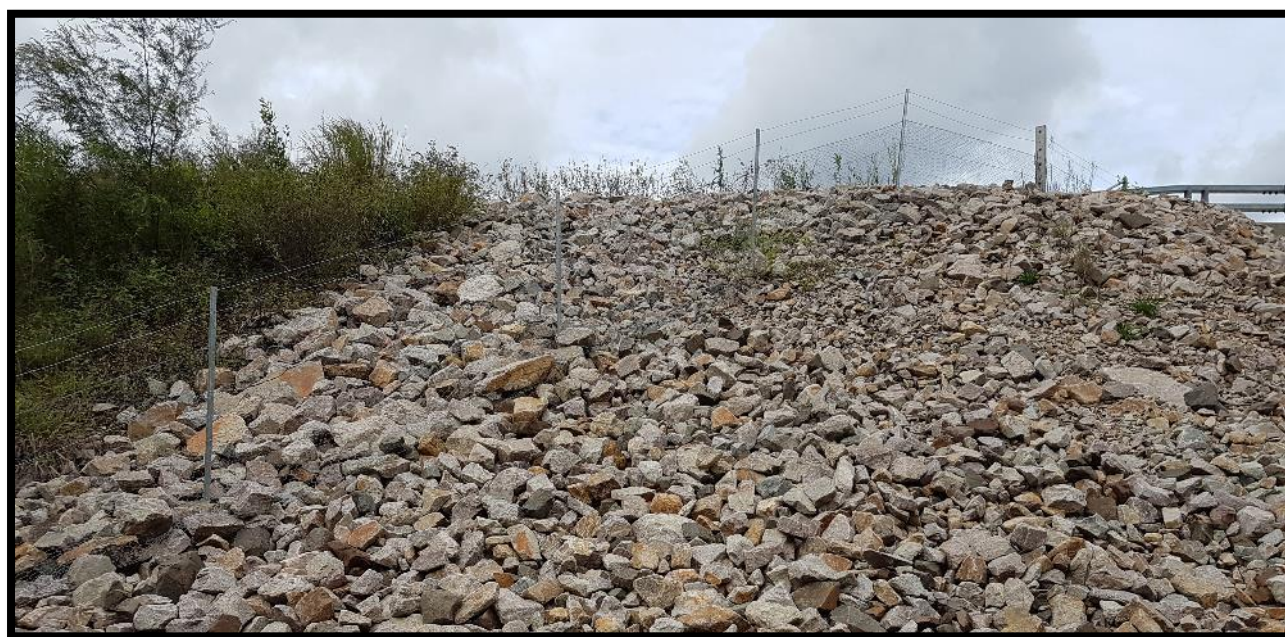
No barred frogs were found along the carriageway side of the permanent frog fence. During these inspections, some of the installed frog fence is not consistent with the designs and was found to contain a large gauge mesh size that would only prevent larger barred frogs from accessing the carriageway, or trapping frogs as they attempt to move through it (Plate 3-4).

Plate 3-4. North bound fence on the Halfway Creek bridge abutment showing large aperture wire not suitable as frog fence.

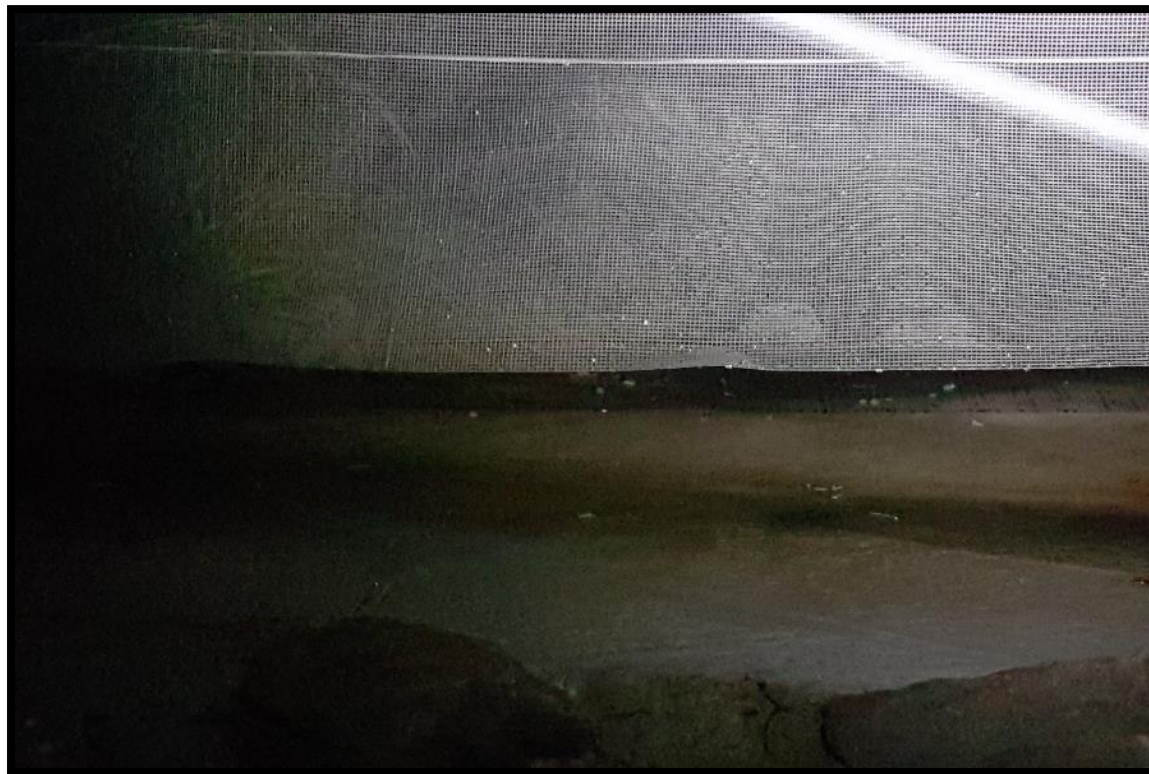
Boney's Creek (Site 4A) – No recaptures were recorded at this site during Year 4 and all eight previously PIT tagged frogs were captured on the downstream side of the carriageway. No Giant Barred Frogs were found on the carriageway side of the fence as part of permanent frog fence surveys. There are however, a number of potential breach points where the bottom of the fence should connect with the natural or reinstated ground (Plate 3-5).

Plate 3-5. Example of permanent frog fence at Boney's Creek that hasn't been pinned to the reinstated ground.

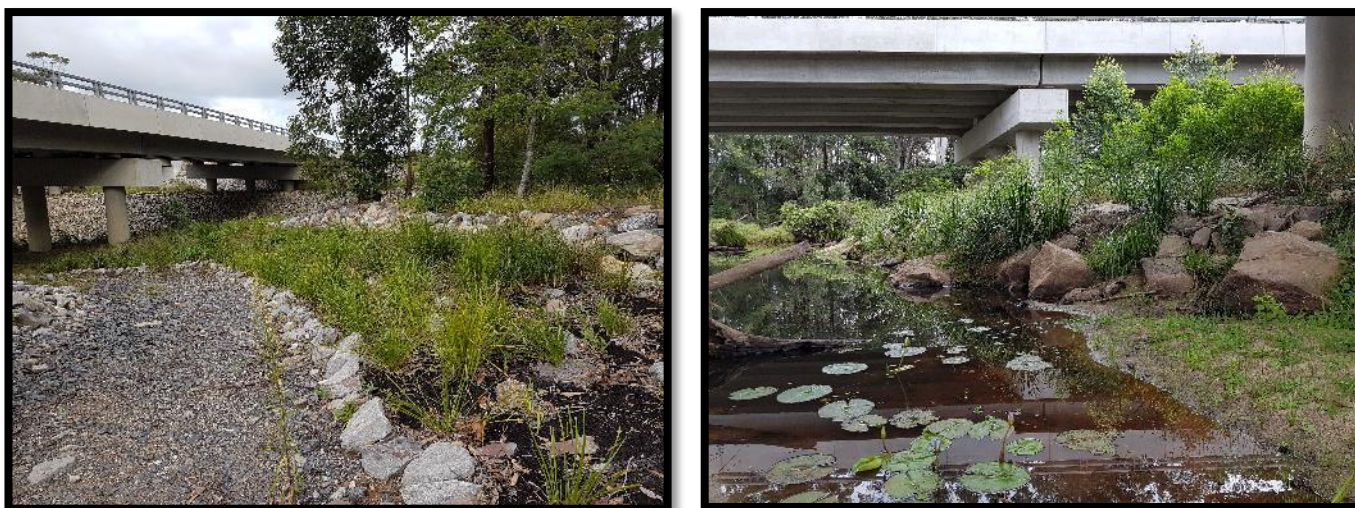
Corindi Creek - Planting failures were measured at 5% (Plate 3-6). Total weed coverage was measured at 8% and limited to the outer edges of planting beds. This is within the accepted tolerance level of 10% in the first year and 20% over the three year maintenance program. Past bank erosion has been addressed on the southern stream bank with large stone pitching. On the northern downstream bank, tree stumps have been used. Both appear effective at reducing or eliminating erosion of this highly dispersive sandy loam in Year 4.

Plate 3-6. Planting beds upstream of the bridge on the upper stream bank (left) and along the streambank edge (right).

Corindi Creek - Planting failures were measured at 5% which is within the accepted tolerance level of 10% in the first year and 20% over the three year maintenance program. Total weed coverage was measured at 8% and limited to outer edges of planting beds. This is within the accepted tolerance level of 30% cover.

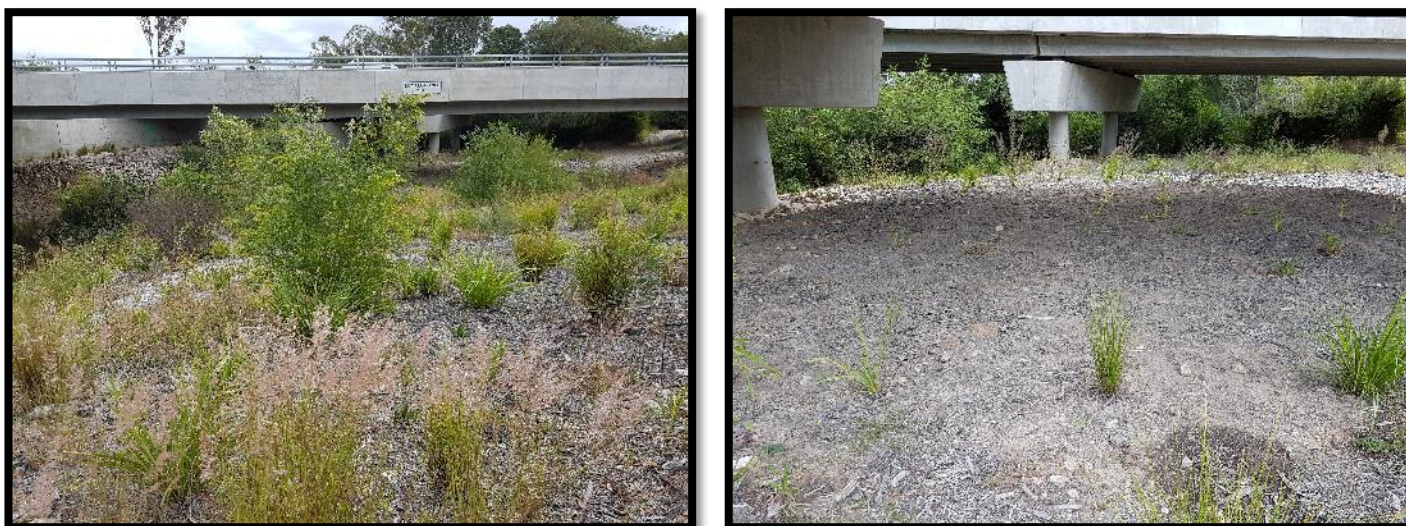
Halfway Creek (3A) - Planting failures were measured at 8% and were concentrated to those beds beneath the bridge spans that receive little or no natural rainfall (Plate 3-7). This is within the accepted tolerance level of 10% in the first year and 20% over the three year maintenance program. Total weed coverage was measured at 12% and became more prevalent on the outer edges of the planting beds, particularly on the northern bank upstream of the south bound bridge (Plate 3-7). Here, most of the weeds are perennial grasses and annual herbaceous ground covers. There was no sign of current bank erosion with some large aggregate used as part of rehabilitating the southern bank.

Plate 3-7. Planting beds upstream of the bridge (left) versus planting beds beneath the bridge (right) with no rainfall.

Halfway Creek (3A) - Planting failures were measured at 8% and were concentrated to those beds beneath the bridge spans that receive little or no natural rainfall. Despite this, the overall planting failures in the riparian zone are still within the accepted tolerance level of 10% in the first year and 20% over the three year maintenance program. Total weed coverage was measured at 12% and falls within the accepted 30% ground cover tolerance. There was no sign of current bank erosion with some large aggregate used as part of rehabilitating the southern bank.

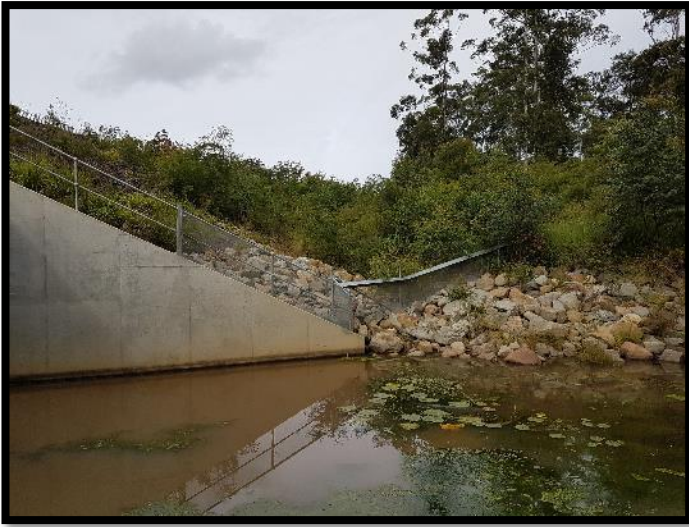
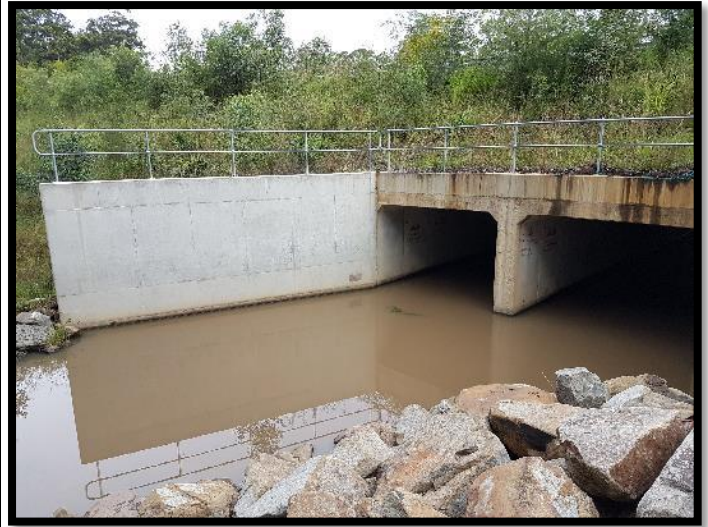
Boneys Creek (4A) - Planting failures were measured at 10%. Total weed coverage was measured at 18% and became more prevalent on the outer edges of the planting beds. This is within the accepted tolerance level of 10% in the first year and 20% over the three year maintenance program. There was no sign of current bank erosion with some large aggregate used to dissipate stream flows during flood events (Plate 3-8). Interestingly, most of the riparian zone consists of large

Plate 3-8. Planting beds upstream of the bridge (left) versus planting beds beneath the bridge (right) with no rainfall.

Boneys Creek (4A) - Planting failures were measured at 10% and fall within the accepted tolerance level whilst the total weed cover was measured at 18% and within the accepted 30% tolerance level. There was no sign of current bank erosion with some large aggregate used to dissipate stream flows during flood events (Plate 3-10).

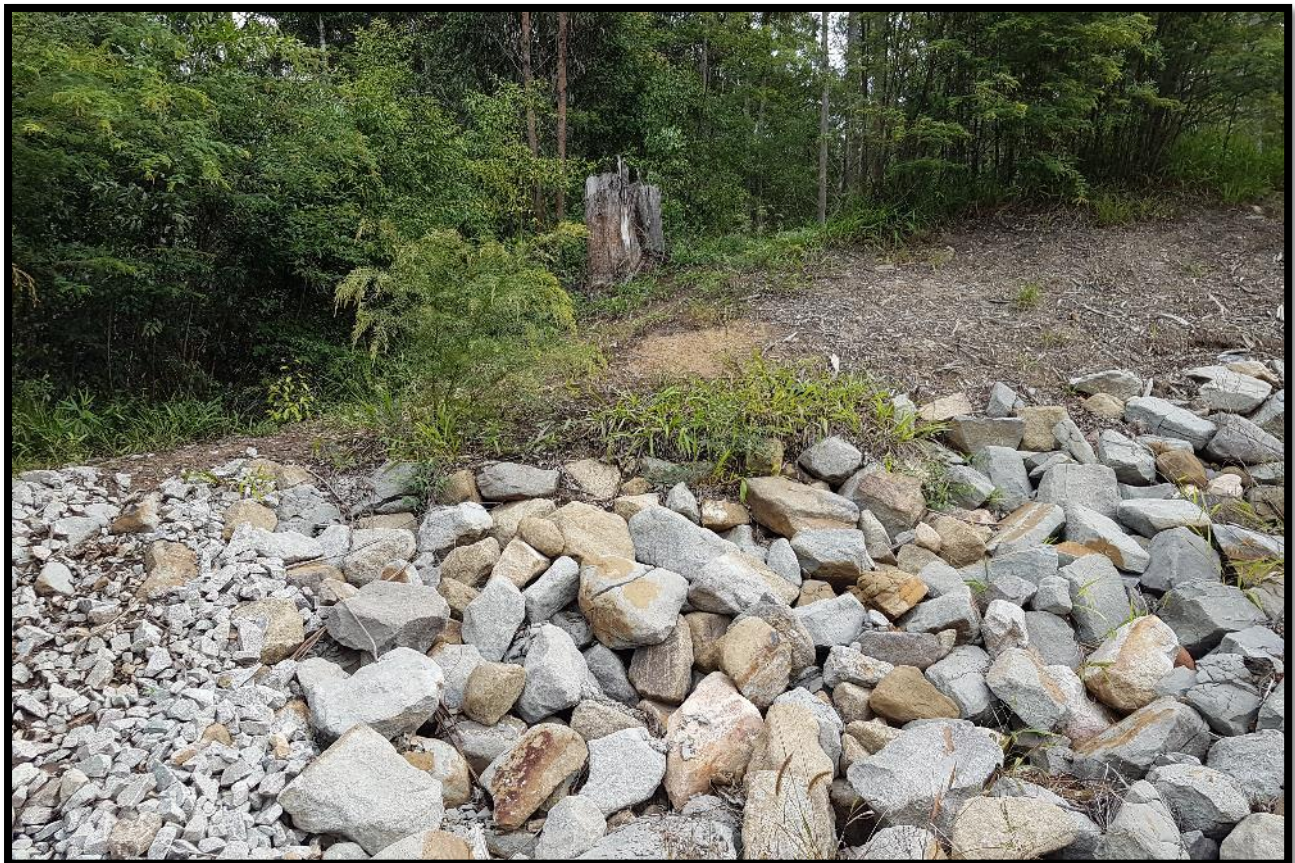
aggregate with only some localised planting beds or the use of frangible mixes whilst some bare earth or mulched areas with no tube stock planting has occurred in other riparian areas (Plate 3-9).

Plate 3-9. Riparian zone on upstream side at Boney's Creek with large aggregate to control erosion but no use of plantings on mulched creek bank.

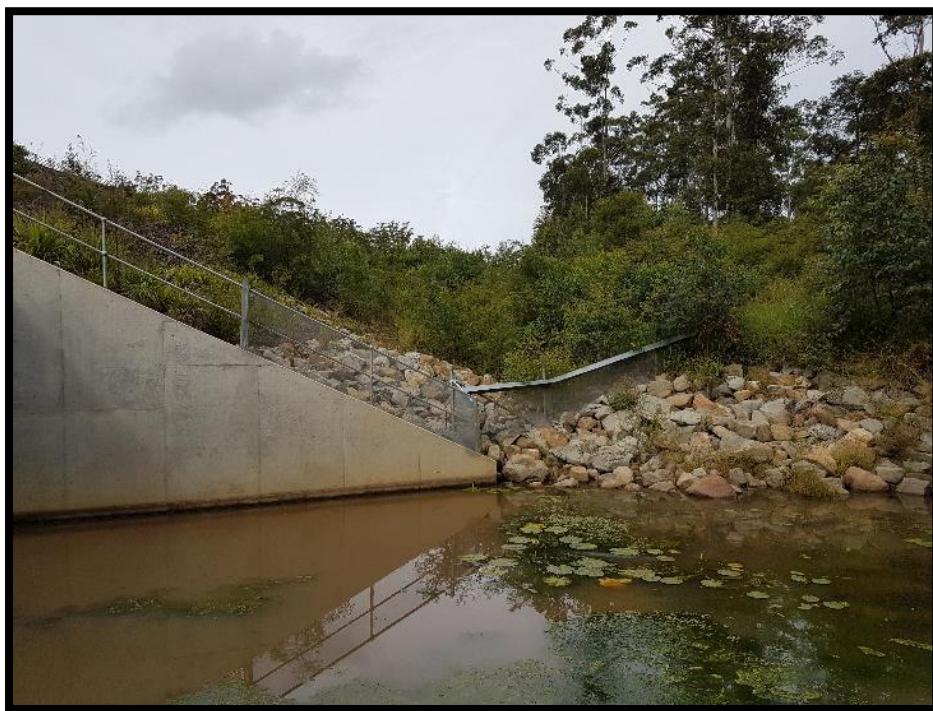
Boneys Creek – To date, there have been no recaptures at this site nor have frogs been recorded on the upstream side of the carriageway. Surveys of the permanent frog exclusion fence found no barred frogs on the road side, however, there were a number of potential breach points, namely where the fence travels over uneven ground (Plate 3-10).

Plate 3-10. Frog exclusion fence at upstream side of Boneys Creek traversing large aggregate with gaps in the fence.

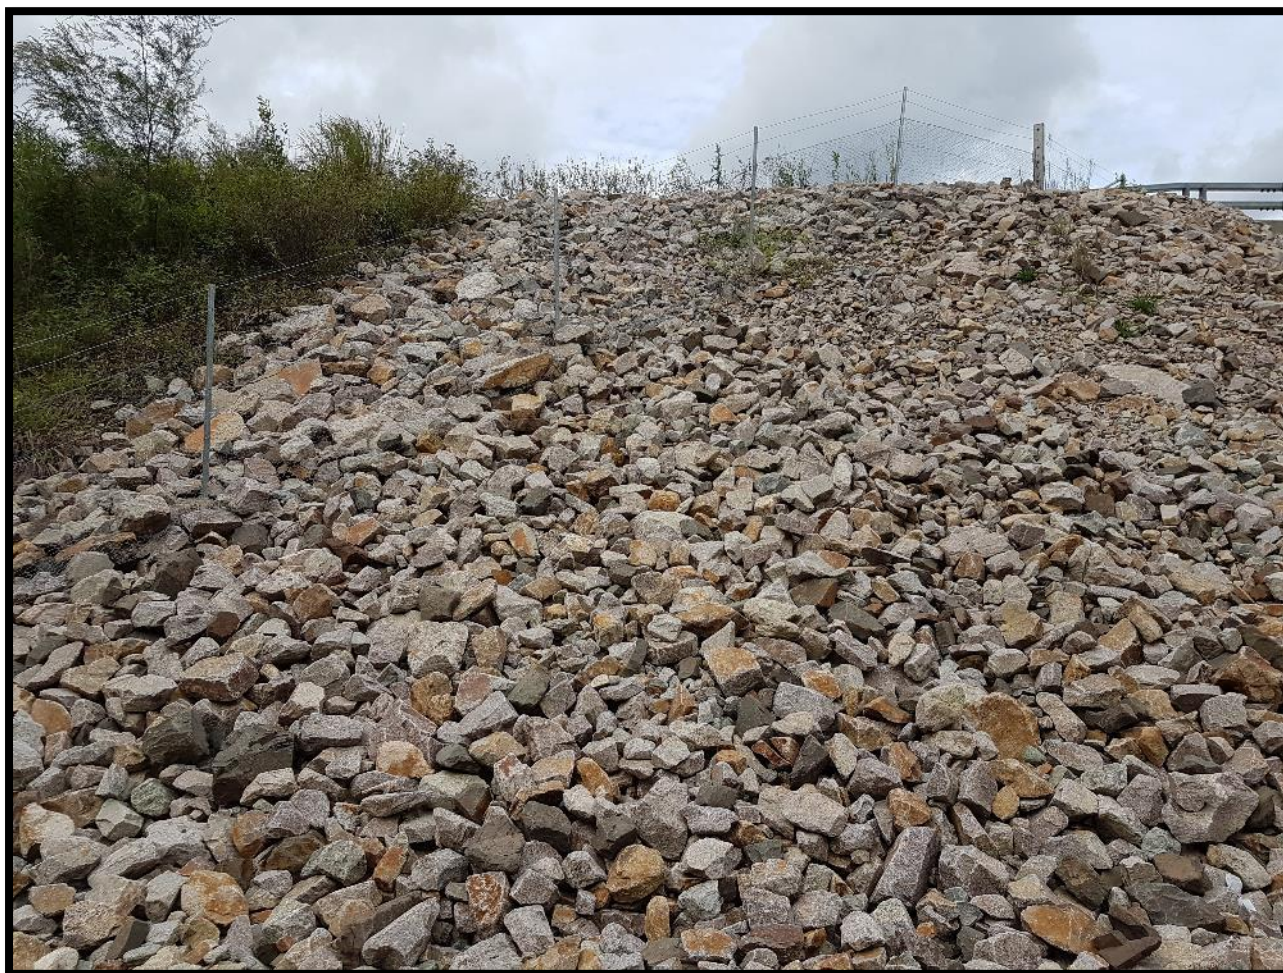
Surveys of the permanent frog exclusion fence found no barred frogs on the road side, however, there were a number of potential breach points, namely where the fence travels over uneven ground, particularly the large aggregate used on the bridge abutments along with the fact that an incorrect frog fence design with large aperture has been used on the northern abutment (Plate 3-11). In reality, these areas would only be used by barred frogs during flood events as individuals move away from the stream bank. Outside of these flood events, the capture data suggests individuals seldom venture further than 20 m from the stream edge whilst these stone abutments are in most cases more than 20 m from the stream. Further monitoring should guide whether or not this fencing extent requires upgrading.

Plate 3-11. Example of an area where large aperture mesh has been used in the frog exclusion fence at Halfway Creek.

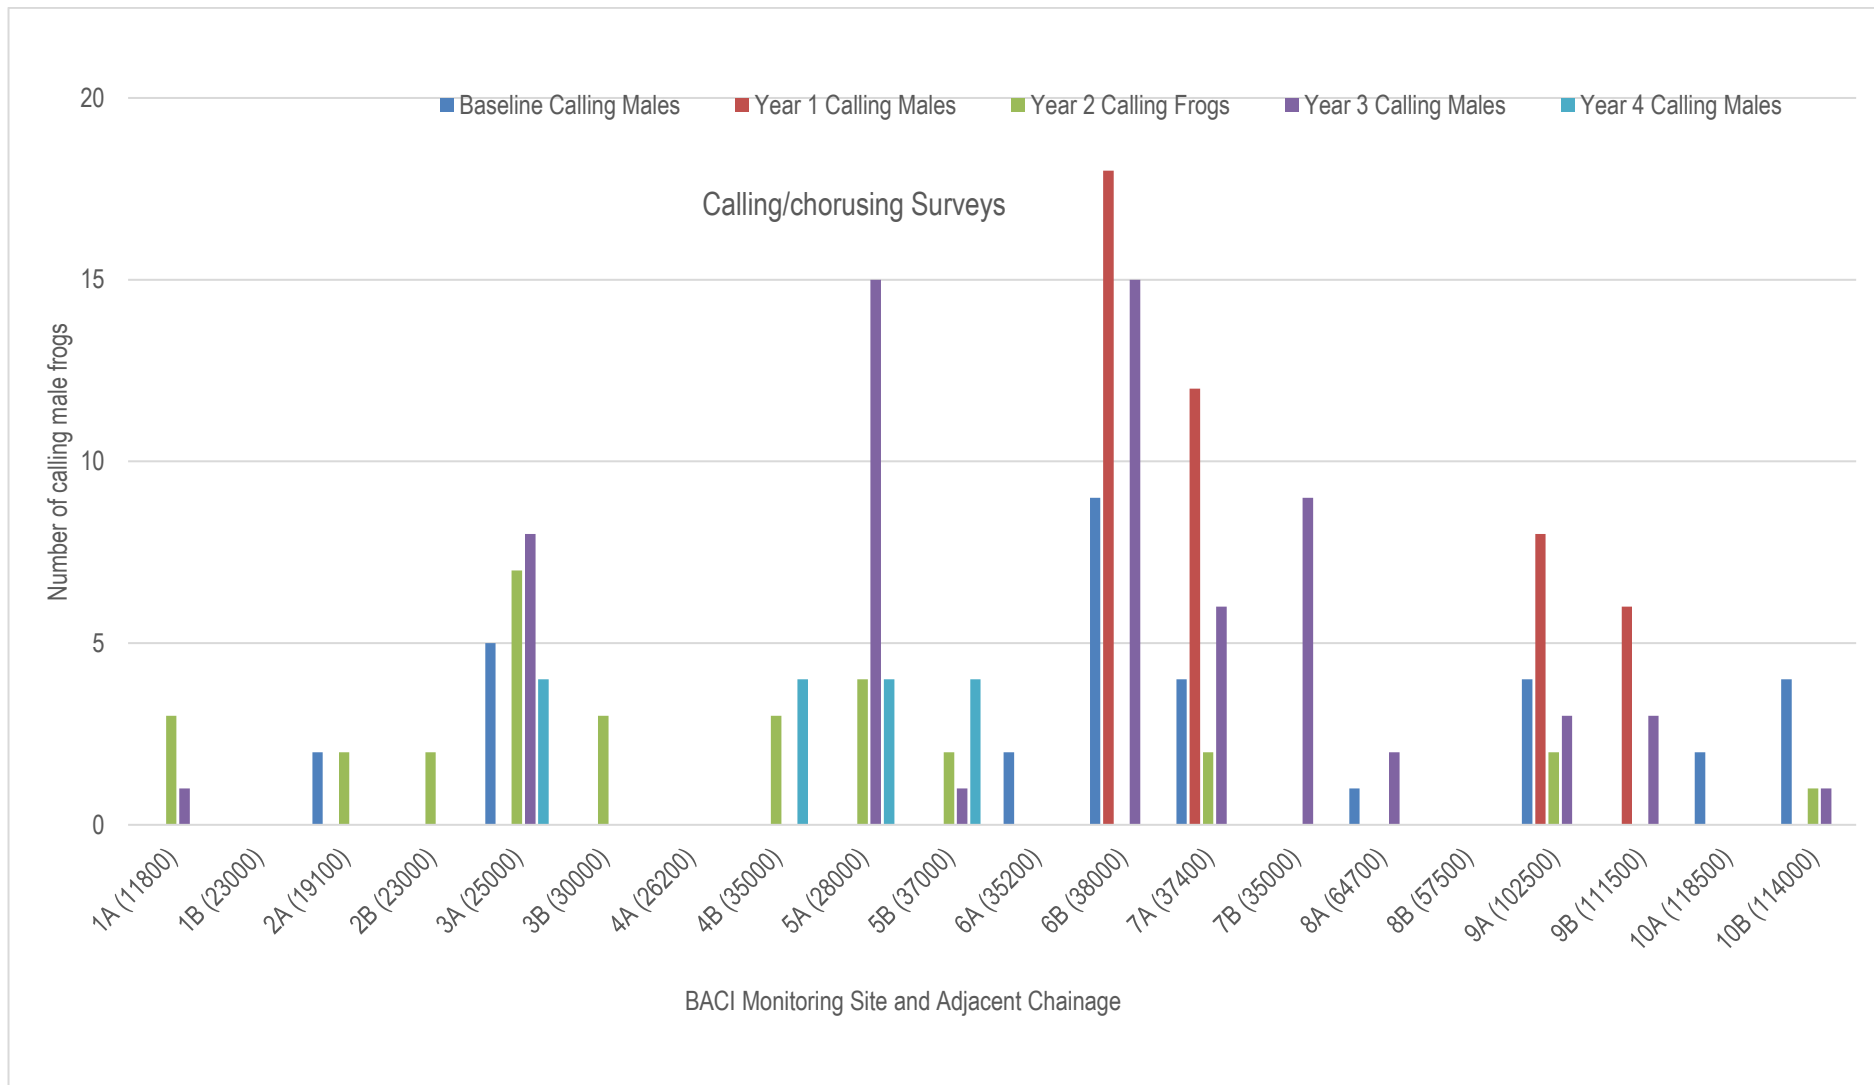
Figure 5-3. The number of Green-thighed Frogs observed between the pre construction surveys and construction/operational monitoring in Years 1-4 at Sites 1-5 and Years 1-3 at Sites 6-10.

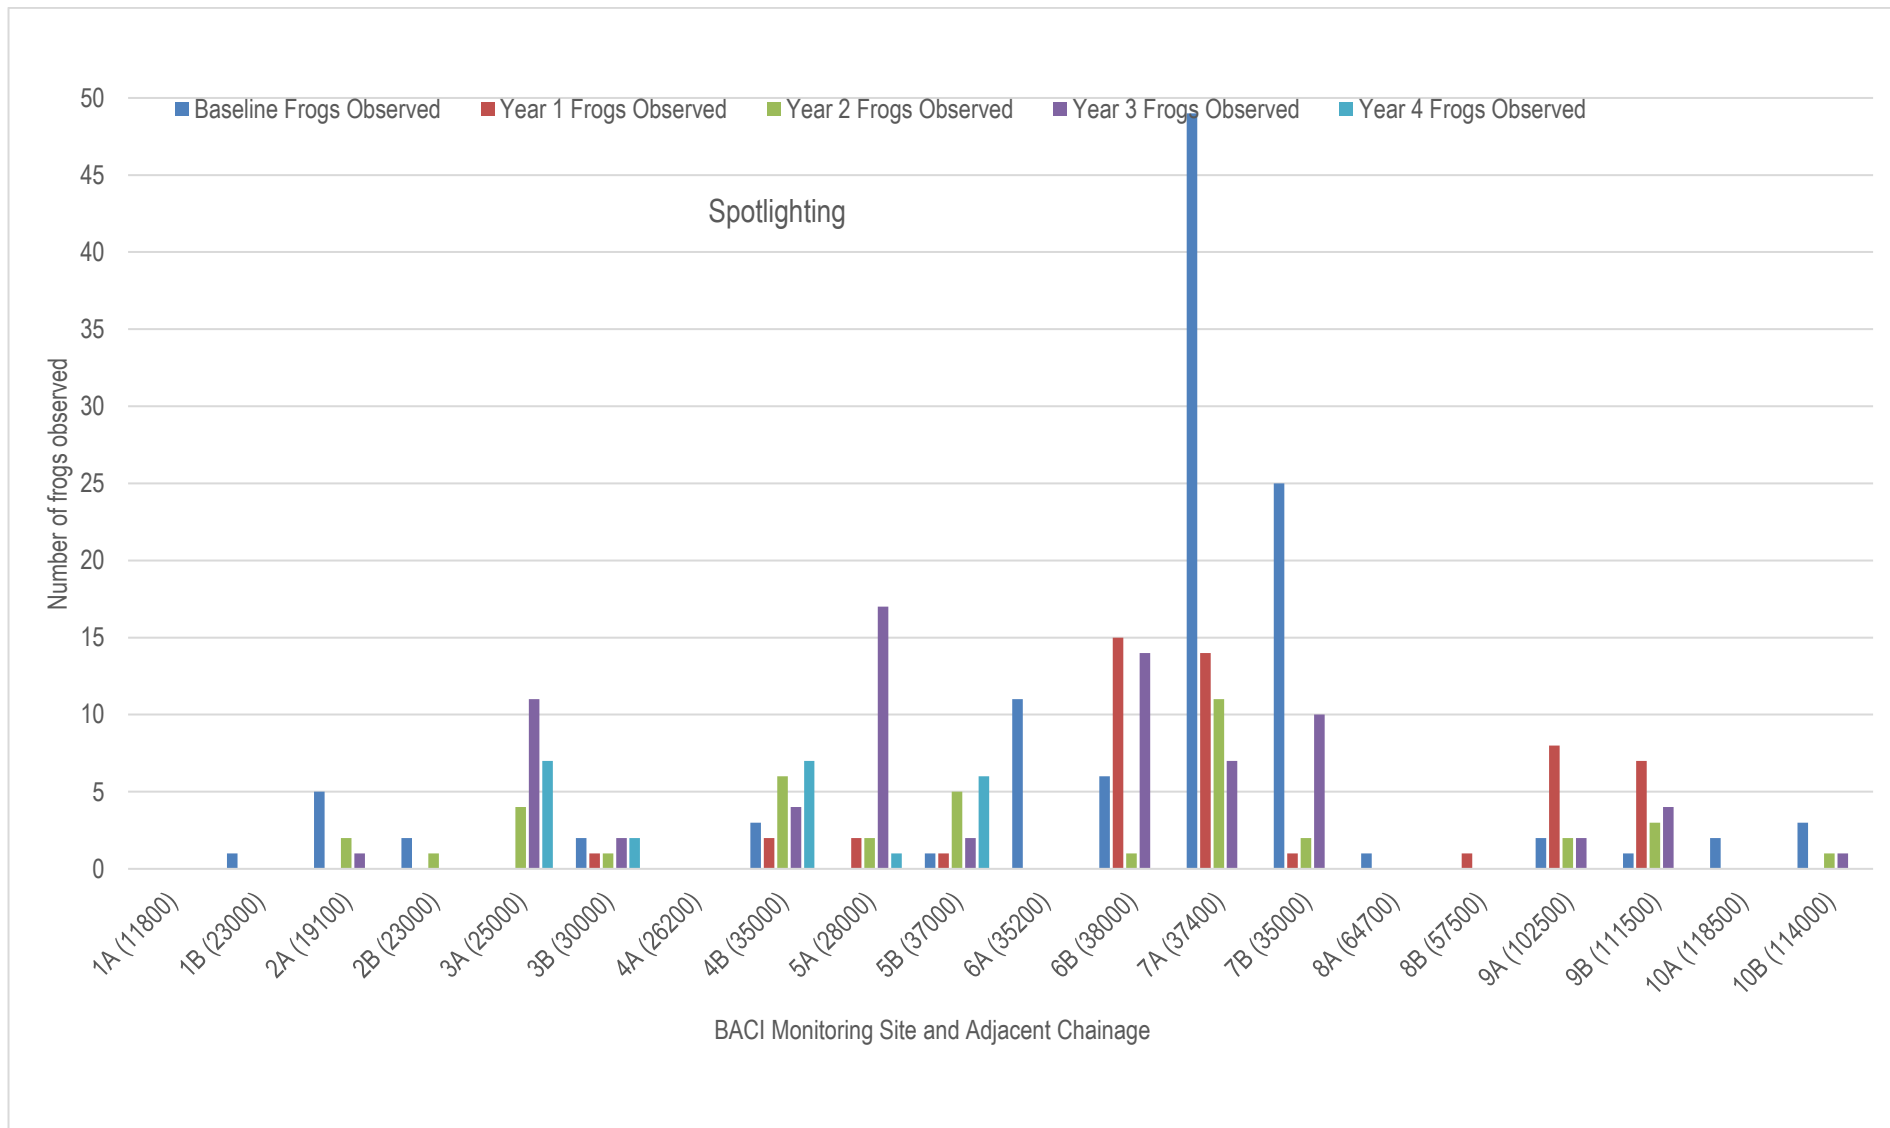
Figure 5-4. The number of Green-thighed Frogs observed between the pre construction surveys and construction/operational monitoring in Years 1-4 at Sites 1-5 and Years 1-3 at Sites 6-10. Note – Site 6A has had no monitoring performed since the baseline due to access limitations.

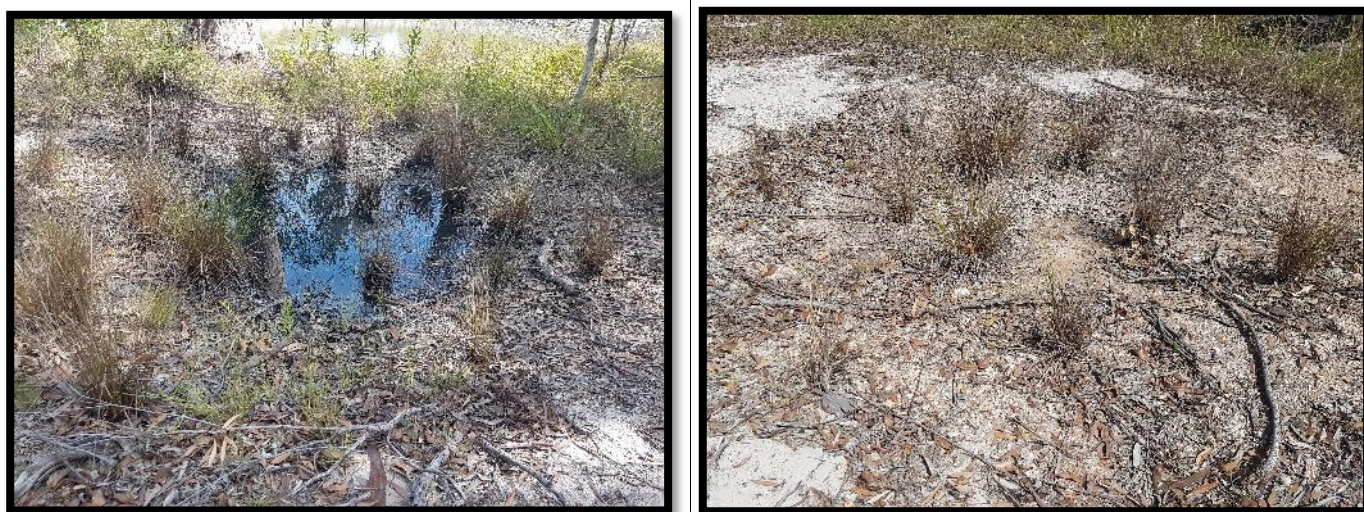
A follow up survey 30 days later on the 16th January revealed three of the ponds had dried out completely, whilst the fourth pond contained around 50 mm of water (Plate 5-3). Three juvenile Broad-palmed Frog (*Litoria latopalmata*) were recorded around the *Juncus* sedges growing at the edge of this pond. Importantly, the ponds are drying at differing rates so in this context it meets the design intentions of the Threatened Frog Management Plan.

Plate 5-3. Pond inspection in mid January 2019 showing ponds with and without water at Redbank Creek ch. 5600.

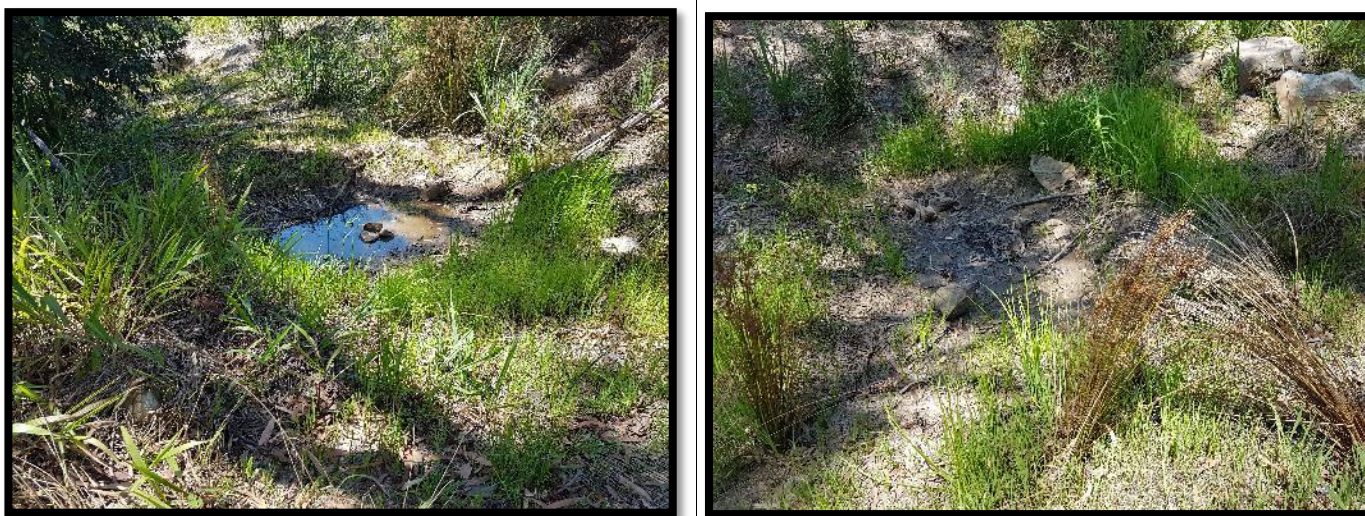
A follow up survey 30 days later on the 16th January revealed four of the ponds had dried out completely, whilst the fifth pond contained around 50 mm of water and was occupied by Common Eastern Froglet (*Crinia signifera*) and Broad-palmed Frog metamorphs, tadpoles and at least two metamorphs (Plate 5-4). Importantly, the ponds are drying at differing rates so in this context it meets the design intentions of the Threatened Frog Management Plan.

Plate 5-4. Pond inspection in mid January 2019 showing ponds with and without water at Falconers ch. 11800.

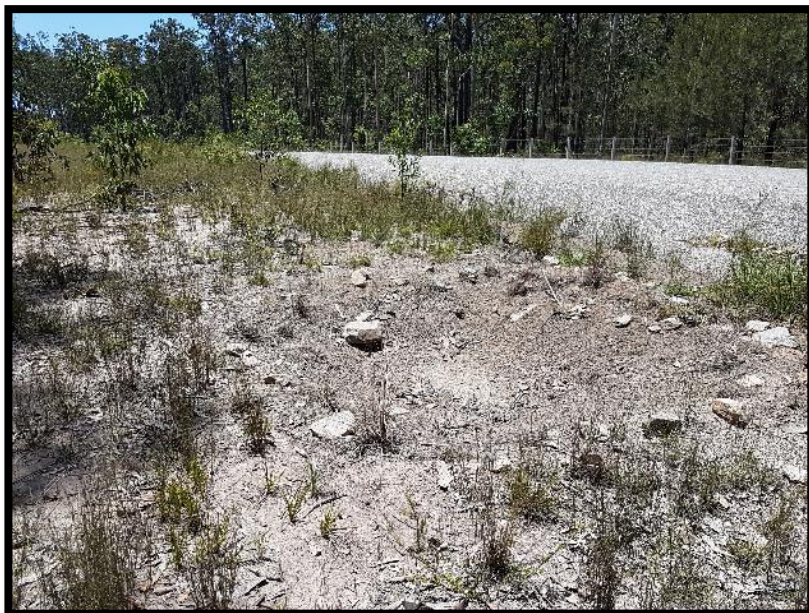
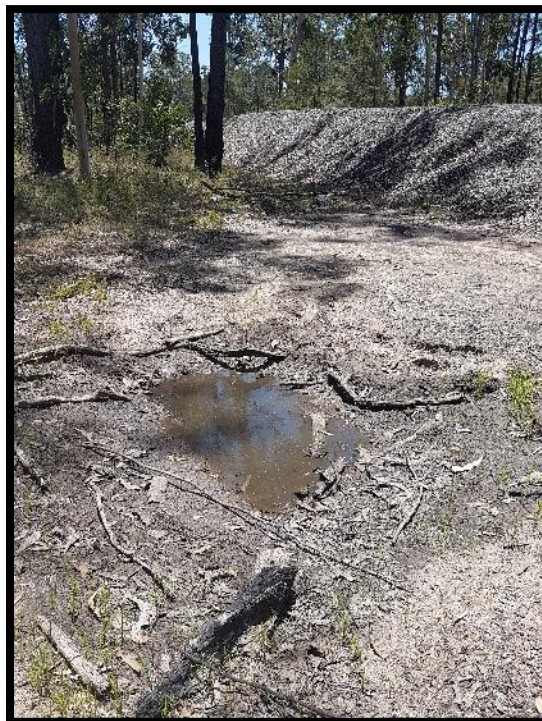
A follow up survey 30 days later on the 16th January revealed four of the ponds had dried out completely, whilst the fifth contained approximately 50 mm of water (Plate 5-5). One of the dried pond had recently dried indicating the five ponds dry at varying rates, an intended design outcome outlined in the Threatened Frog Management Plan.

Plate 5-5. Pond inspection in mid January 2019 showing ponds with and without water at Bald Knob Tick Gate Road ch. 25000.
