Oxley Highway to Kempsey

2019/20 Annual Ecological Monitoring Report

Transport for NSW | October 2020

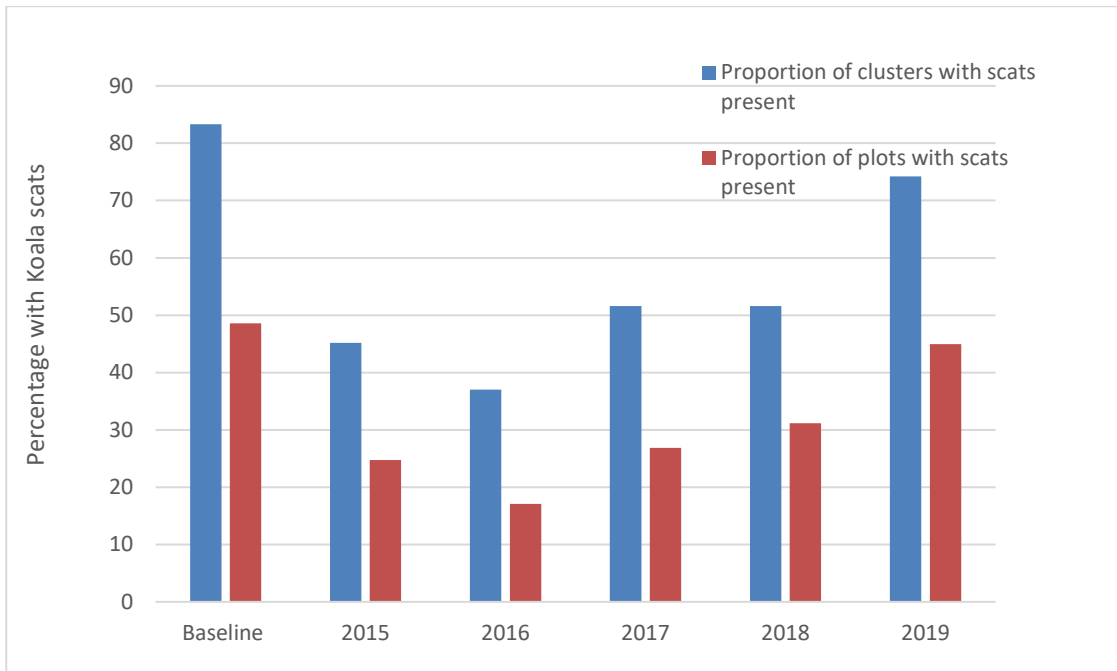
Graph 1: Percentage of plots and clusters with scats present for each monitoring event to date

Of the 89 surveyed plots, Koala scats were recorded at 46% (41 of 89) of the individual plots. This is higher than 2015, 2016, 2017 and 2018 surveys (25%, 17%, 27% and 31% respectively), but lower than the 49% recorded during baseline surveys. When grouped according to cluster, Koala scats were recorded at 74% of clusters (23 of 31). This is higher than 2015, 2016, 2017 and 2018 surveys (45%, 37%, 52% and 52% respectively), but lower than the 83% recorded during baseline surveys. It should be noted that baseline surveys included only 24 (*cf* 31) clusters; if we consider only those clusters in common between baseline and 2019 surveys, scats were recorded at 83% (19 of 23) of these clusters during the 2019 monitoring.

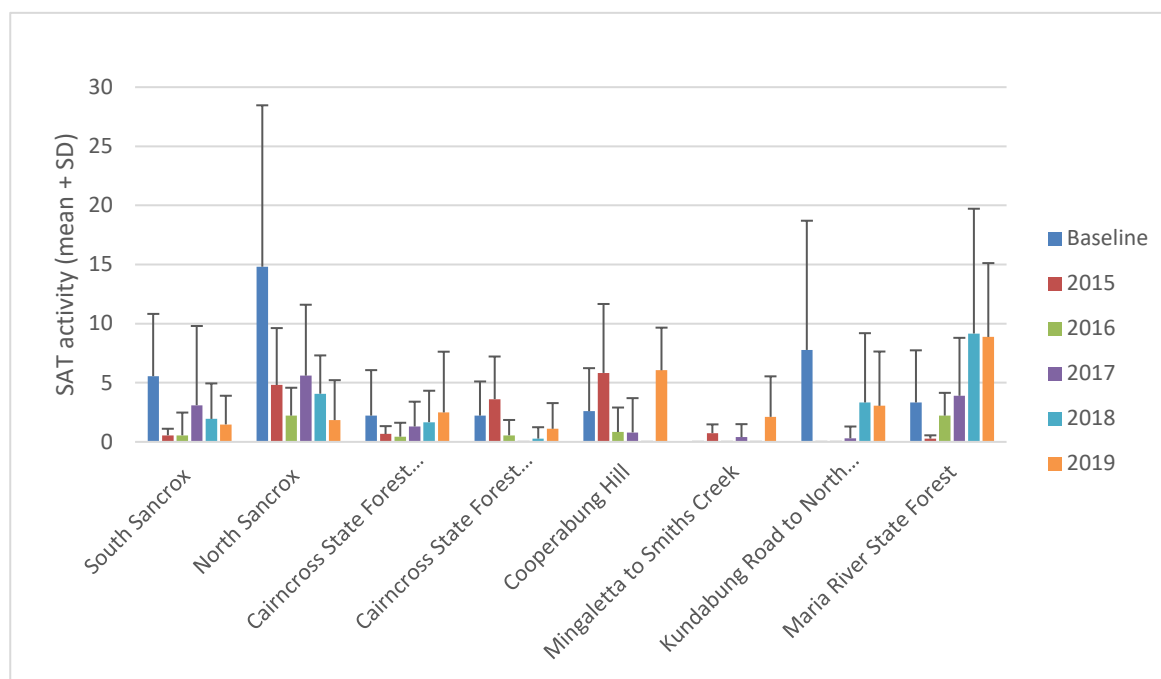
Graph 3: Koala activity across the eight monitoring areas

Contrary to the 2018 notable reduction in apparent activity within the Cooperabung Hill area, whereby no scats were recorded in 2018, activity in this area in 2019 increased substantially to levels not observed since 2015.

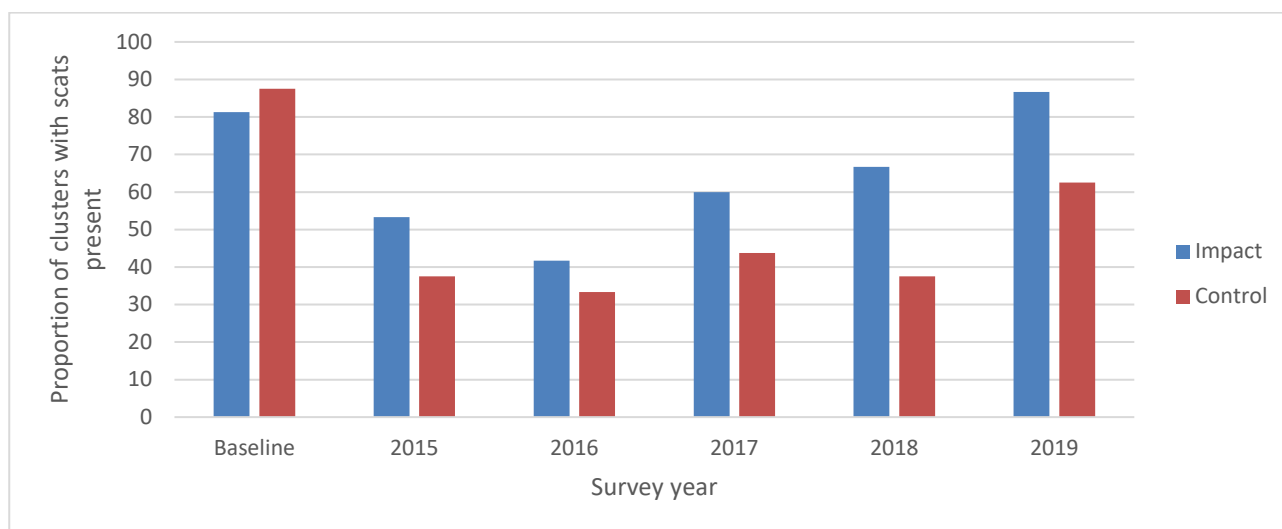
Graph 4: Koala presence at control and impact clusters

A higher percentage of impact clusters had scats present than did control clusters during the 2019 monitoring period (87% cf 63%). This result is the same as that of the previous monitoring years (Graph 4). If we compare the Koala presence/absence results between control and impact clusters there is no significant difference in Koala presence at impact and control clusters between the 2019 surveys and baseline, 2015, 2016, 2017 or 2018 surveys ($X^2 = 0.081$, $df = 1$, $p > 0.05$; $X^2 = 0.971$, $df = 1$, $p > 0.05$; $X^2 = 0.775$, $df = 1$, $p > 0.05$; $X^2 = 0.961$, $df = 1$, $p > 0.05$ and $X^2 = 0.351$, $df = 1$, $p > 0.05$ respectively).

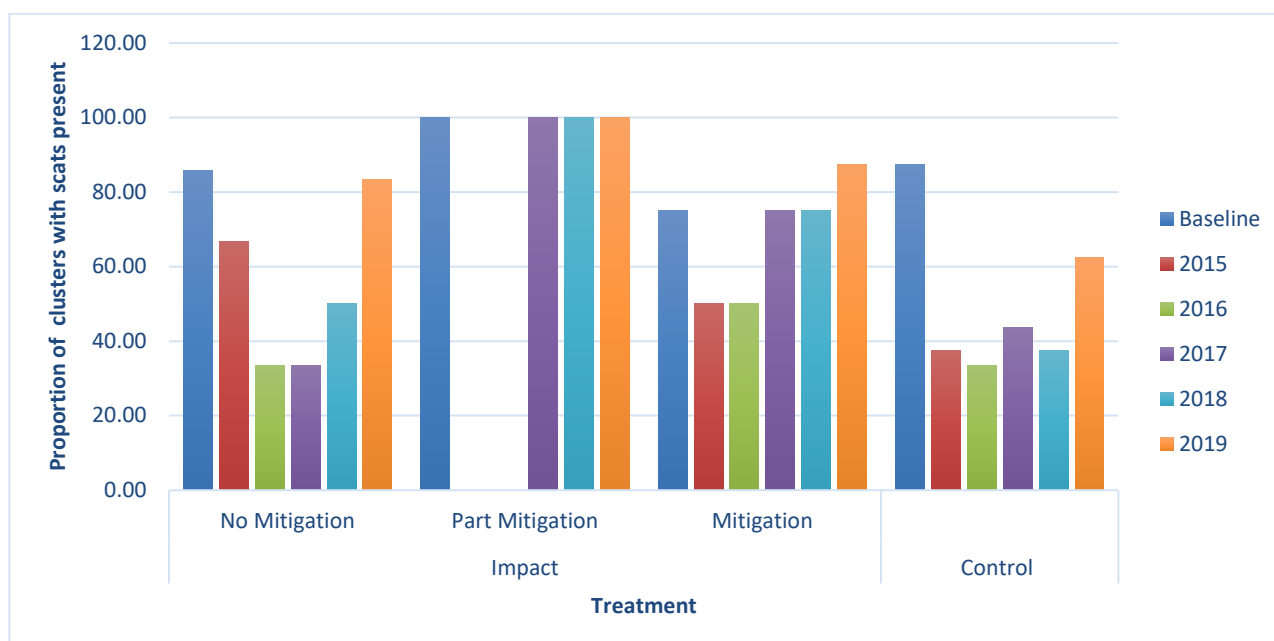
Graph 5: Koala presence and cluster type

Comparing Koala presence between mitigation and no-mitigation clusters shows no significant difference between the 2019 surveys and baseline, 2015, 2016, 2017 or 2018 surveys ($X^2 = 0.434$, $df = 1$, $p > 0.05$; $X^2 = 0.175$, $df = 1$, $p > 0.05$; $X^2 = 0.161$, $df = 1$, $p > 0.05$; $X^2 = 0.002$, $df = 1$, $p > 0.05$ and $X^2 = 0.121$, $df = 1$, $p > 0.05$, respectively). Graph 5 shows the percentage of clusters with scats present within different cluster types. There is no overall apparent trend between impact clusters with mitigation or without mitigation. While mitigation clusters appear to have a higher presence percentage in 2016, 2017, 2018 and 2019 than clusters with no mitigation, the presence percentage at clusters with no mitigation is similar to the presence percentage at control clusters during these years. This suggests that any difference is likely site specific and not necessarily related to construction activities.

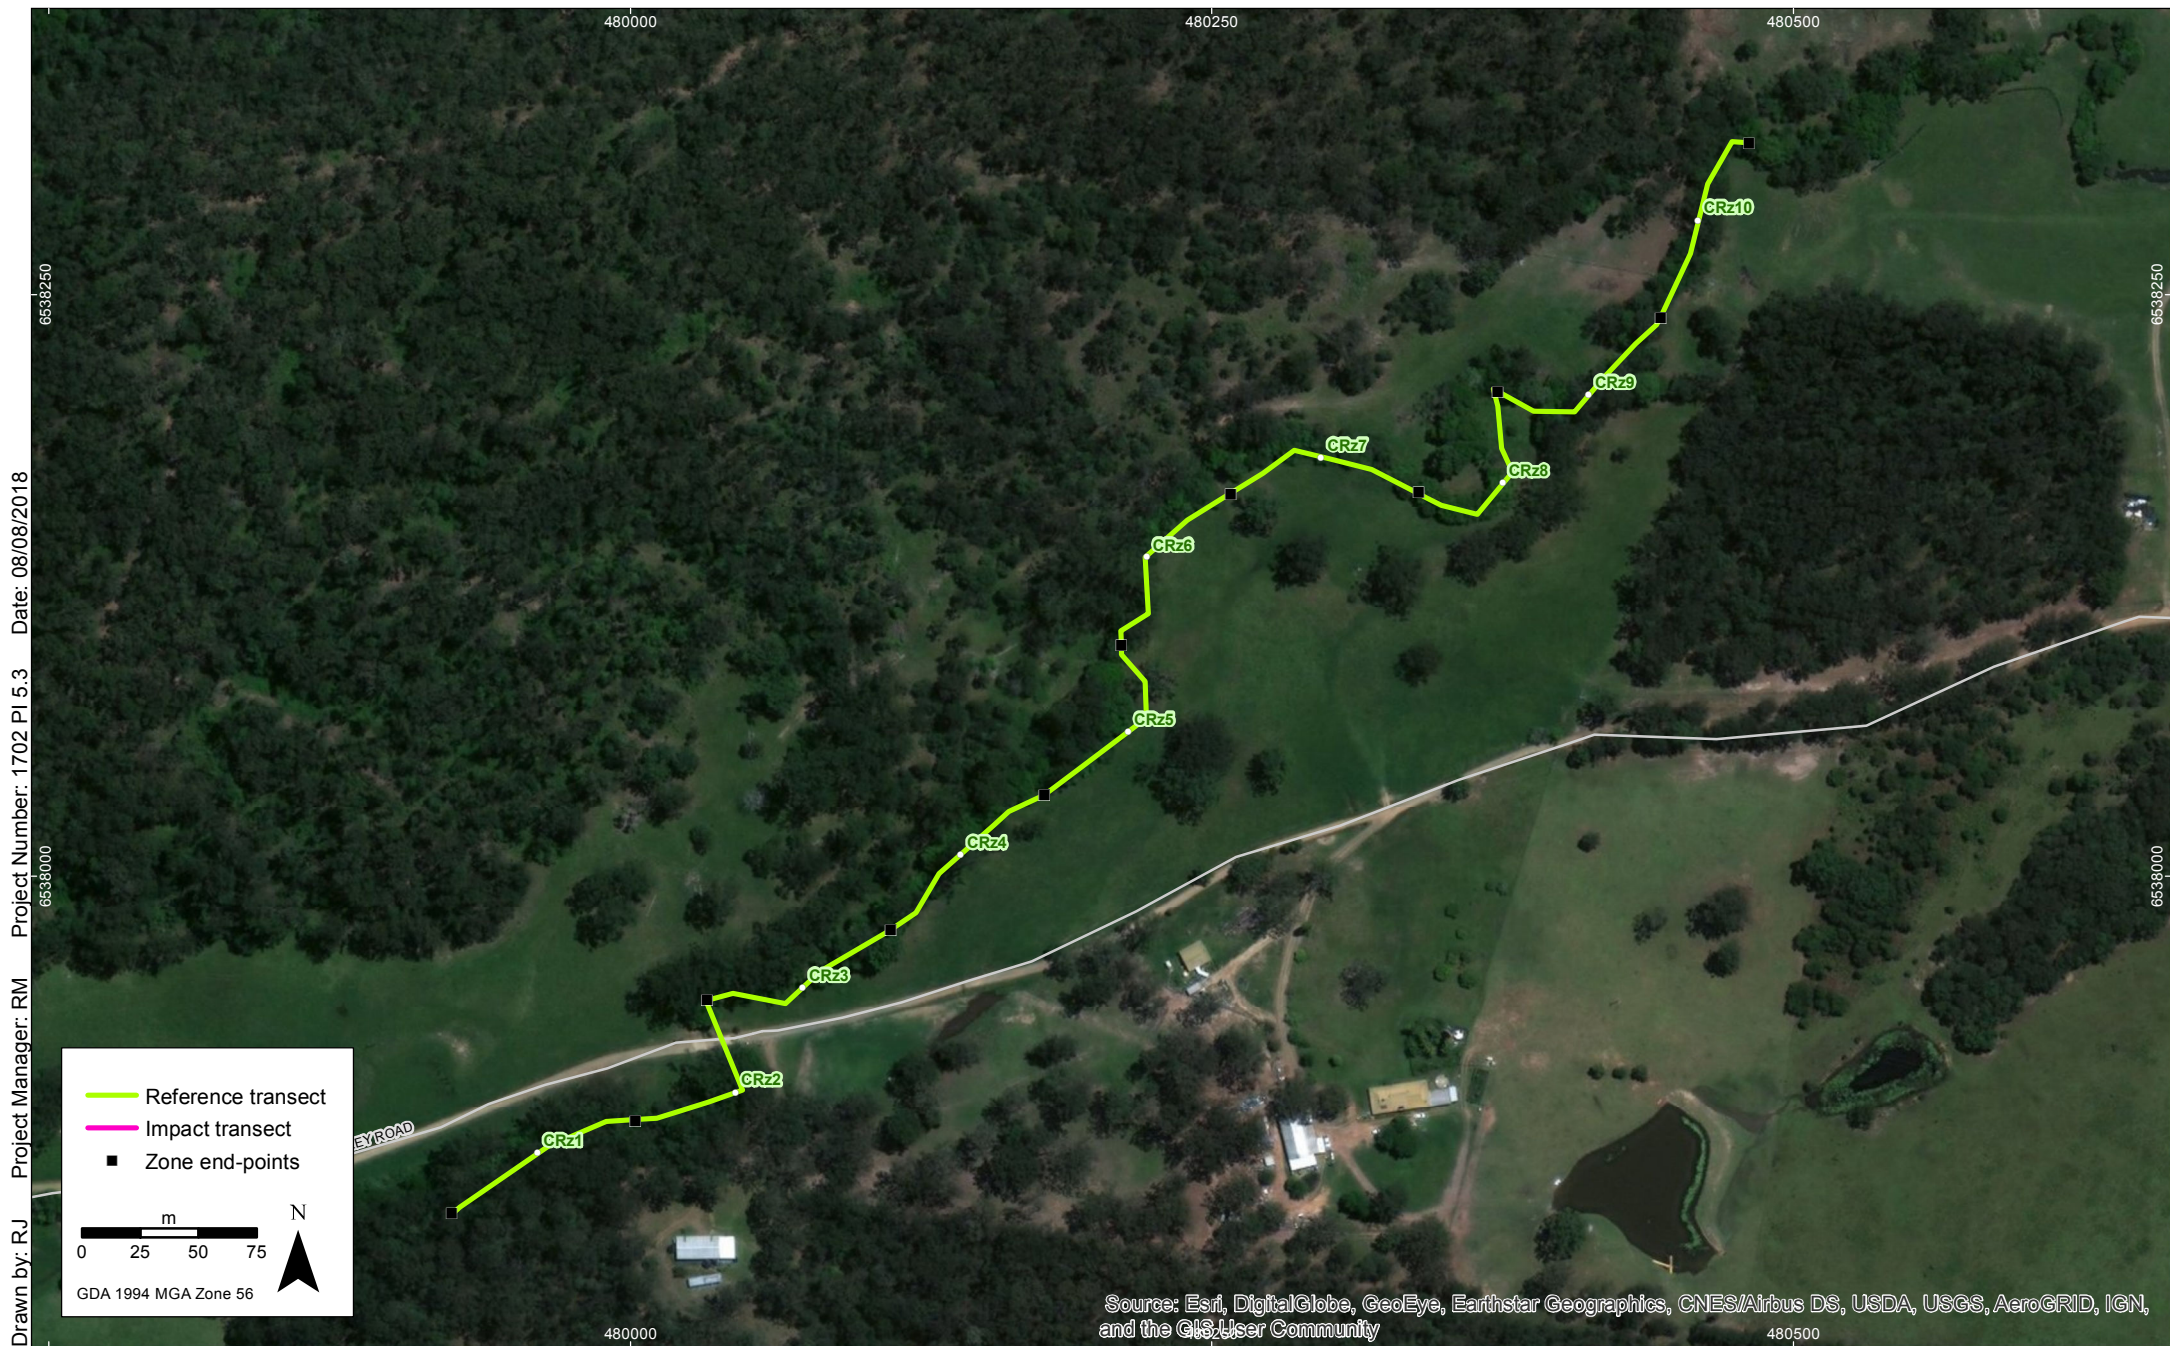
FIGURE 6

Giant Barred Frog monitoring: Cooperabung Creek reference site
Pacific Highway Upgrade - Oxley Highway to Kempsey

The location of all monitoring sites is shown in Figure 1, with detailed locations for each site transect provided in Figure 2 to Figure 7.

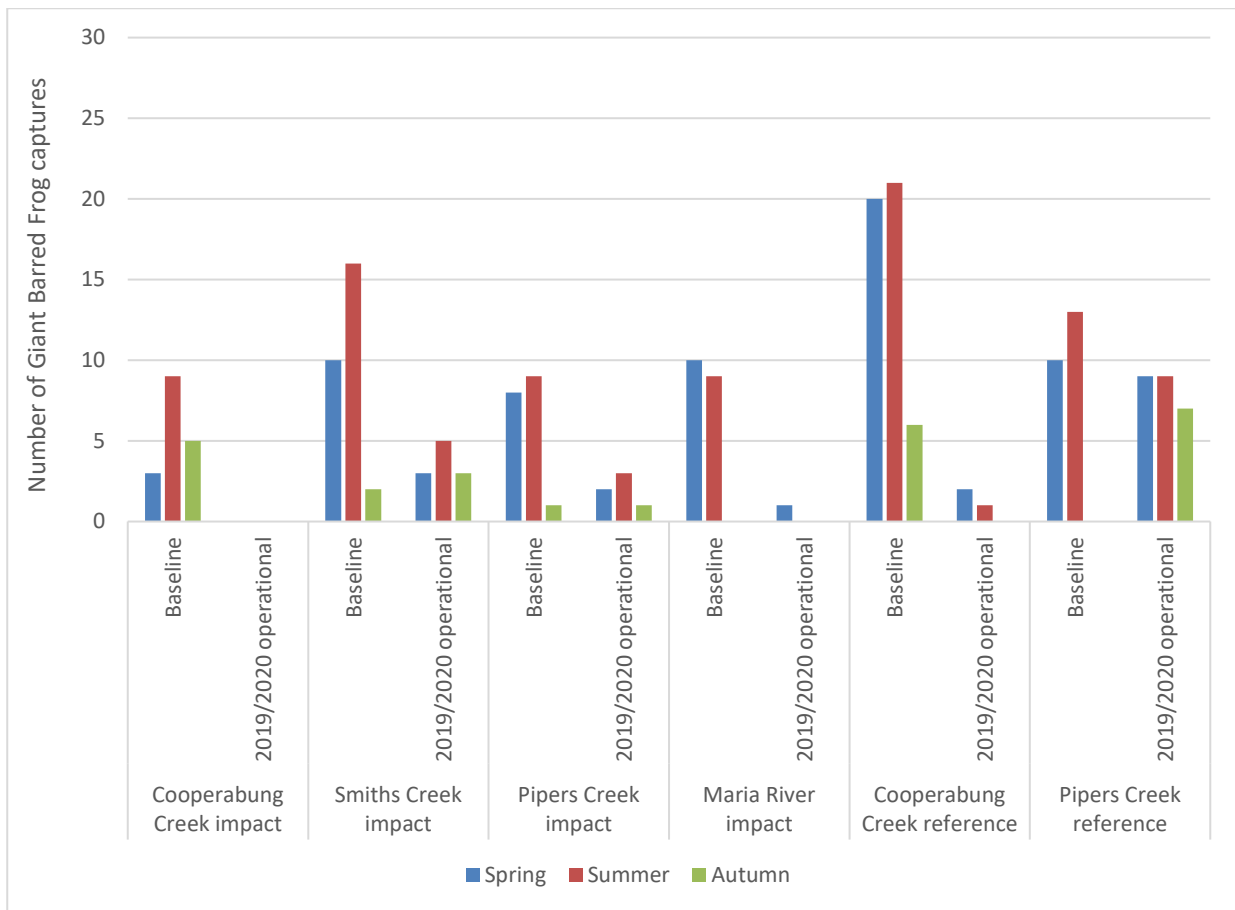
Graph 1: Giant Barred Frog records: baseline and 2019/2020 monitoring

Giant Barred Frogs were recorded at five of the six sites during spring, at four site during summer and three sites in autumn 2019/2020 surveys. Giant Barred Frogs were not recorded at Cooperabung Creek impact site during the 2019/2020 surveys, where it was recorded during baseline surveys. Giant Barred Frogs were also not recorded at Maria River impact site in summer and Cooperabung Creek reference site in autumn, where it was recorded during baseline surveys.

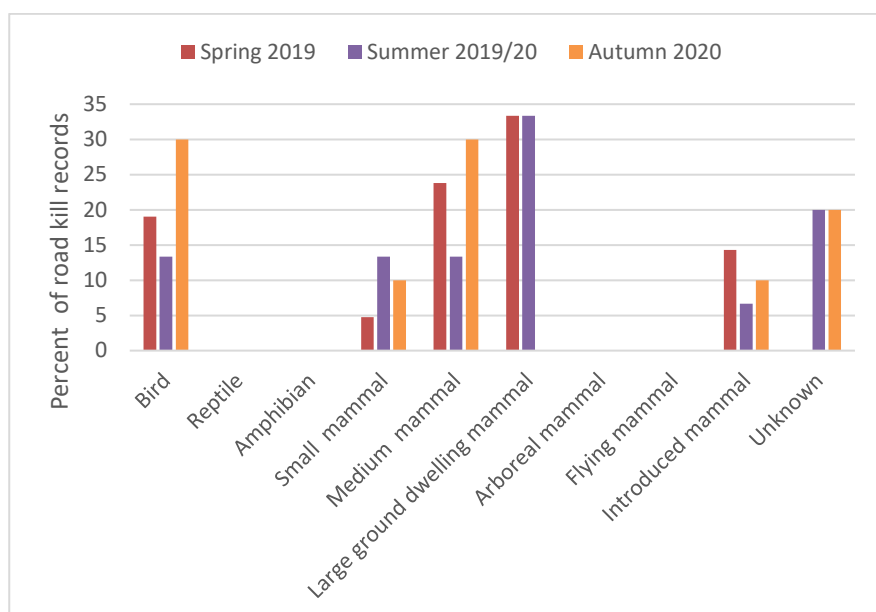
Graph 1: 2019/2020 road kill records

There were a total of 46 road kill records, comprising 21 in spring, 15 in summer and 10 in autumn. The percentage of road kill records for each category for the current monitoring period is presented in Graph 1. Combining spring, summer and autumn results, large ground dwelling mammals (26.1%, n = 12), medium ground dwelling mammals (21.7% of road kill, n = 10) and birds (19.6% of road kill, n = 9) were the most commonly recorded fauna groups.
