Oxley Highway to Kempsey EPBC 2012/6518

Condition 8 Annual Report 2020

Transport for NSW (TfNSW) | October 2020

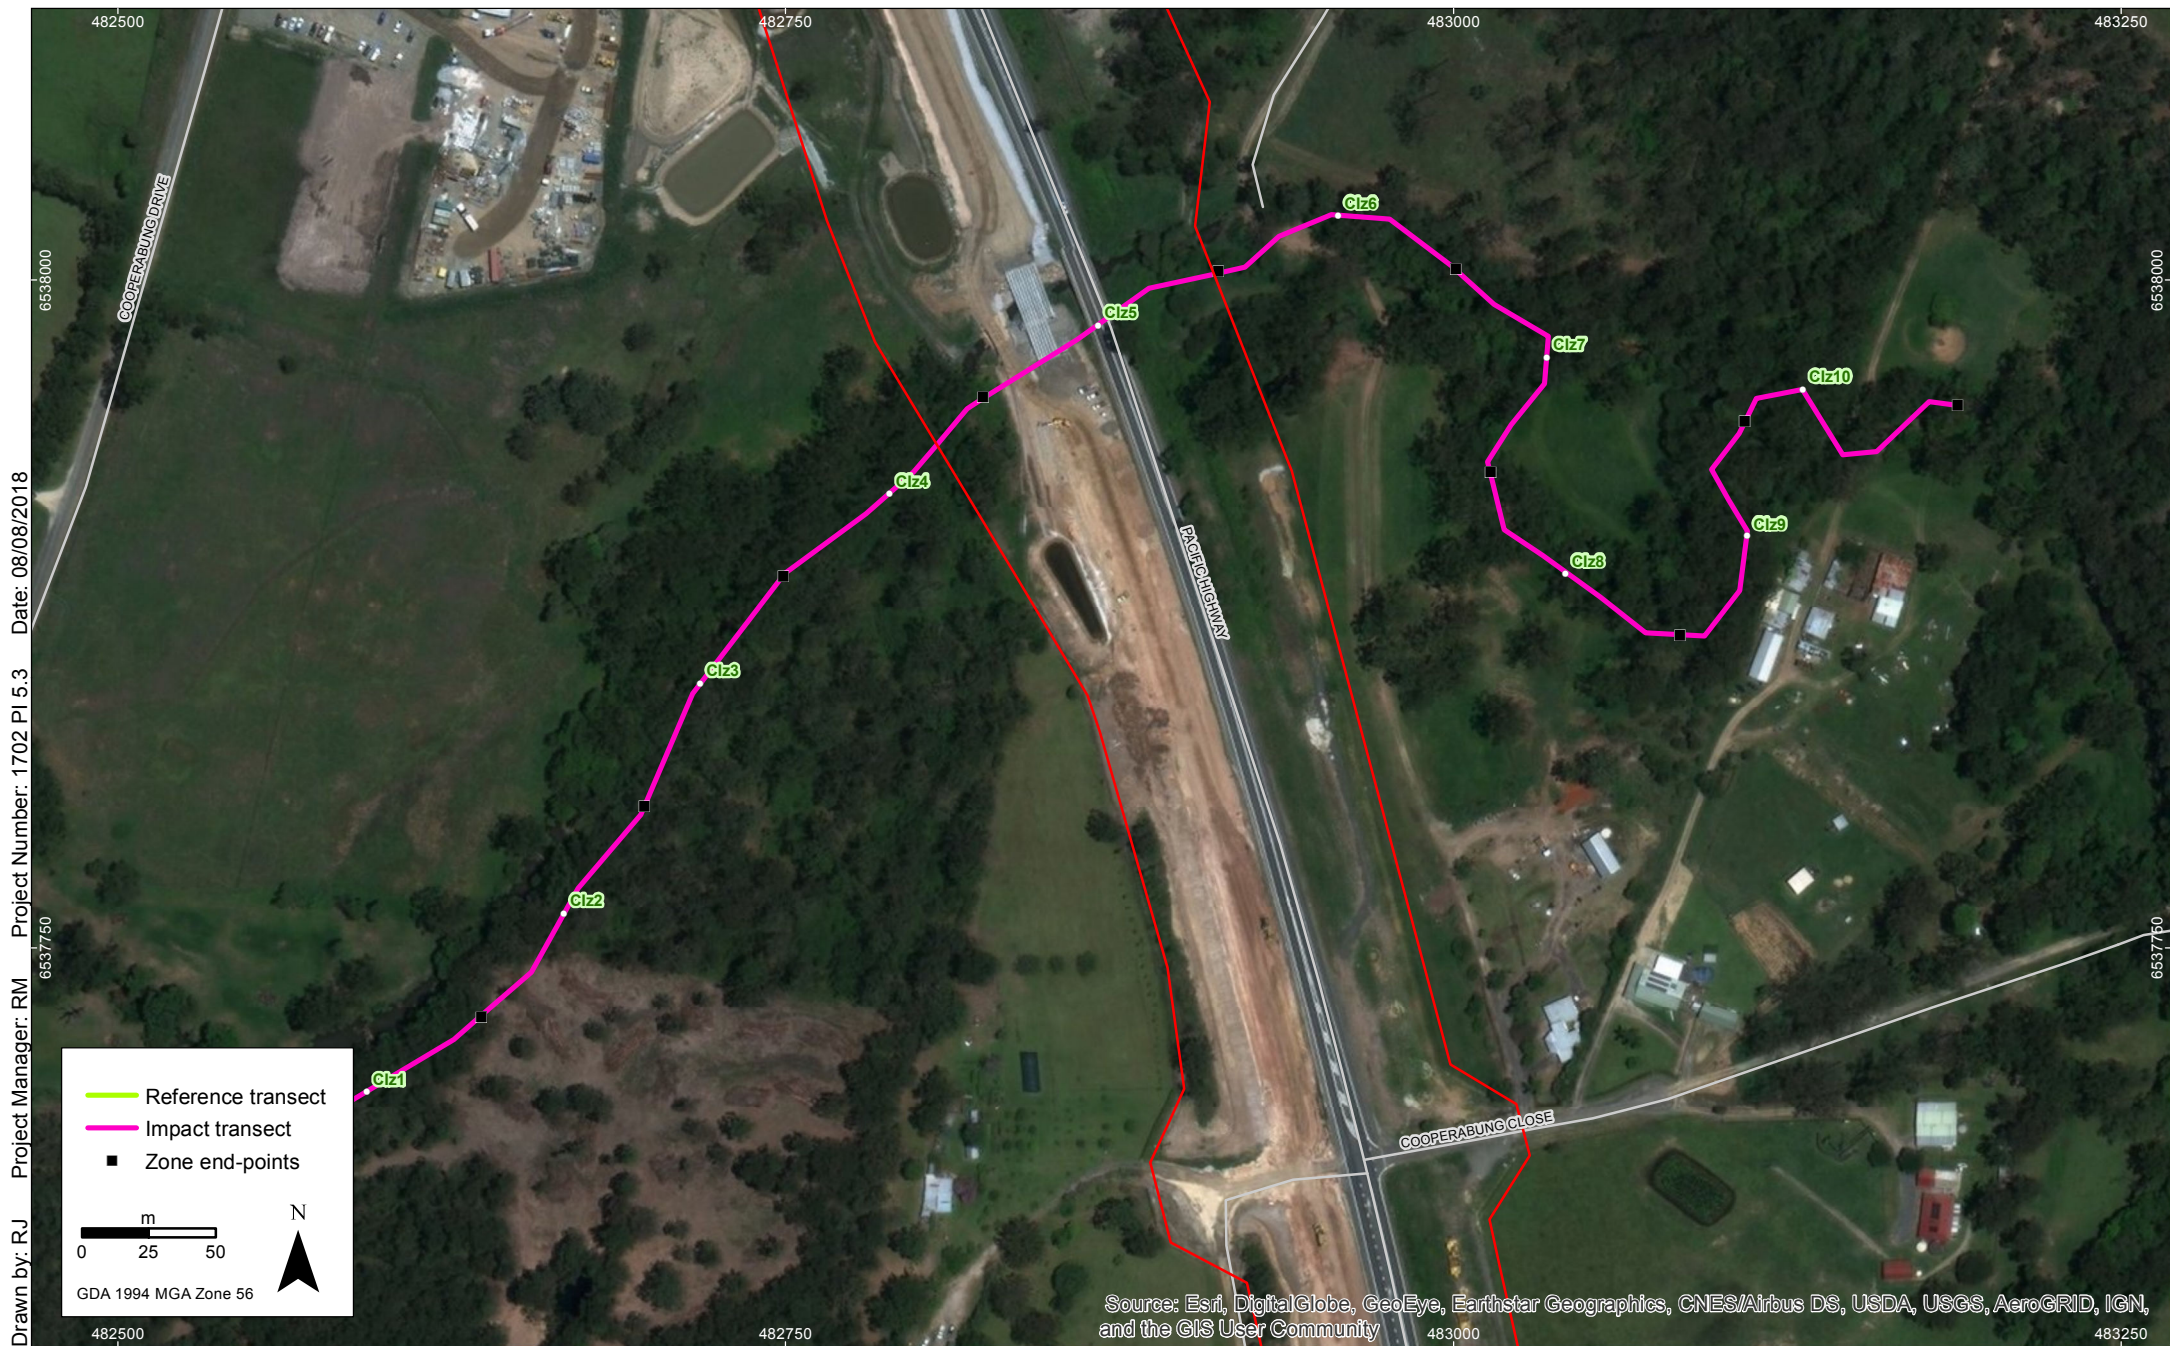
FIGURE 1

Giant Barred Frog Monitoring Sites: overview
Pacific Highway Upgrade - Oxley Highway to Kempsey

The location of all monitoring sites is shown in Figure 1, with detailed locations for each site transect provided in Figure 2 to Figure 7.

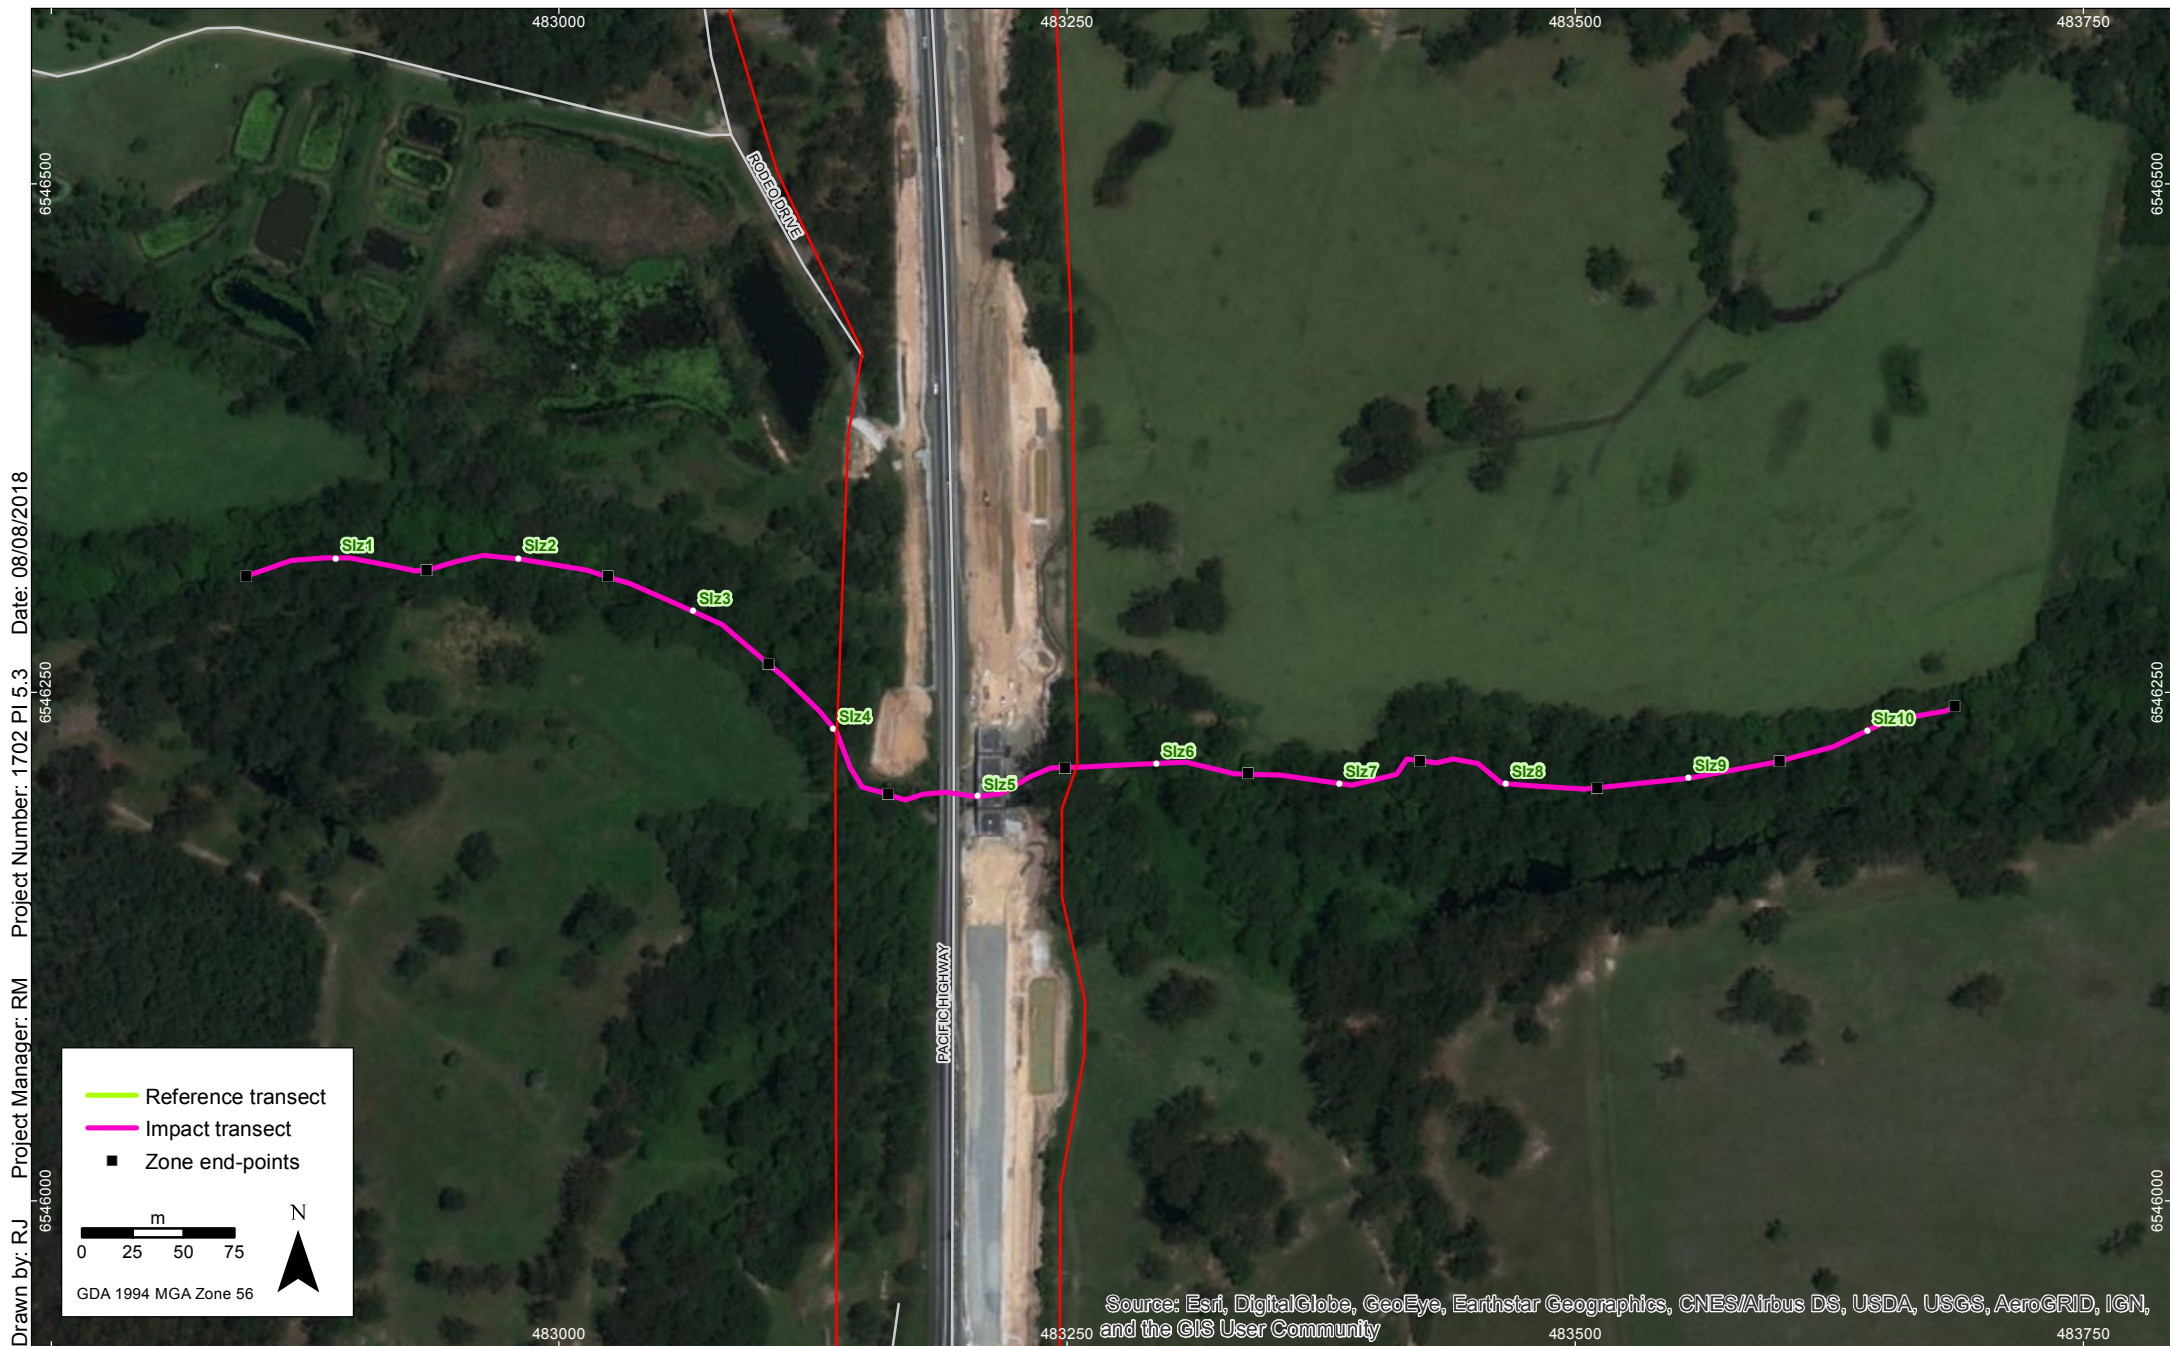
FIGURE 2

Giant Barred Frog monitoring: Cooperabung Creek impact site
Pacific Highway Upgrade - Oxley Highway to Kempsey

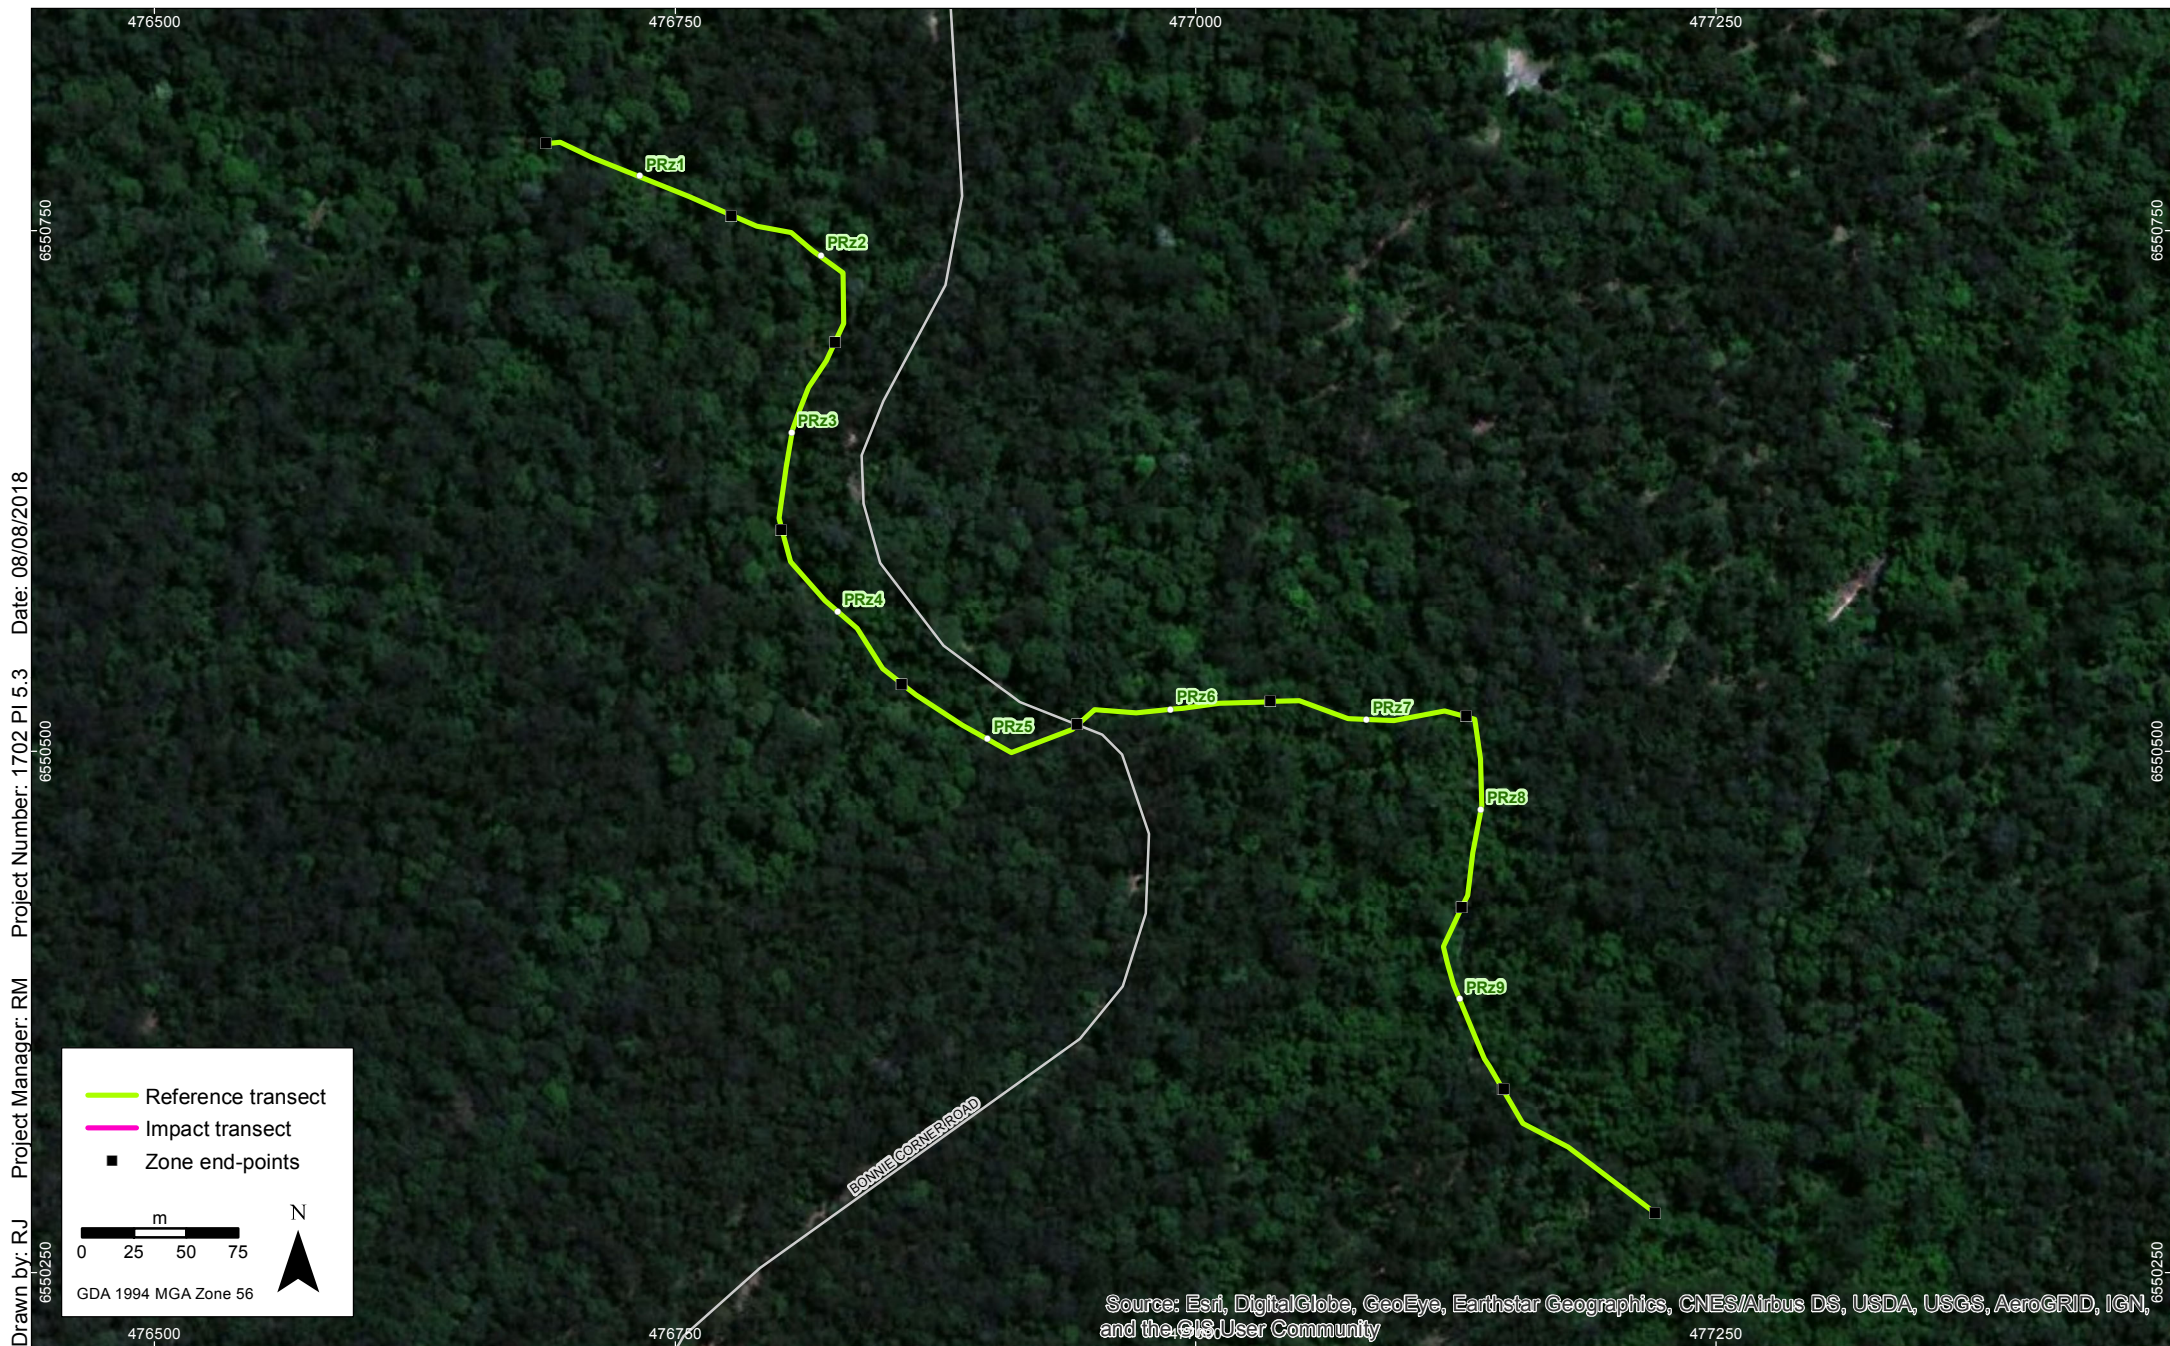
FIGURE 6

Giant Barred Frog monitoring: Cooperabung Creek reference site
Pacific Highway Upgrade - Oxley Highway to Kempsey

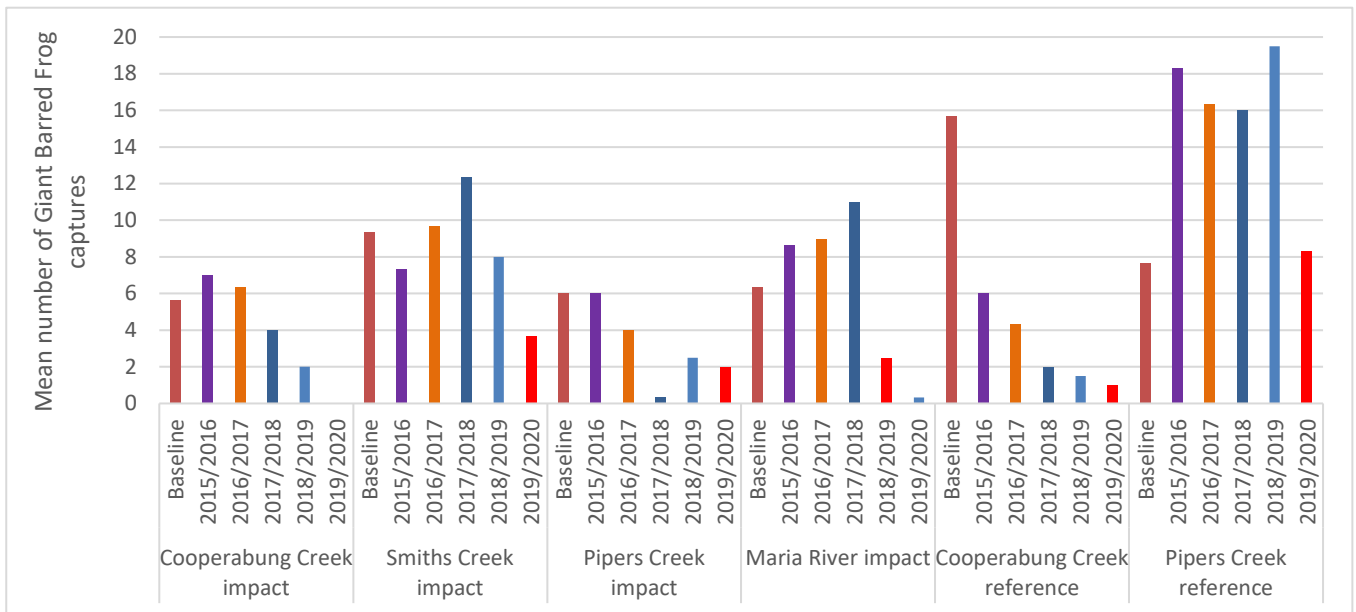
Graph 2: Mean annual Giant Barred Frog records by site

The mean number of Giant Barred Frogs recorded during the current monitoring period decreased from the previous monitoring event at all sites. It should be noted that 2019/2020 experienced lower than average rainfall (Graph 3), resulting in dry creek beds with the remaining water pooling rather than flowing during spring and summer surveys of the 2019/2020 monitoring period.

Given the variable nature of annual mean records among sites, the evidence of a decreasing trend at a reference site and the lack of a distinct difference between impact and reference sites, it is not possible to attribute observed changes in frog numbers to the Project.

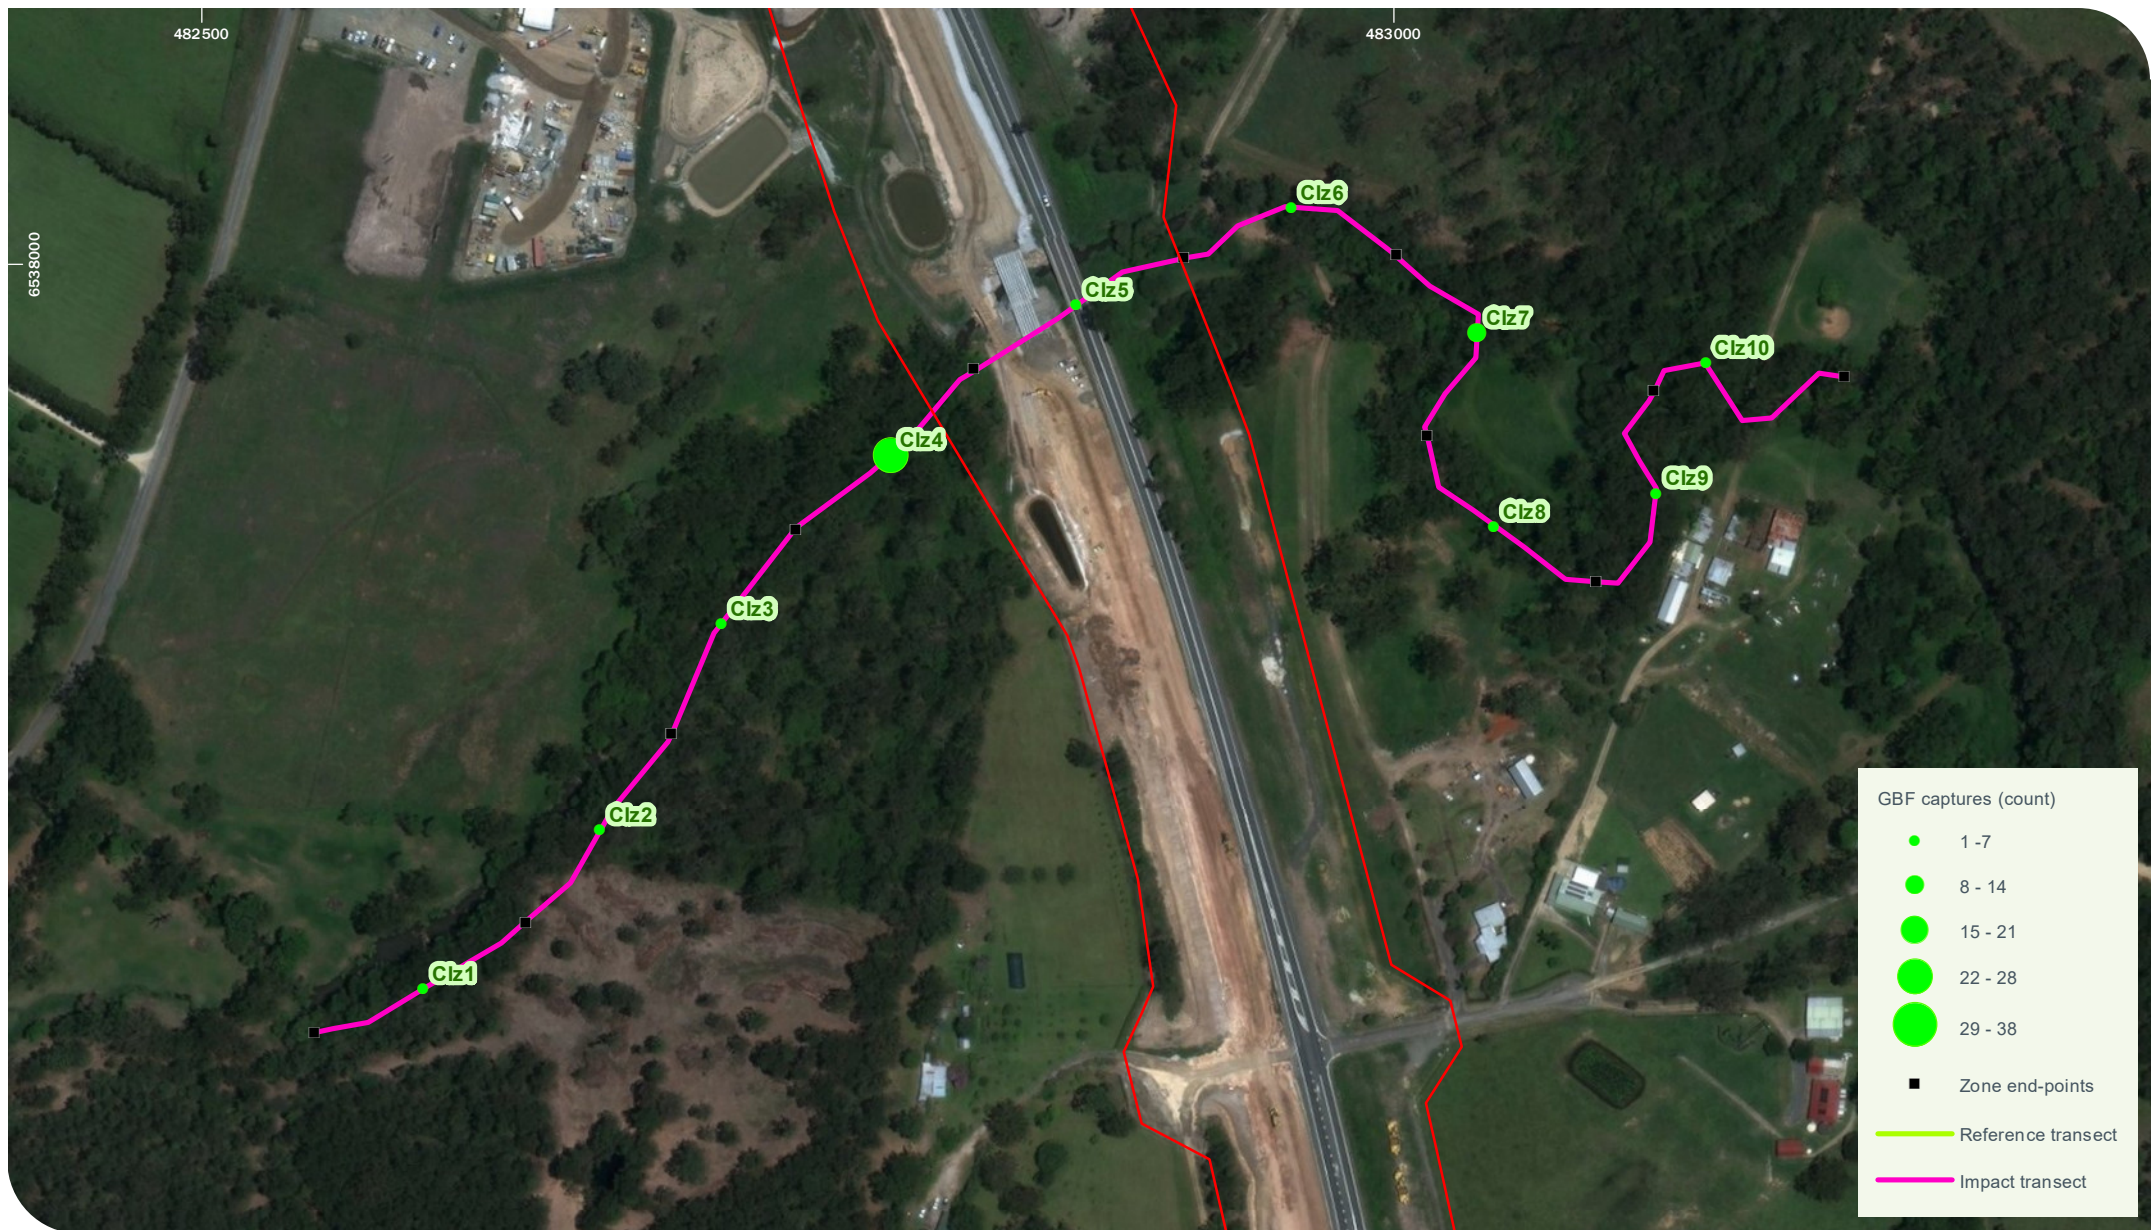
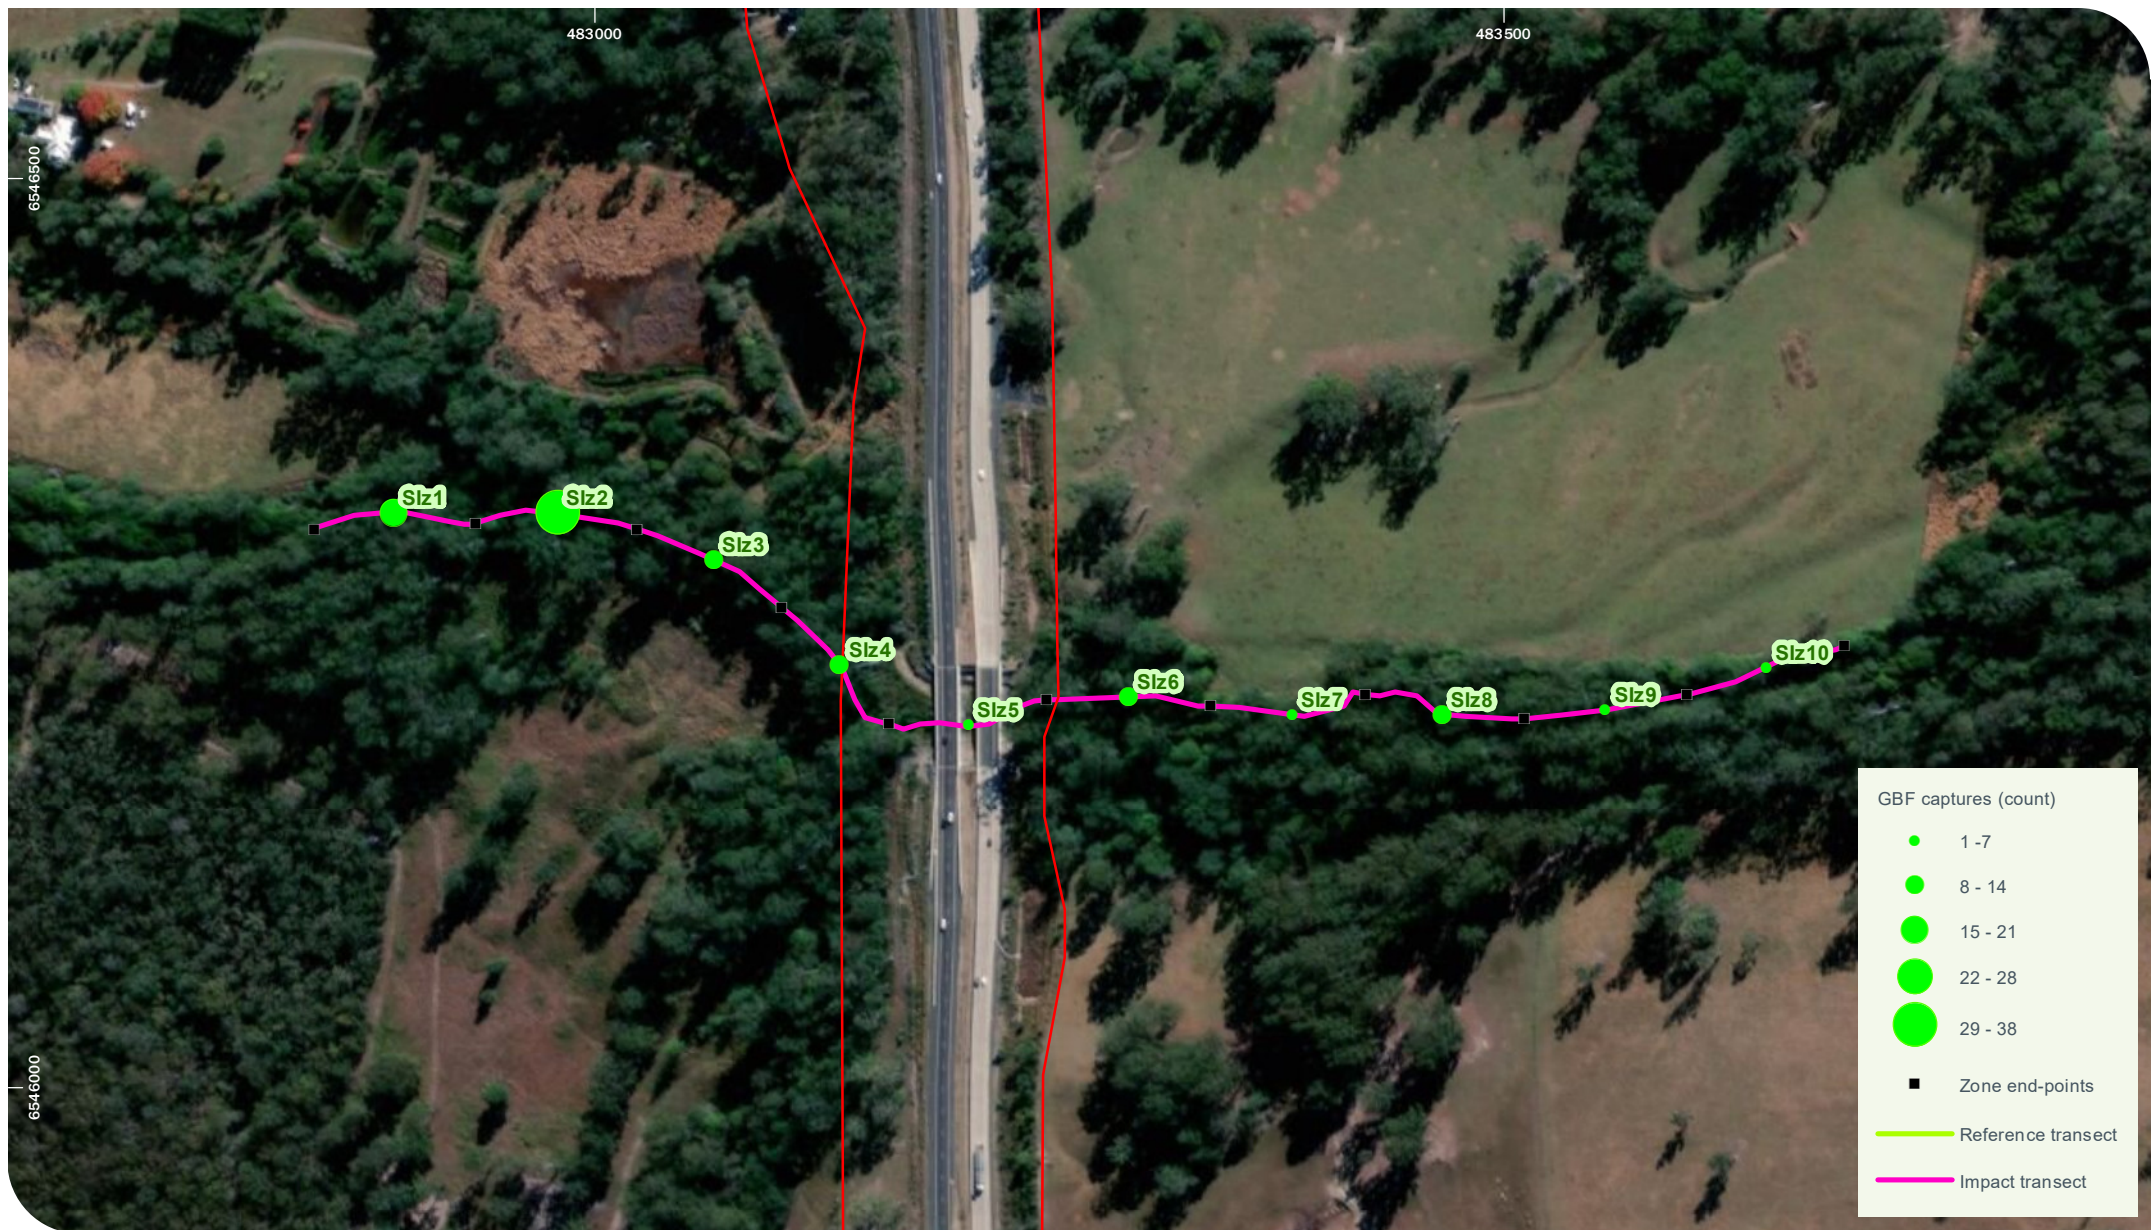
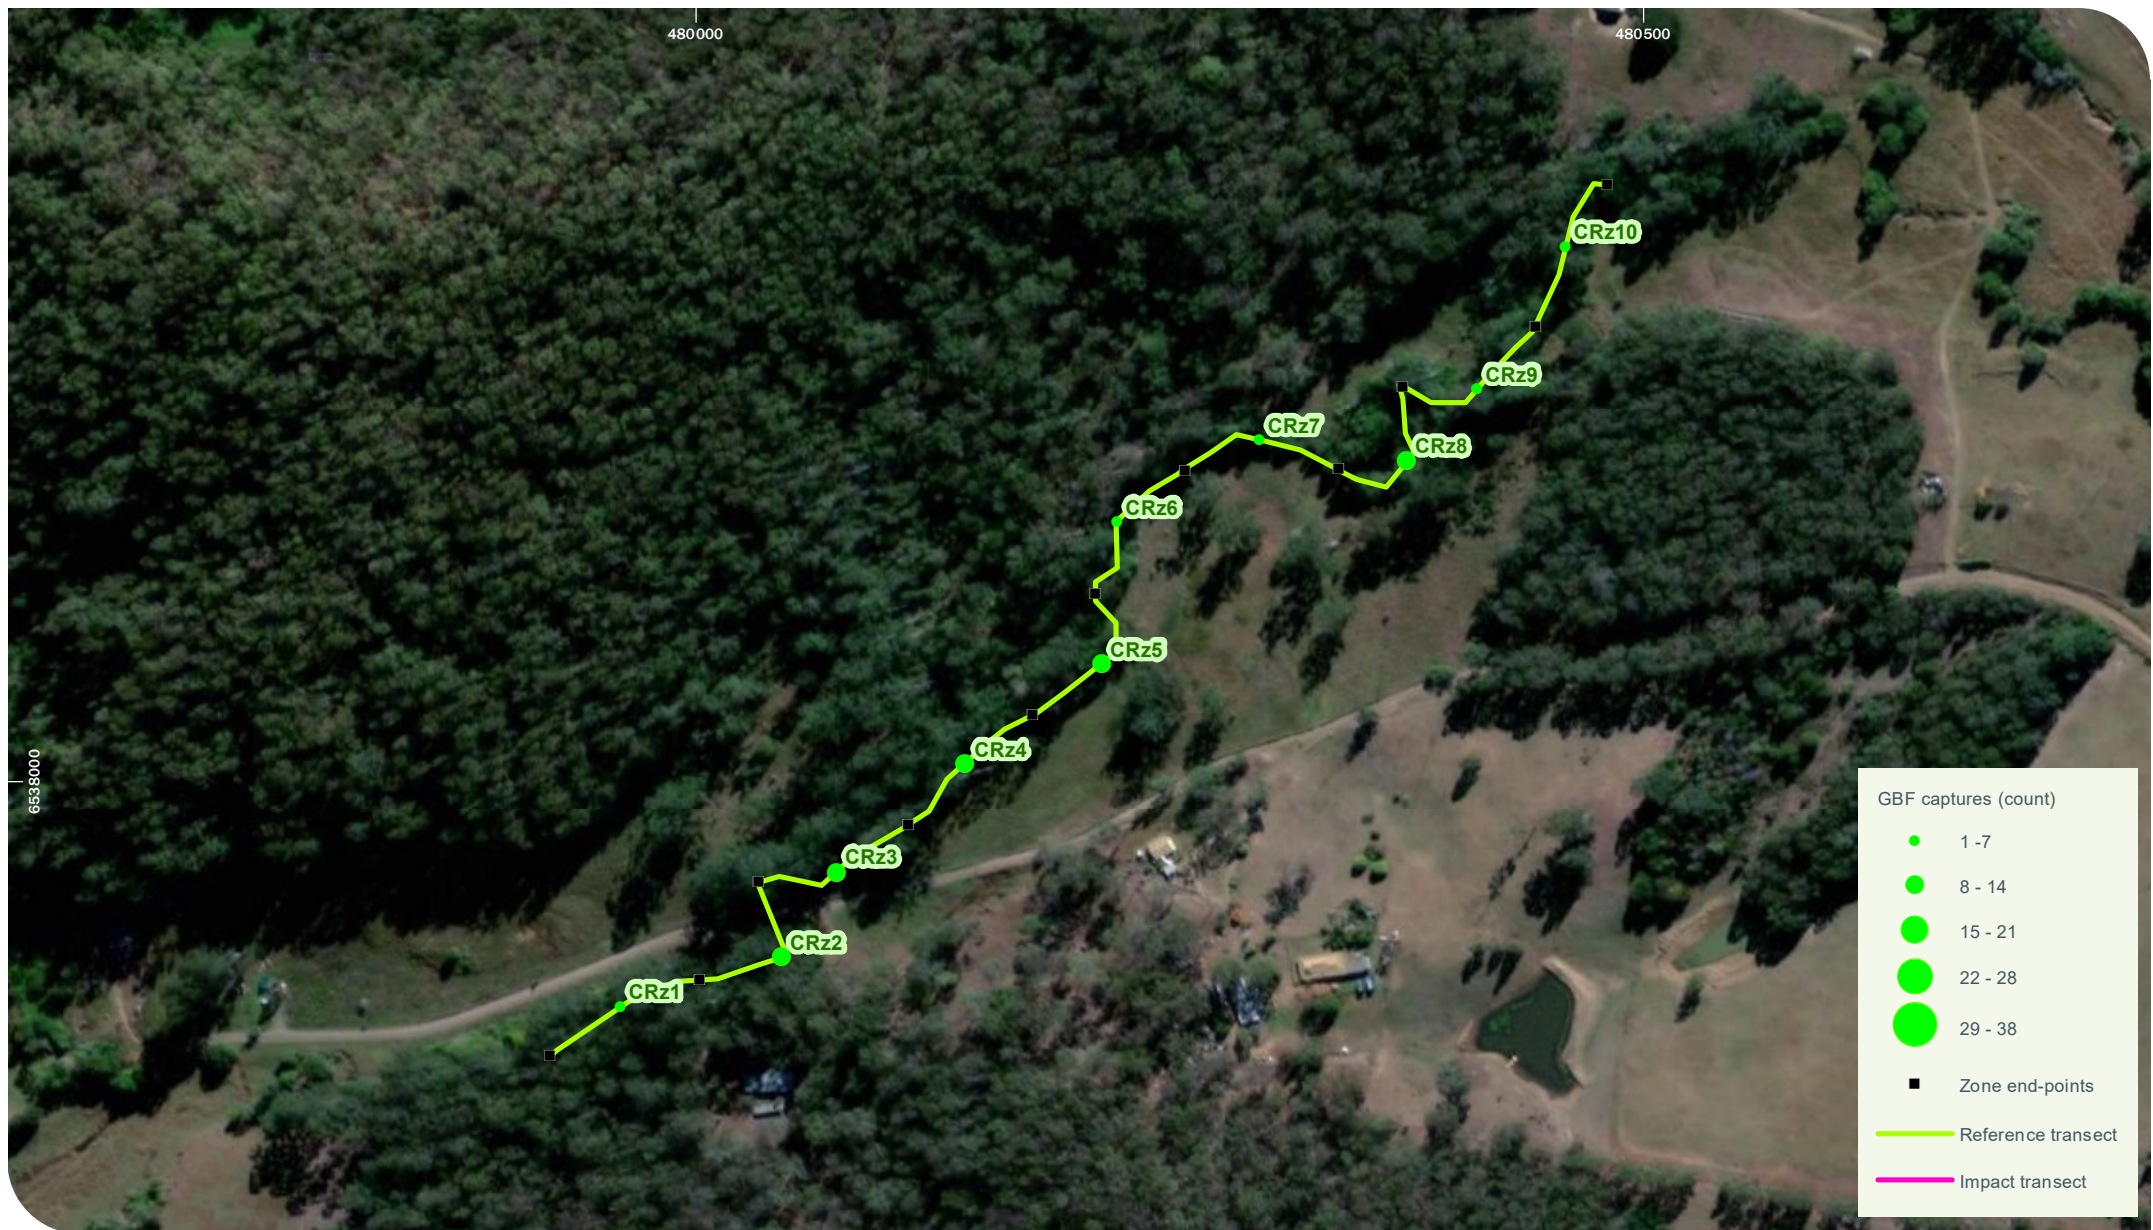
Figure 8 - Figure 13 shows all capture records (i.e. cumulative records), whereby capture records (including recaptures) are shown as count ranges, where larger circles indicate larger frog counts. While density data indicates that frog distribution along the transects varies from year to year, when considering all years, frogs mostly appear to be using the entire length of the transect and there is no evidence of frogs being recorded only in one particular zone. In addition, there is no evidence of frogs being absent from zones 5 and 6. While capture frequencies within zones directly under the carriageway consistently fall into the lower range category (1-7 frogs), the low capture frequency range occurs regularly along the transects and at all sites.
