Woolgoolga to Ballina Pacific Highway upgrade

Coastal Emu Monitoring Program Annual Report 2021

Operation Phase (Year 1)

Project No: IA136900
 Document Title: W2B Coastal Emu Monitoring 2021 Annual Report
 Revision: v1
 Document Status: Final
 Date: 14 December 2022
 Client Name: Transport for NSW
 Project Manager: Chris Thomson
 Author: Chris Thomson
 File Name: W2B_Emu monitoring_Annual Report 2021_Draft_v1

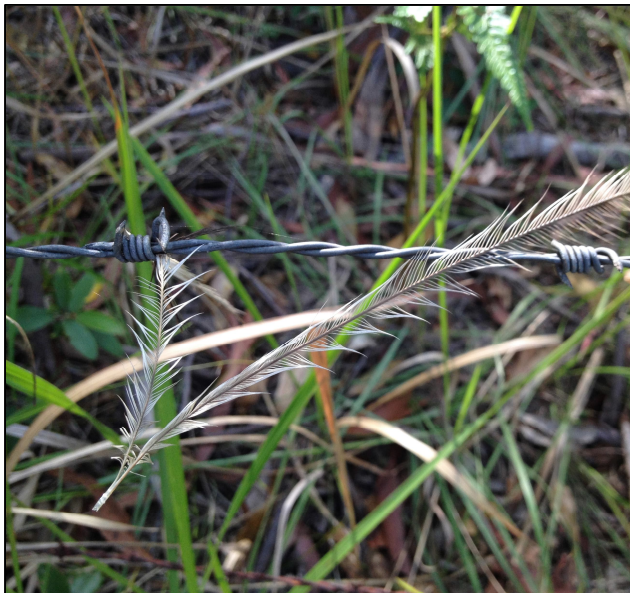
Plate 1. Example of Emu feathers 'snagged' on barbed wire

Where possible transects have been placed along fence lines, and 3 and 4 strand barbed wire fences are particularly effective at 'snagging' feathers from birds, and hence identifying Emu presence. Not all transects were able to be located on suitable fence lines, which is limited where plain wire is present or there is no fence. However, this factor does not affect the long-term comparison of results, as the conditions have not changed from the baseline survey. Occasionally fences have been replaced or sections removed and resulting in a change to the effectiveness of the transect at detecting Emu presence. To overcome this limitation, small changes or additions have been made to the transect, while still maintaining a similar search length and area of the transect as discussed previously.

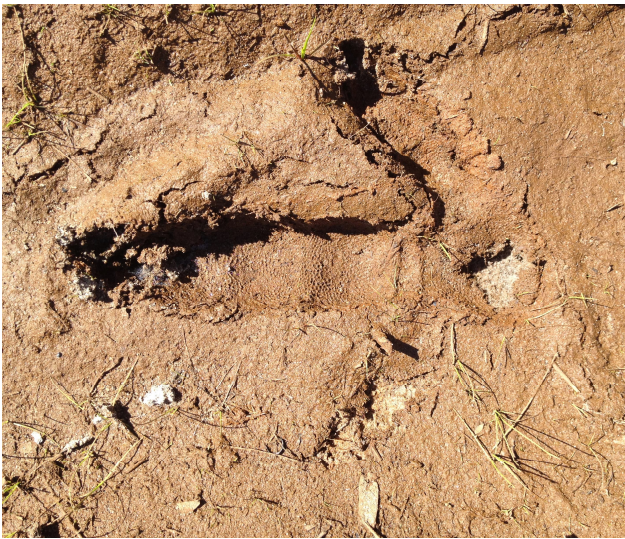
Plate 3. Example of muddy transect where Emu tracks are apparent

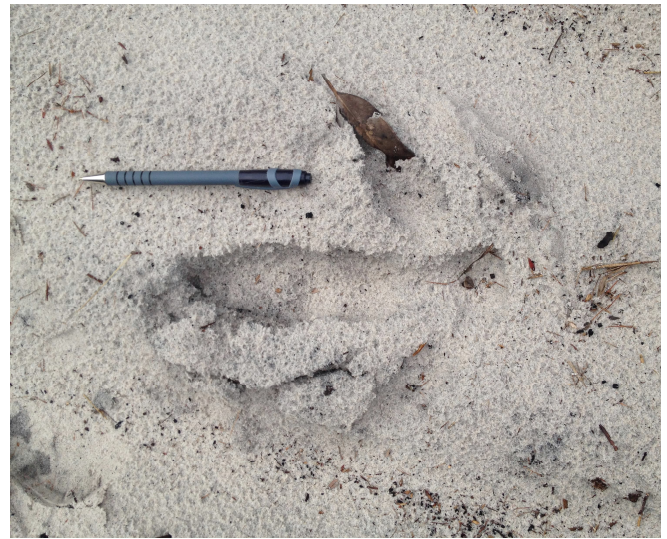
Plate 4. Example of sandy transect where Emu tracks are apparent

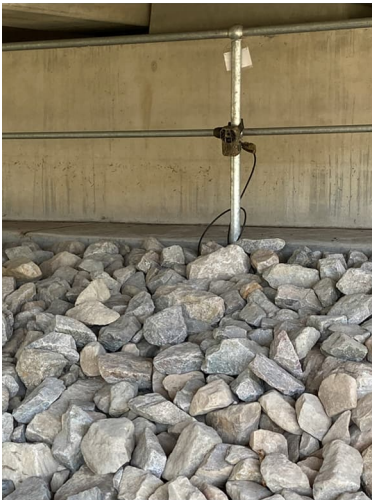
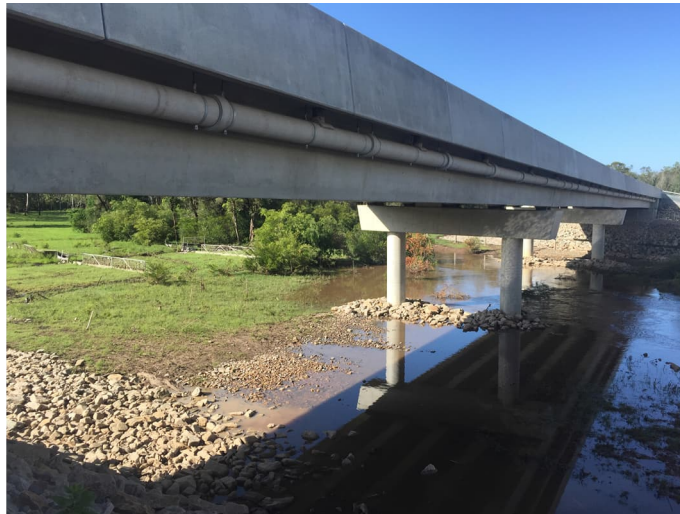
Plate 5. Example of camera traps positioned on railings and view of undercarriage

Monitoring of Emu usage at each potential crossing structure occurred continuously through the first year of operation (January-December 2021 for 365 days ~ 52 weeks). This involved the placement of camera traps (Stealth Cam GN45) below each structure, consisting of between 1-5 cameras depending on the width of the structure and conditions under the bridge (refer Table 2-4) and Plates 5 and 6. The number and configuration of cameras at each structure aimed to confirm Emu usage and determine the direction and frequency of Emu passes below the structure. Due to the high risk of flooding, some cameras were positioned on the railing below the bridge soffit, pointing down to ground-level with the sensor set to 'extended' distance to ensure passing emus were captured (Plate 5). Cameras were also positioned on fauna furniture and trees close to the bridge, aimed at the spaces between the bridge pylons. The two combined camera positions were required for adequate spatial coverage below long bridges.

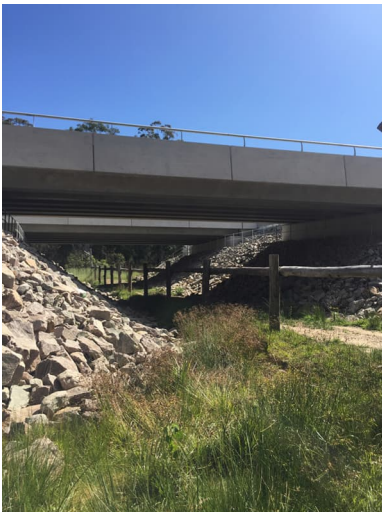
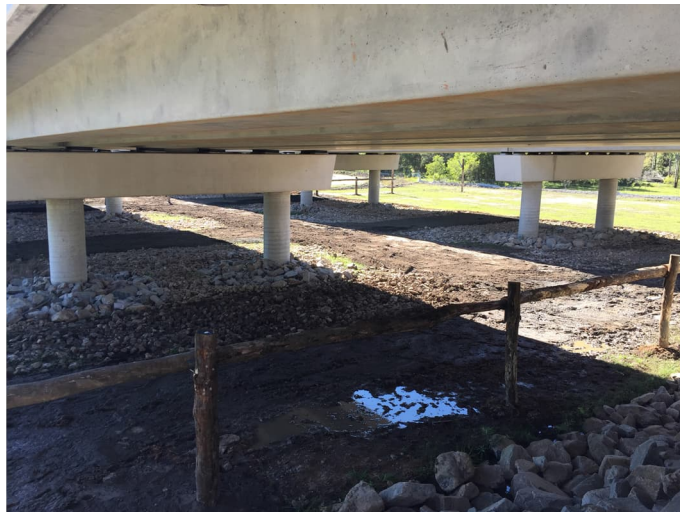
Plate 6. Example of fauna furniture used to attach multiple cameras across width of bridge opening

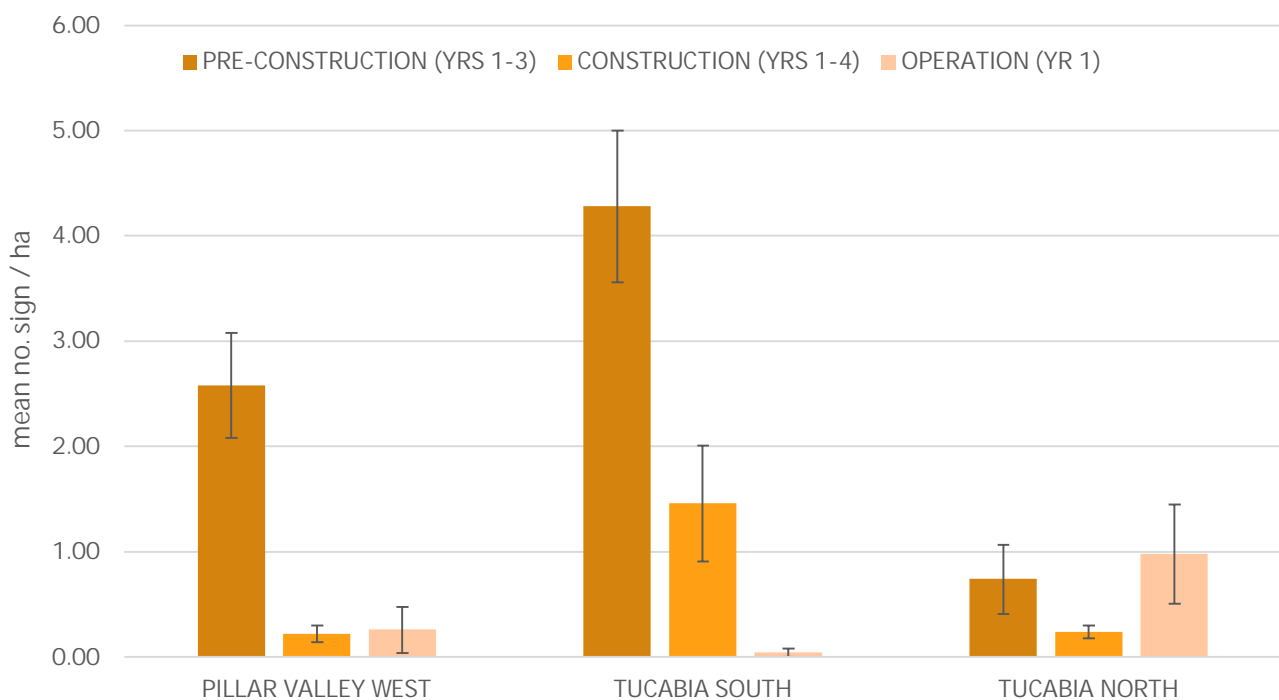
Figure 3: Mean density of Emu sign (no./ ha ±se) at impact survey areas comparing pre-construction (2014-16) and construction (2017-20), and operation (June 2020 to Dec 2021)

The density of Emu sign during the first year of operation is significantly lower than from the two southern ‘impact’ survey areas compared with the 3-year pre-construction (baseline) period from the same locations (Pillar Valley west $P=0.013$; Tucabia south $P=0.002$) (Figure 3:). This pattern of decline was first observed during construction and there has been no change in Pillar Valley west and further decline noted in Tucabia south during this first 18 months of operation. The density of emu sign in the Tucabia north impact survey area has increased in the operational phase compared with baseline and construction but is not significant ($P=0.696$). This is an encouraging evidence of emu activity returning where absences were previously noted.

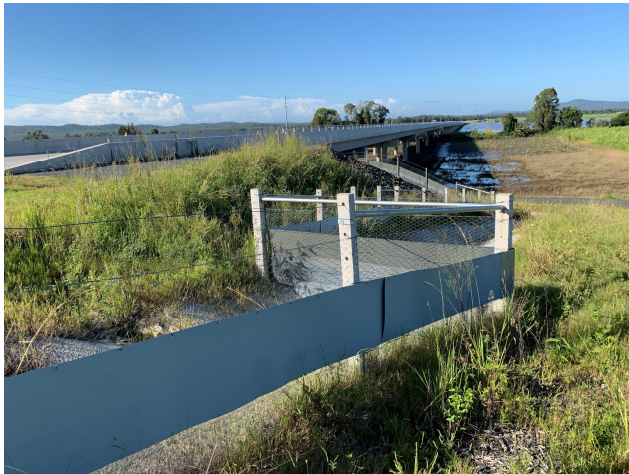
Plate 13. Photo looking from hill to the south over the inundation on the floodplain

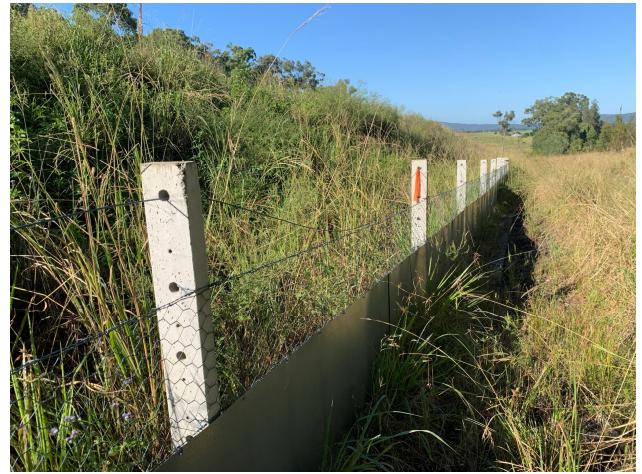
Plate 14. Damaged fauna fence identified on western side of hill on 29.03.21, was repaired same day

An Emu was struck by a vehicle on the highway on 29 March 2021, on the southbound lane (approx. chainage 76.000), which is on a hill located between the McIntyres Lane overpass and Shark Creek bridge. The injured bird was collected and taken to local vet and euthanised. The incident was reported to TfNSW and immediately followed up with an inspection of the fauna fence between Shark Creek Road and McIntyre’s Lane (east and west) to search for damage to the fence. The inspection identified a section of fauna fence where the top wire was broken at Chainage 75.800 (Plate14) and causing sagging of the wire across 10 metres of fence. The fence was subsequently repaired while staff remained at the site to prevent further crossing attempts by Emus. During the inspection, TfNSW staff in attendance had noted another adult emu with 3 juveniles walking the fence and looking for crossing opportunities (Plate 16).

There has been no evidence of an emu injured by exclusion fencing in year one operation. The reported emu road strike in March 2021 was immediately followed with a corrective action to survey and inspect the exclusion fence, and subsequent repairs were made to the fence within 24 hours of the incident being reported, which follows the corrective actions in the Emu Management Plan (Table 7.3). No further road fatalities were reported in year one operation.

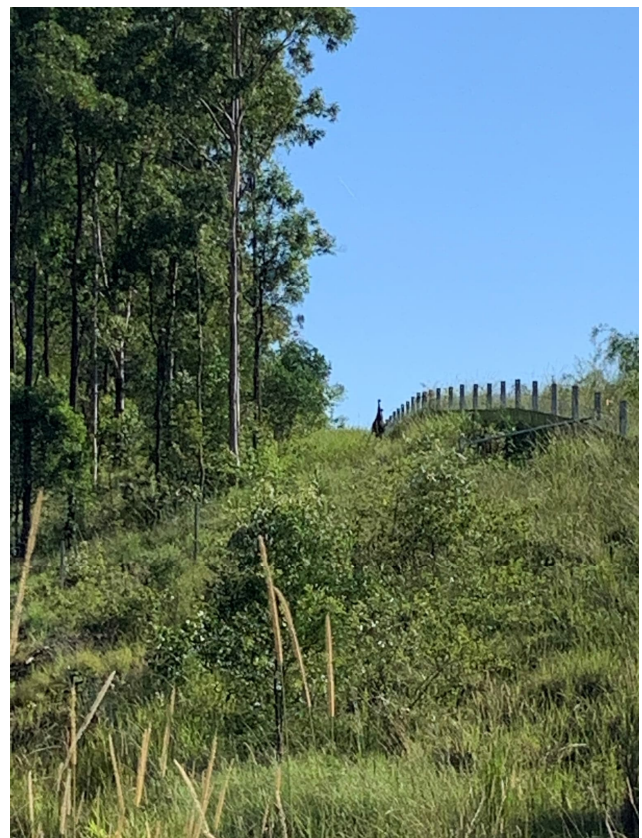
Plate 16. Emu observed walking along the western fauna fence within vicinity of vehicle strike incident
