# Pacific Highway Upgrade Woolgoolga to Ballina 3-11

Threatened Gliders Monitoring Program, Year Six  
(2022)

Transport for New South Wales | August 2023 | Final Report

Sections 3-11 Threatened Glider  
Monitoring – Year Six Annual Report  
(2022)

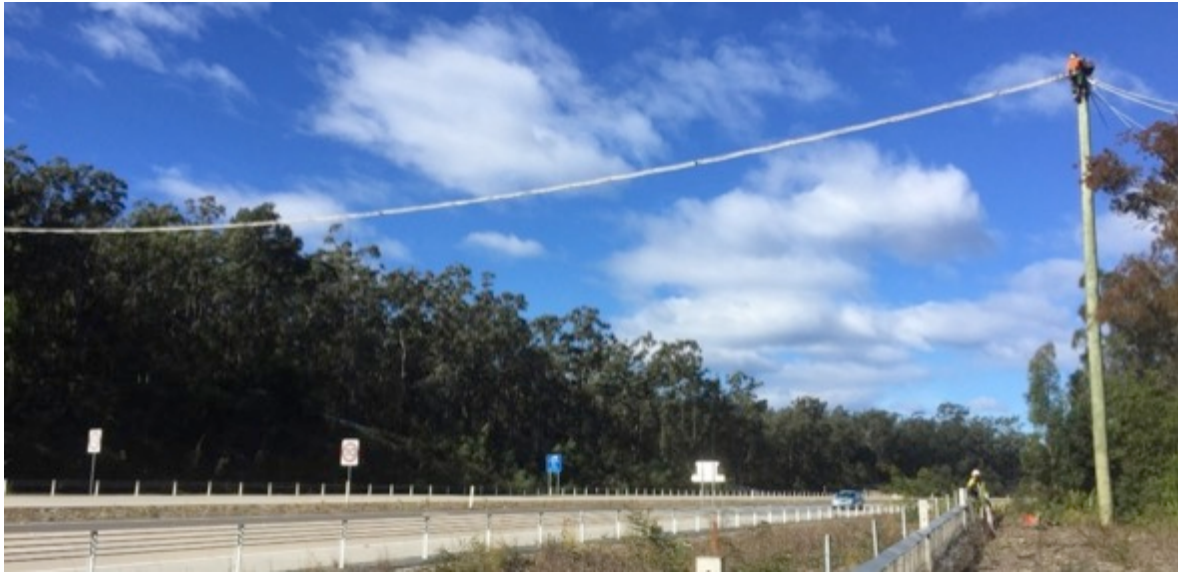
**Plate 1:** Rope bridges were suspended >10m above the road surface and supported by poles adjacent to the forest edge. A camera was fitted to the bulkhead at each end of the bridge. Black core-flute was cable tied to the underside of the rope ladder at each end during year 1 to reduce the incidence of false-triggering caused by traffic.

On rope bridges cameras were initially set at medium sensitivity to reduce the incidence of false triggering caused by passing traffic. Sensitivity was reduced to low at a small number of sites where a high incidence of false triggers occurred (e.g. RB11). Upon activation, each camera sent up to three photographs to a central email address, with no delay between triggers. The number of images sent was dependent on wireless signal strength with only one image sent if signal strength was low. Video was not used on wireless cameras due to concern about signal strength and battery capacity. Images from the previous night were reviewed daily, false triggers discarded immediately and active images saved for further review. Consequently, the number of images taken was not recorded for cameras in S3-11 other than during maintenance inspections.

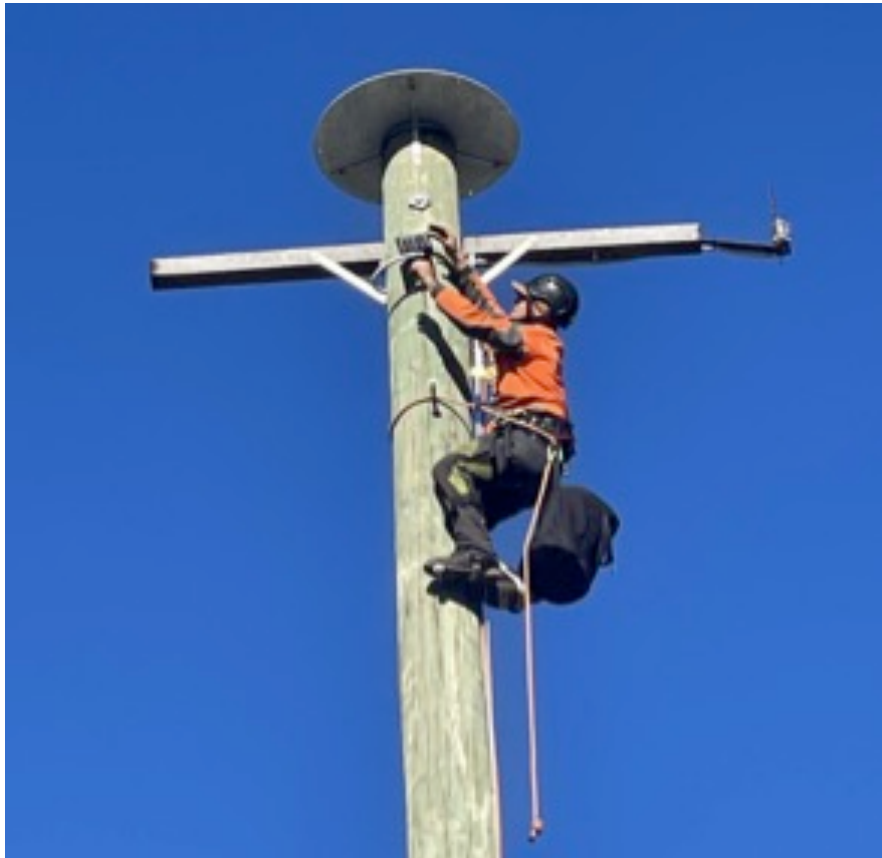
**Plate 2:** Location of camera attachment on glide poles in S3-11. Each structure contained a wireless 4G Enduro camera with a solar panel.

An arborist installed wireless 4G Swift Enduro cameras on rope bridges in sections 3-11 between 26 May and 7 July 2021 (Plate 2). Wireless cameras were installed to minimise the number of aerial climbs required to download and maintain cameras, thereby improving safety. Cameras were installed on brackets attached to the bulkhead at each end of the 12 rope bridges and were oriented along the bridge. A 1 m sheet of corflute was attached to the bottom of each bridge to reduce the incidence of false triggers. Wireless cameras were equipped with a 16 or 32GB SD card. A small solar panel with inbuilt battery was attached to each camera, and all cameras were fitted with 12 NiMH rechargeable batteries as a back-up during cloudy conditions. The cameras' active period was set from 2000-0500hrs EST from 1 January to 31 December 2022.

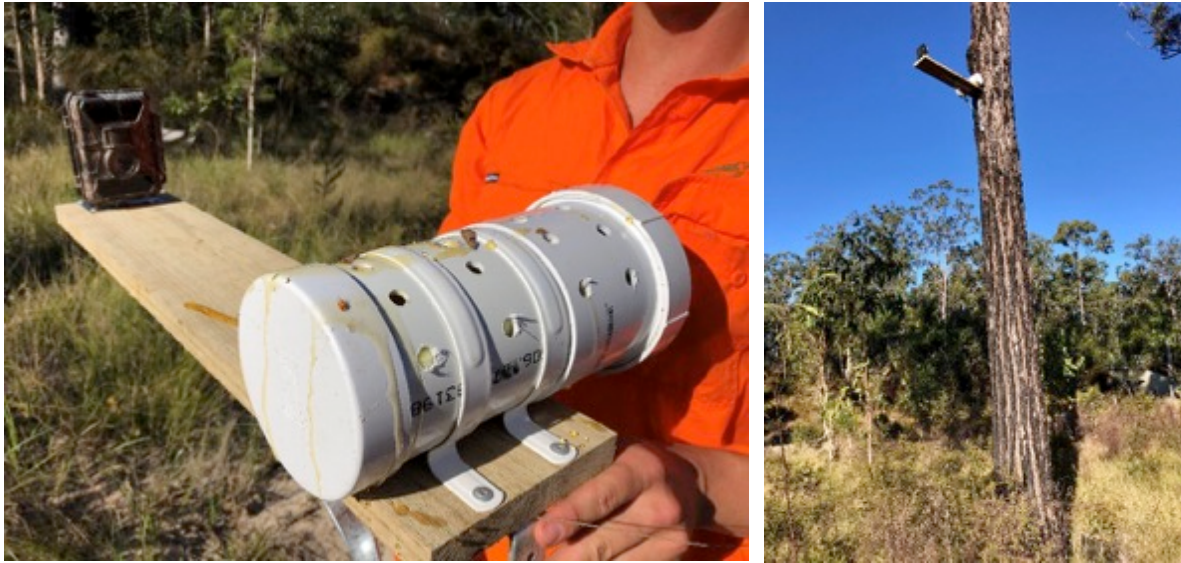
**Plate 3:** Vegetated median camera trap set up.

Four camera traps were installed in the Tabbimoble median to detect the presence of gliders (Table 6). Two camera traps (TVM1 and TVM2) were installed in the Tabbimoble median on 21 January 2021 as part of year one operational monitoring (Table 6). Two additional cams were installed on 27 September 2022 (TVM3) and 29 November 2022 (TVM4) late in year two monitoring to improve coverage of the median. Camera traps were positioned at feasible glide crossing locations and featured a Swift Enduro camera, mounted to a 150 mm x 500 mm x 10 mm timber board, oriented towards a capped 250 mm x 100 mm diameter PVC pipe (Plate 3). The PVC pipe was perforated by numerous holes and filled with creamed honey and a sponge. The camera array was attached to a metal bracket and mounted to subject trees approximately 6m above ground level (Plate 3). A dilute mixture of honey and water was sprayed up the tree trunk above the camera trap as an extra attractant.

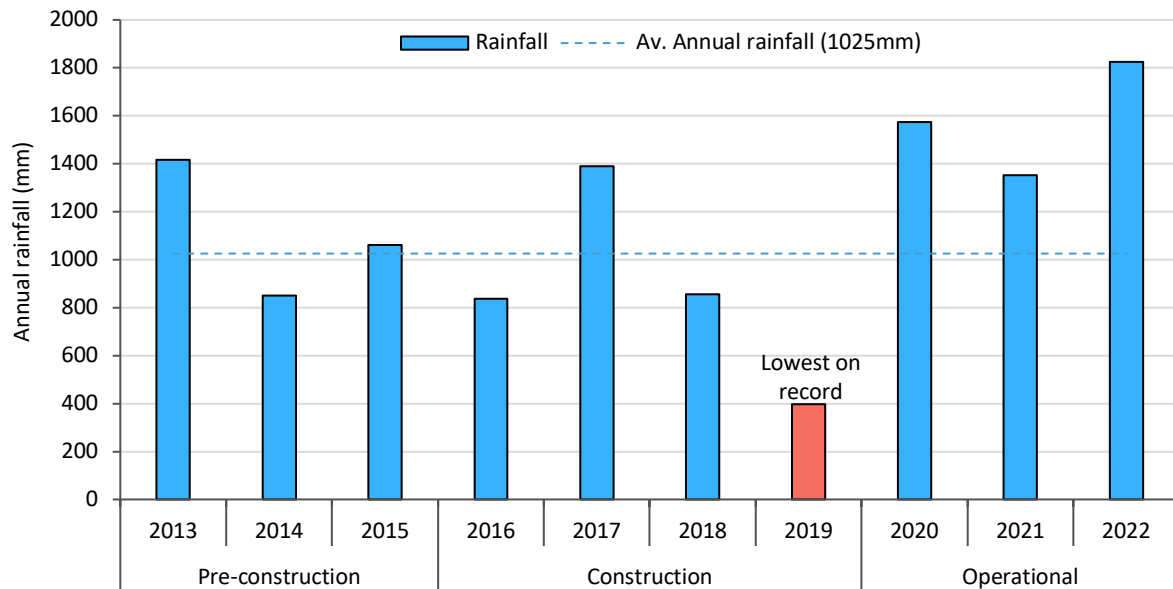
**Figure 6:** Total annual rainfall in the study area from 2012 to 2022. Data source: Bushgrove (BoM, station no. 58006).

Rainfall in the study area has fluctuated considerably over time (Figure 6). Annual rainfalls totals have ranged from a minimum of 397.2 mm in 2019 to a maximum of 1826.2 mm in 2022, compared to the average annual rainfall of 1025.5 mm (Figure 6). Rainfall totals have been above average in six years (2013, 2015, 2017, 2020, 2021, and 2022) and below the average in five years (2014, 2016, 2018, and 2019) (Figure 6). The most notable drop occurred from 2018 to 2019, when it decreased by more than half (from 855.2 mm to 397.2 mm) and was the lowest recorded annual rainfall on record for the Bushgrove station (Figure 6). The most notable increase occurred from 2019 to 2020, when it almost quadrupled (from 397.2 mm to 1575 mm).

The study area continued to experience a recovery from the severe drought and wildfires that occurred in 2019, as La Nina conditions prevailed during 2022 monitoring (Table 7). The annual rainfall in 2022 (year two operation phase) was 78% above the average of 1025.5 mm (Figure 6 and 7).

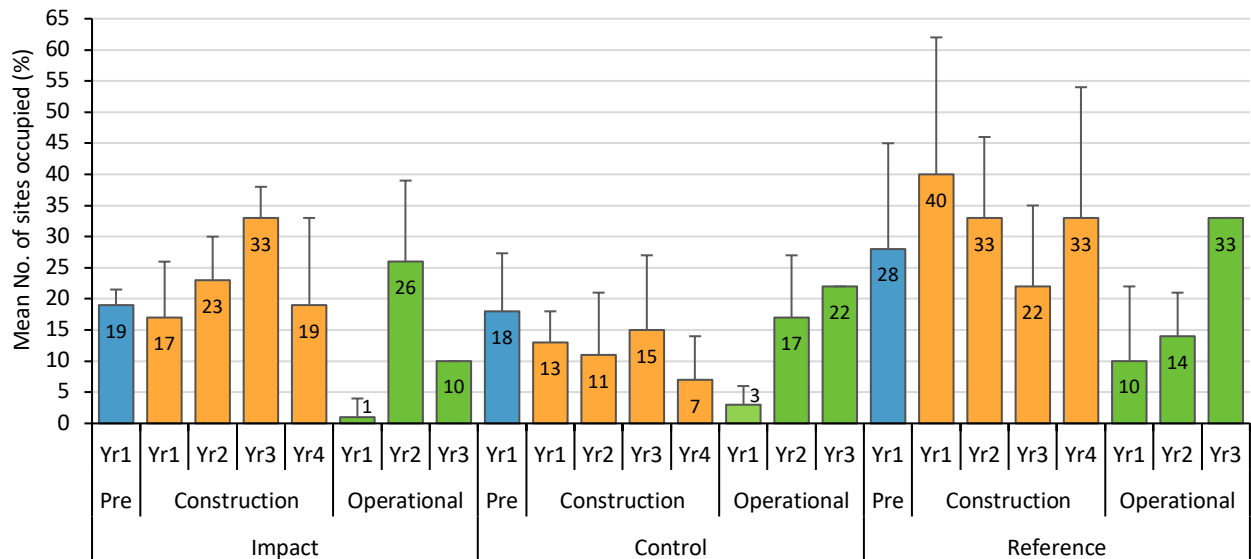
**Figure 8:** Mean  $\pm$  SD occupation rates for squirrel glider at impact, control, and reference sites in sections 3-11 during pre-construction, construction, year one and two of the operation phase and one-quarter of year three (i.e., Q4 2022). Pre = pre-construction. The legend is the same as Figure 7.

The annual occupancy rates of squirrel gliders have varied over time across all treatments, (Figure 8). During the pre-construction phase, occupancy rates were similar among treatments, ranging from 18% to 28%, with the highest rate recorded at reference sites (Figure 8). During the construction phase, occupancy rates tended to increase at the impact and reference sites and remained similar or slightly lower at control sites (Figure 8). Occupancy rates at impact and reference sites peaked during construction, with the highest occupancy occurring in year 1 for the reference sites (40%) and year 3 for the impact sites (33%). In contrast, the control sites had the highest occupancy rates during the pre-construction phase (18%) (Figure 8).

Squirrel glider occupancy also declined across all treatments towards the end of the construction phase, with a more substantial decline following drought and bushfires in year one of operation (2021) (Figure 8). Squirrel glider populations in the study area were likely impacted by similar mechanisms as discussed for the yellow-bellied glider. However, their higher fecundity has likely enabled populations to recover more quickly. The substantial decline in occupancy recorded in year one of operation was likely due to the combined effects of drought and bushfire on food availability as noted by Sharpe (2004).

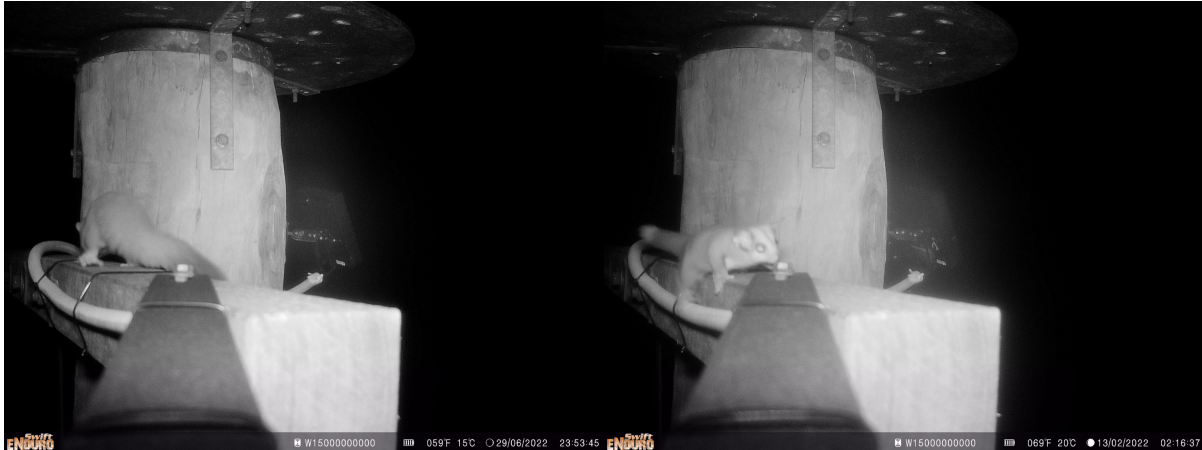
**Plate 4:** Squirrel glider (left) and sugar glider (right) recorded at the same position on glide pole #7. Note the difference in body and tail size and shape.

Squirrel gliders were recorded on eight of the 13 monitored glide poles, with a total of 38 detections (Table 8, Plate 4). The highest number of detections occurred at GP7 west (9 detections), followed by GP4 east (7 detections) and GP7 west (7 detections; Table 8). Of these instances, squirrel gliders were observed crossing the alignment on nine occasions, with the highest number of crossings occurring at median pole GP8 ( $n = 4$ , cc/week = 0.08) (Table 8). Complete crossings were also observed at median pole GP6 ( $n = 2$ ), GP7 in both an easterly ( $n = 1$ ) and westerly ( $n = 1$ ) direction, and GP4 once in an easterly direction (Table 8). The weekly

Sugar gliders were the least frequently detected species, with a total of 15 detections (Plate 4). They were observed crossing the alignment twice, at GP10 east and GP8 median, with a weekly crossing rate of 0.02 cc/week at both locations (Table 9). Across all sites, the mean crossing rate for sugar gliders was  $0.006 \pm 0.008$  SD (see Table 9). For more detailed information on glide pole detections refer to Appendix C.

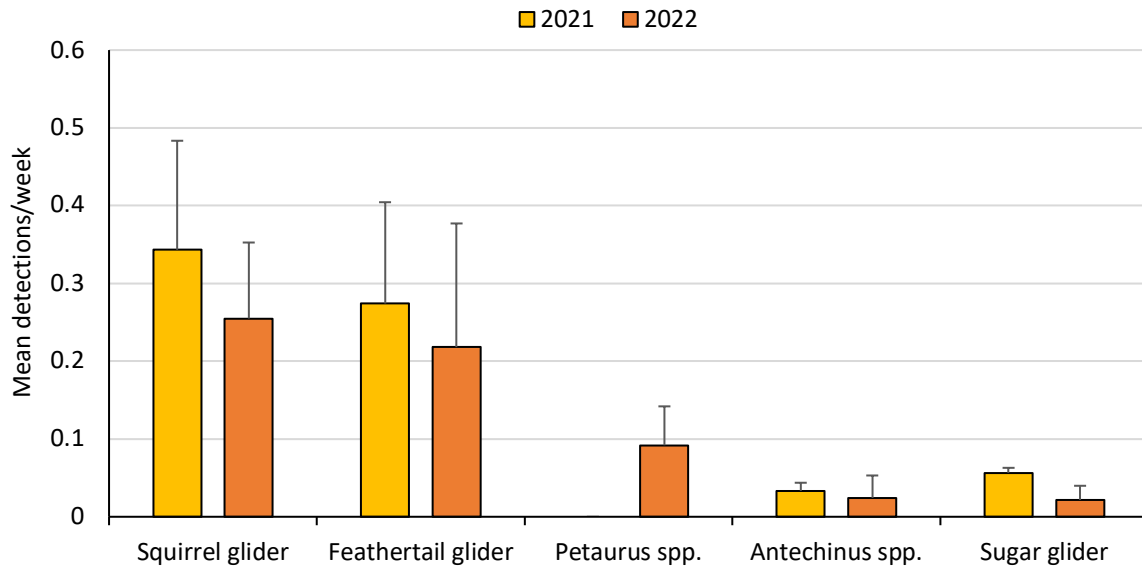
**Figure 11:** Comparison of mean  $\pm$  SD fauna detections for 2021 (year one) and 2022 (Year two) camera trap monitoring at the Tabbimoble vegetated median, W2B.
