# Woolgoolga to Ballina Pacific Highway upgrade

## Coastal Emu Monitoring Program Annual Report 2023

Operational Phase (Year 3/4)

Project No: IA136900  
Document Title: W2B Coastal Emu Monitoring 2023 Annual Report  
Revision: Final Report  
Document Status: Final Report  
Date: 4 October 2024  
Client Name: Transport for NSW  
Project Manager: Chris Thomson  
Author: Chris Thomson  
File Name: W2B\_Emu monitoring\_Annual Report 2023\_Final\_202401004

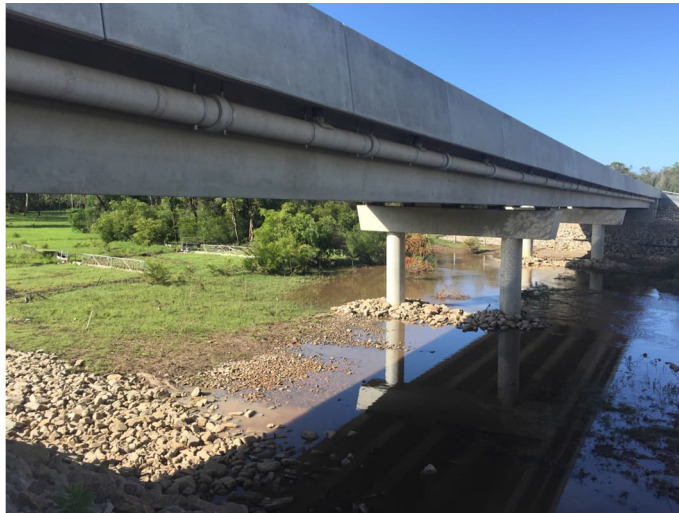
**Plate 5.** Example of camera traps positioned on railings and view of undercarriage

Monitoring of Emu usage at each potential crossing structure occurred continuously through the third year of operation (December 2022–December 2023 for 371 days ~ 53 weeks). This involved the placement of camera traps (Stealth Cam GN45 and Swift Enduro) below each structure, consisting of between 1–5 cameras depending on the width of the structure and conditions under the bridge (refer Table 2-4) and Plates 5 and 6. The number and configuration of cameras at each structure aimed to confirm Emu usage and determine the direction and frequency of Emu passes below the structure. Due to the high risk of flooding, some cameras were positioned on the railing below the bridge soffit, pointing down to ground-level with the sensor set to 'extended' distance to ensure passing emus were captured (Plate 5). Cameras were also positioned on fauna furniture and trees close to the bridge, aimed at the spaces between the bridge pylons. The two combined camera positions were required for adequate spatial coverage below long bridges.

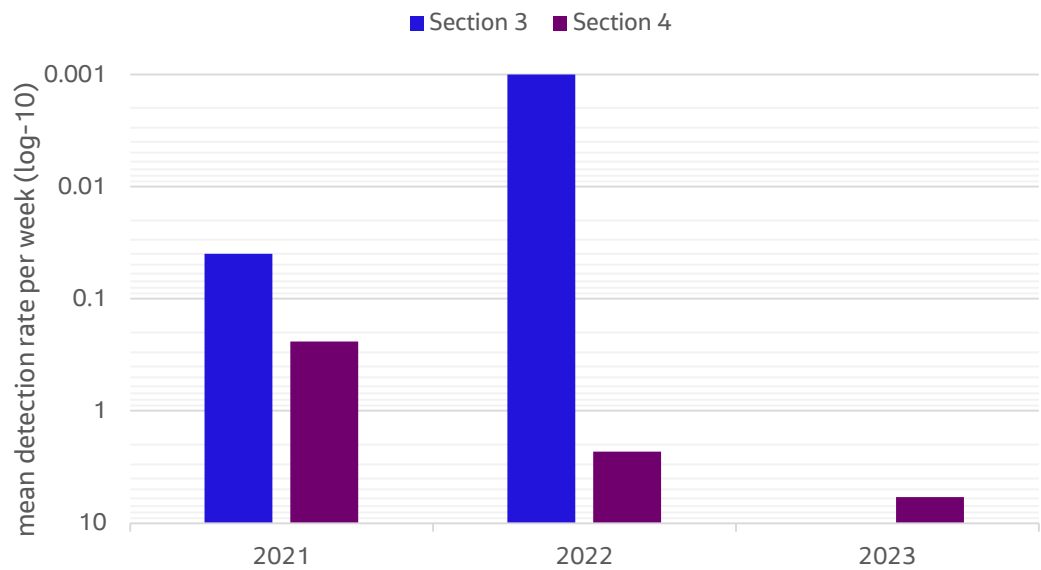
**Figure 9:** Mean detection rates / per week ( $\log^{-10}$ ) for emus photographed using bridges to cross highway in year 1- 3 operation in section 3 and 4

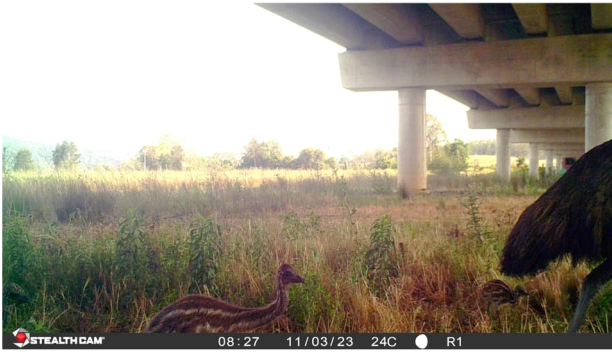
**Plate 7.** Shark Creek bridge (Site R) adult male and striped chicks in late spring period

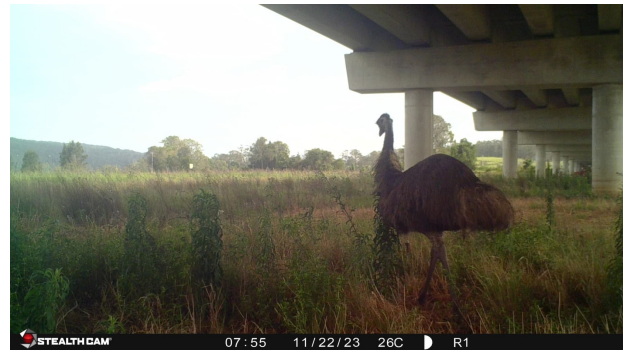
**Plate 8.** Shark Creek bridge (Site R) bird regularly crossing in all seasons

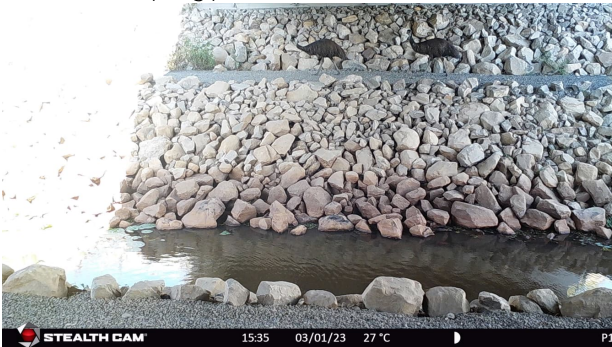
**Plate 9.** Cane drain (site P) Pair crossing to the west

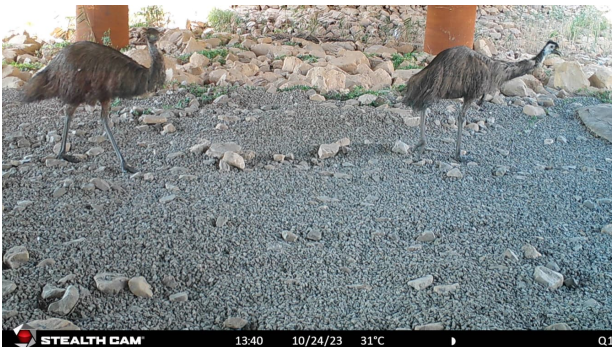
**Plate 11.** Cane drain (P) crossing to the east during spring season

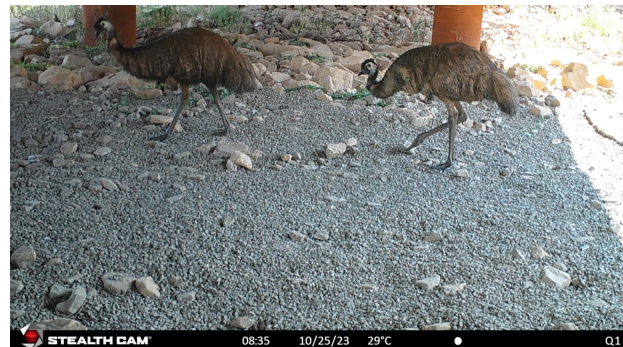
**Plate 12.** Cane drain (P) crossing to the west during spring
