Woolgoolga to Ballina Pacific Highway upgrade

Coastal Emu Monitoring Program Annual Report 2022

Operational Phase (Year 2/3)

Project No: IA136900
Document Title: W2B Coastal Emu Monitoring 2022 Annual Report
Revision: Final Report
Document Status: Final Report
Date: 19 October 2023
Client Name: Transport for NSW
Project Manager: Chris Thomson
Author: Chris Thomson
File Name: W2B_Emu monitoring_Annual Report 2022_Final_20231020

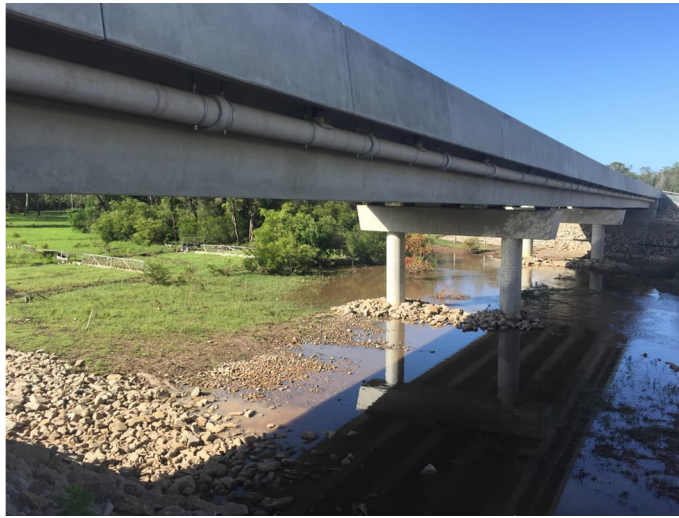
Plate 5. Example of camera traps positioned on railings and view of undercarriage

Monitoring of Emu usage at each potential crossing structure occurred continuously through the second year of operation (January-December 2022 for 365 days ~ 52 weeks). This involved the placement of camera traps (Stealth Cam GN45 and Swift Enduro) below each structure, consisting of between 1-5 cameras depending on the width of the structure and conditions under the bridge (refer Table 2-4) and Plates 5 and 6. The number and configuration of cameras at each structure aimed to confirm Emu usage and determine the direction and frequency of Emu passes below the structure. Due to the high risk of flooding, some cameras were positioned on the railing below the bridge soffit, pointing down to ground-level with the sensor set to 'extended' distance to ensure passing emus were captured (Plate 5). Cameras were also positioned on fauna furniture and trees close to the bridge, aimed at the spaces between the bridge pylons. The two combined camera positions were required for adequate spatial coverage below long bridges.

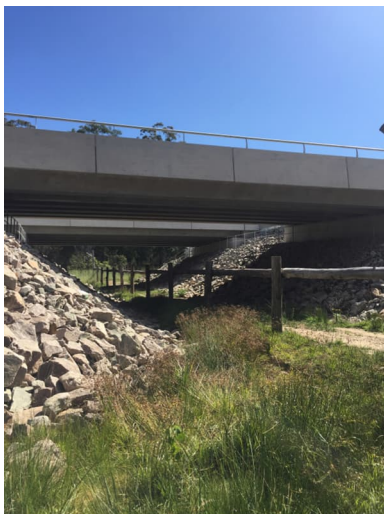
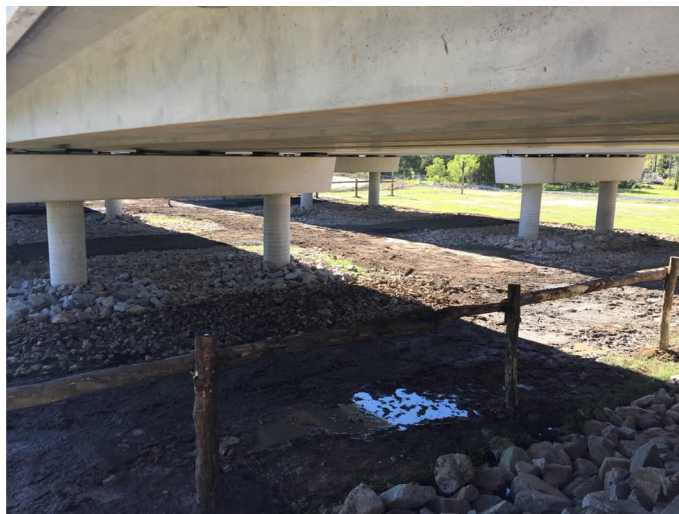
Plate 6. Example of fauna furniture used to attach multiple cameras across width of bridge opening

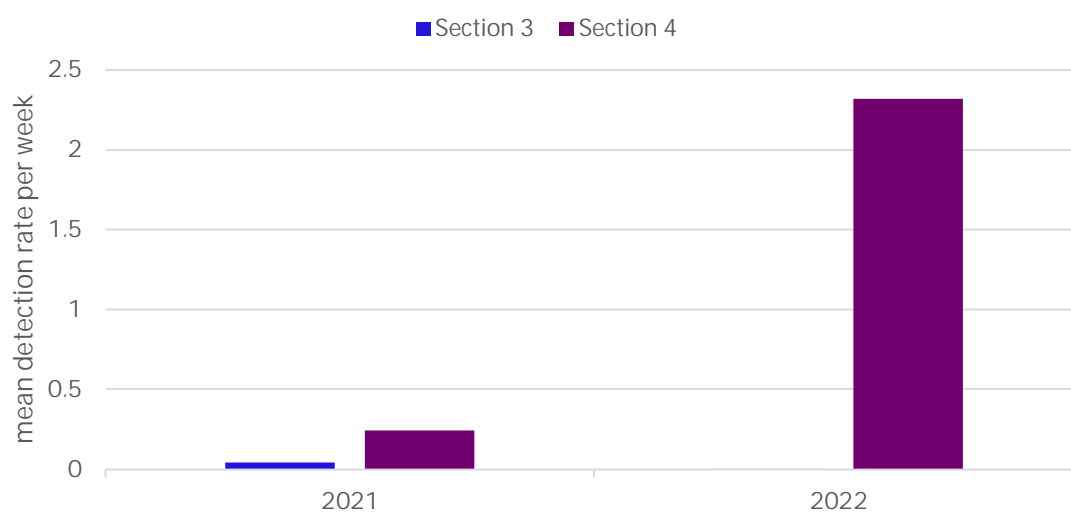
Figure 9: Mean detection rates / per week (±se) for emus photographed using bridges to cross highway in year 1 and 2 operation in section 3 and 4

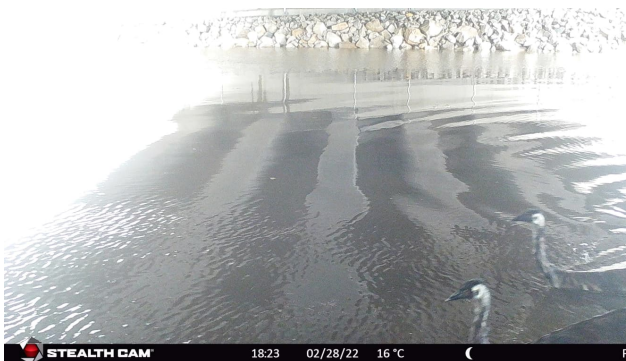
Plate 9. Cane drain (site P) 28 February 2022 – Emus wading along ledge in flood waters

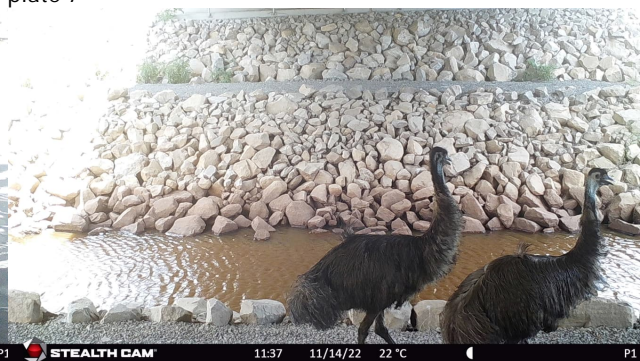
Plate 10. Cane drain (Site P) during late spring. Birds are using the same ledge as described in Plate 9
