Woolgoolga to Ballina Pacific Highway Upgrade

Threatened mammal underpass monitoring
program, sections 3-11, year 3 operation phase.
Annual Report 2022-23

Transport for New South Wales | June 2025

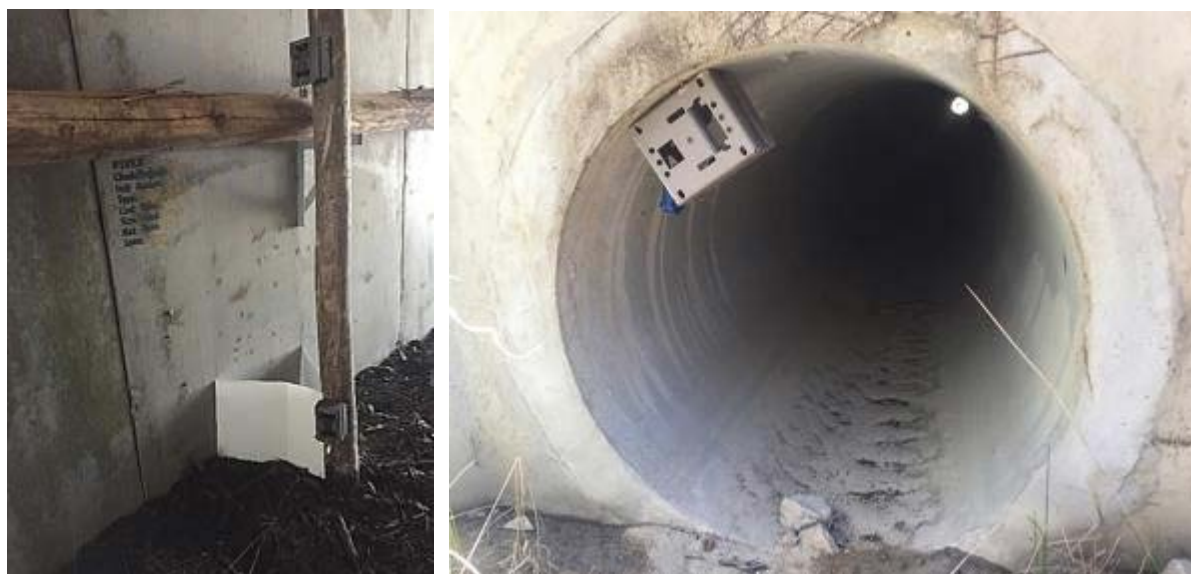
Plate 1: Within each box culvert, cameras were installed on the centre post— one viewing along the rail and the other along the floor (left). Within pipes, cameras were installed on the upper edge of the obvert (to reduce inundation) and angled towards the floor.

Cameras installed were predominantly Swift Enduro, with some Swift 3c, Reconyx HC500, Moultrie S-50i and Spromise S108 installed at sites with a higher risk of theft. For box culverts and bridges, two cameras were mounted on the central post of the fauna furniture – one positioned to capture animals moving along the furniture and the other positioned approximately 400mm above ground level to capture animals moving along the floor or fauna ledge (Plate 1). As bridge sites often featured two series of fauna furniture or had dual passages due to a waterway running centrally below the bridge, the setup was replicated on each side with a total of four cameras installed. All cameras were oriented east and were housed in security cases with padlocks. Within pipes, cameras were installed on the upper edge of the culvert (to reduce inundation) and angled towards the floor (Plate 1).

Cameras were set on medium to high sensitivity, depending on the risk of false triggers, and programmed to take 10 seconds of video on activation. They were scheduled to turn on at 1500hr and turn off at 0900hr. Cameras were inspected during the middle of each monitoring session to change batteries and SD cards. Cameras affected by false triggers were assessed and, if necessary re-oriented or re-programmed to reduce false triggers. During the interim and final download the battery status and number of videos taken was recorded for each camera.

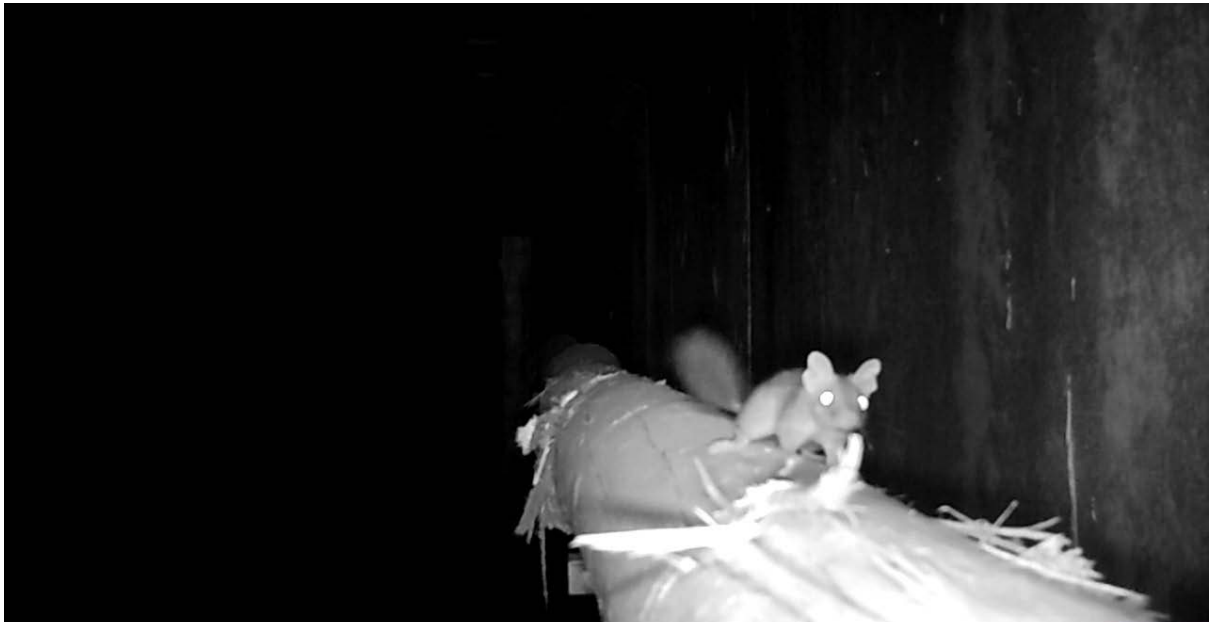
Plate 2: A brush-tailed phascogale recorded making a westward crossing using fauna furniture at site M12 in June 2019.

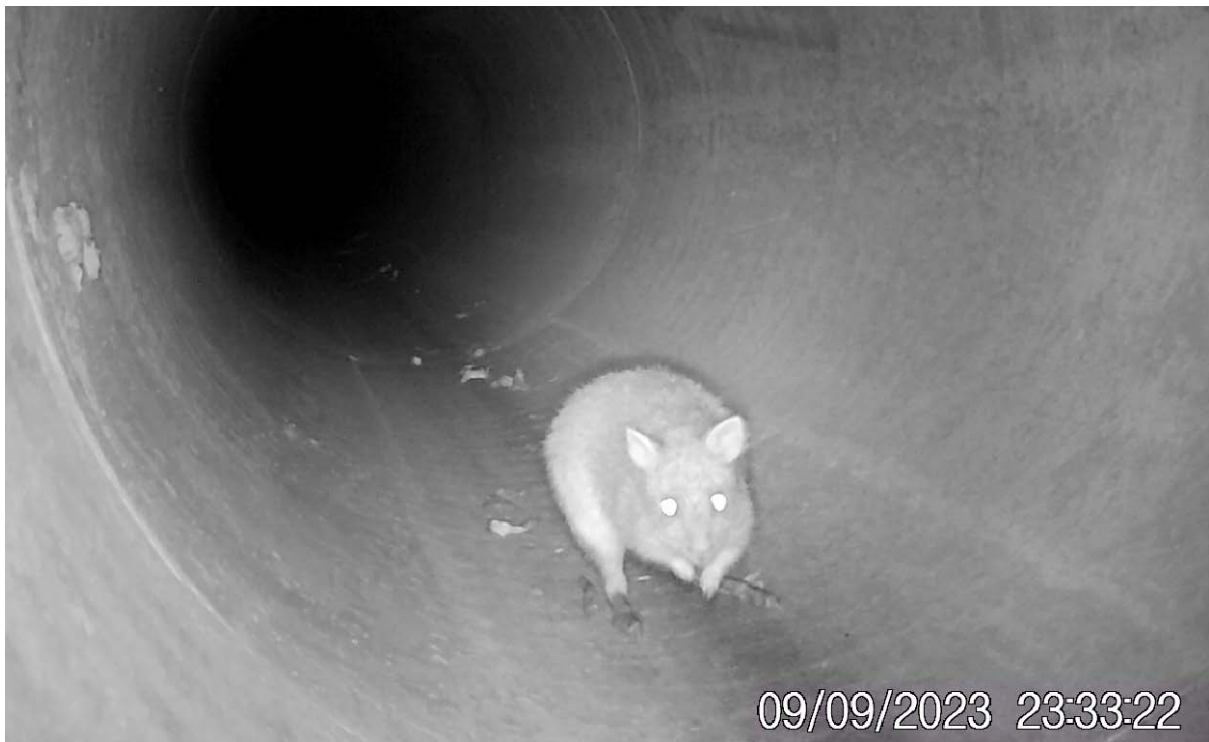
Plate 3: A rufous bettong recorded using a (0.9m Ø x 47m long) RCP (site M20) to cross the Pacific Highway on 9 September 2023.

Rufous bettong was recorded making an eastward crossing through M20, a (0.9m Ø x 47m long) RCP, during the autumn/winter 2023 survey event (Plate 3). No long-nosed potoroos were recorded during the spring 2022 to winter 2023 survey events.

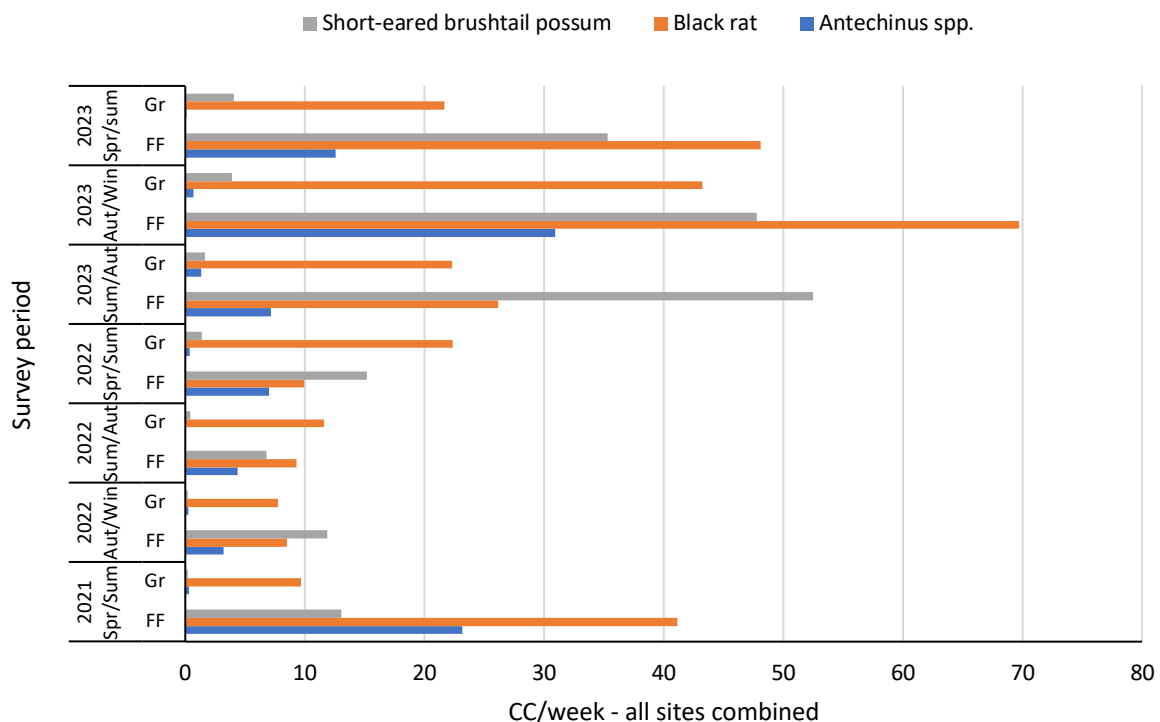
Figure 14: Comparison of complete crossings/week by three species of mammal using fauna furniture (FF) and the culvert floor (Gr).

Total crossings/week (all sites combined) for two scansorial (*Antechinus* spp. and black rat) and one arboreal (short-eared brushtail possum), species including an introduced species (black rat) was compared between fauna furniture and the ground (Figure 14). The comparison shows a clear difference in use of fauna furniture and the ground during each survey period by *Antechinus* spp. and short-eared brushtail possum. This contrasts with black rat which used furniture and the ground in similar rates during most survey periods. Despite frequent use by an introduced species the result emphasises the value of fauna furniture for native arboreal and scansorial species.

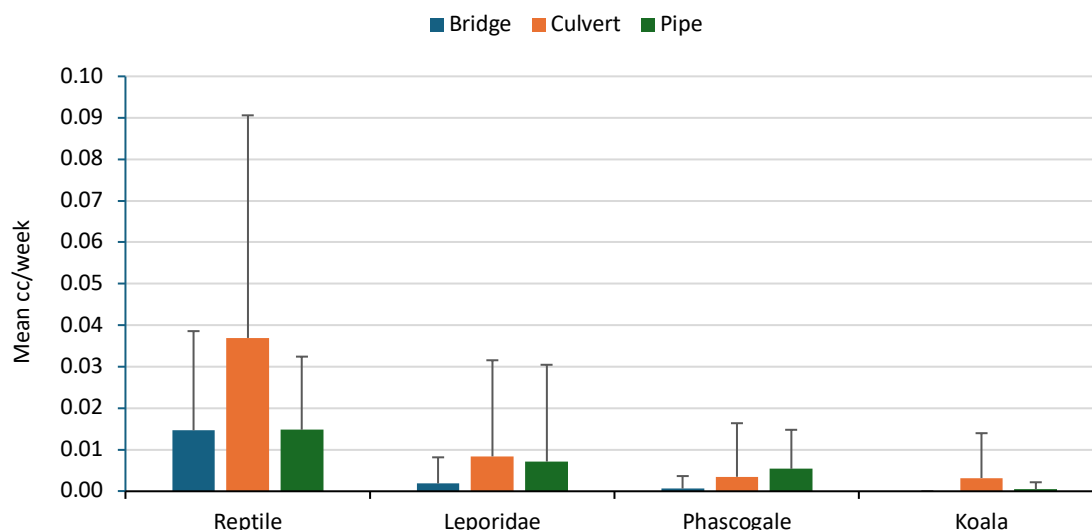
Figure 15: Complete crossings/week (+SD) for 13 fauna species/groups recorded in sections 1-11 of W2B. Note the differences in the vertical scale on each graph.

Comparison of mean cc/week for 13 fauna species/fauna groups between bridges, culverts and pipes shows variable use (Figure 15). One-way analysis of variance identified significant differences in the use of different structures for *Antechinus* spp., brush-tailed phascogale, rodent spp. and cat (Table 6). *Antechinus* sp. used culverts significantly more than bridges, brush-tailed phascogale used pipes significantly more than bridges and culverts, rodent species used culverts significantly more than bridges and cat used pipes significantly more than bridges. Differences in structure use were almost significant for bandicoot ($P=0.061$) and reptiles ($P=0.051$) with both species using culverts more frequently than bridges.

Non-significant differences in structure use were evident for other species/groups. The absence of significant differences for these species is due to high standard deviations or high variability in use within structure types. For example, mean cc/wk by macropods was substantially greater at bridges, however, mean cc/wk at bridges ranged from nil to 27.64. Likewise mean cc/wk by rodents at bridges ranged from 0 to 5.336 and mean cc/wk by possums ranged from 0 to 2.96. This high variability reflects the variable distribution of fauna species/groups and habitat across the study area and shows that when high quality habitat occurs on both sides of an underpass the mean number of complete crossings can be high. Combined data for the six fauna groups shows that the highest mean cc/week occurred in culverts (0.503; SD 1.074), followed by bridges (0.280, SD 0.487) and pipes (0.233, SD 0.323).

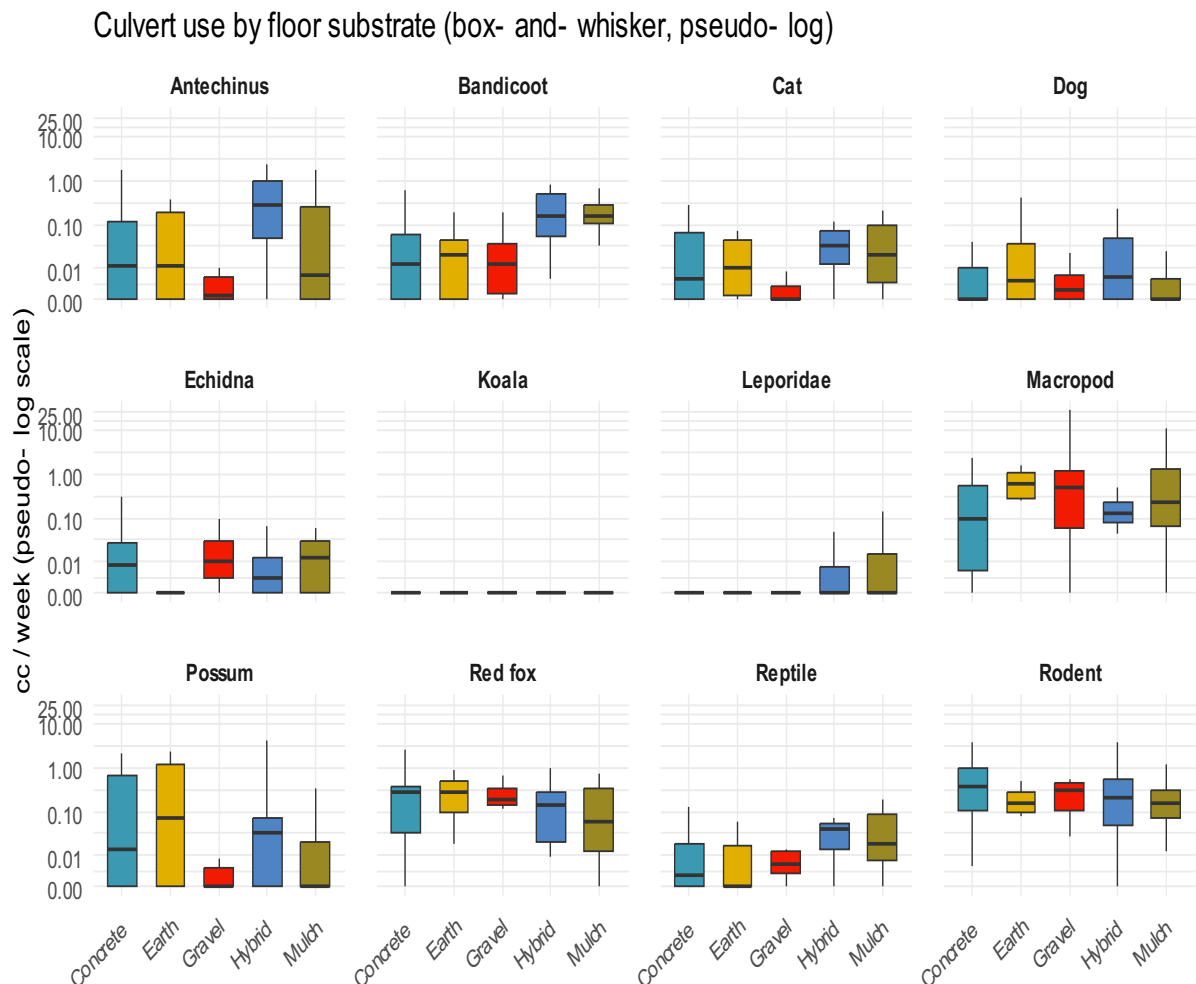
Figure 16: Box and whisker plots of mean cc/wk at underpasses with different substrate types. The hybrid substrate type includes structures with a combination of substrate types. Note the log scale on the vertical axis.

The box and whisker plots highlight the significant differences identified by the one-way ANOVA for *Antechinus* spp., bandicoot and reptile (Figure 16). Although the analysis for *Antechinus* spp. identified a significant result for the hybrid and concrete and hybrid and gravel comparisons the box and whisker plot show a difference between hybrid and earth which according to the Tukeys HSD test was almost significant ($P=0.0567$). Bandicoots and reptiles displayed a preference for hybrid and mulch substrates, with almost significant differences recorded for reptiles between mulch and gravel ($P=0.075$), and mulch and earth ($P=0.077$). Species/groups that displayed limited variation between substrates were dog, echidna, macropod, possum, red fox and rodent. Whilst not significant, cc/wk by cats were higher in structures with a hybrid or mulch substrate.

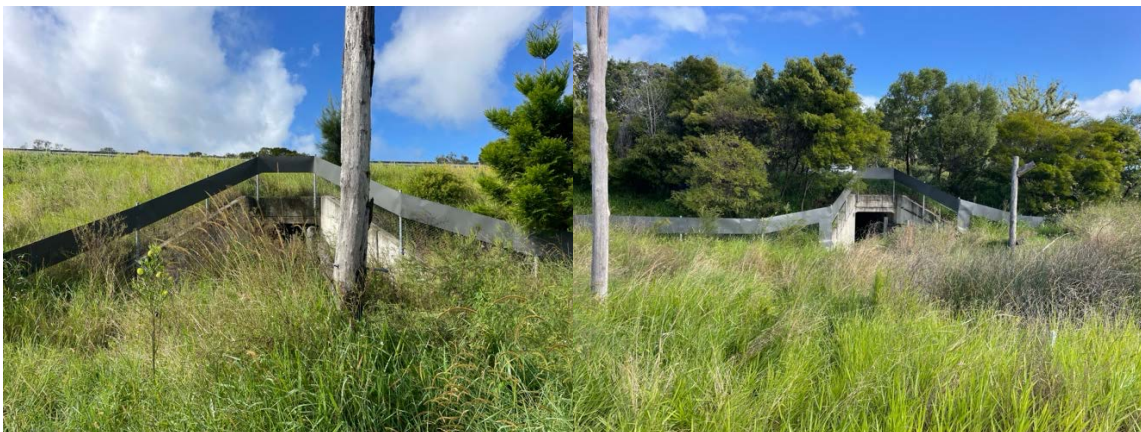
Plate 4: Example of grass growth at the entrance of two underpasses in section 10 of W2B.

Numerous culvert entrances in sections 10 and 11 of W2B are obscured by dense pigeon grass (*Setaria* spp) which has dominated former grazing land and areas disturbed during construction (Plate 4). Pigeon grass forms dense swards that can be difficult for humans to move through. These swards likely inhibit movement and the ability of koalas to see underpasses. Whilst koalas are known to move through dense native ground vegetation, such vegetation is often dominated by clumping species like saw sedge (*Gahnia* spp.) which has open areas at ground level. Notwithstanding, there are some culverts at Laws Point that have open entrances on the western side, in areas known to be used by koalas. These sites may be constrained by the presence of stock fences extending across underpass entrances and occupation by Indian peafowl (Plate 5).

Pigeon grass around culvert entrances was cut in mid-2022, however, there was no obvious increase in koala use at effected sites. Peafowl commonly roost in M50 and M51 at Laws Point. Male peafowl defend small territories (Rands *et al.* 1984) and there is anecdotal evidence of aggressive behaviour towards other birds although we could find no published studies on exclusion of other species from territories and ground fauna like short-beaked echidna (*Tachyglossus aculeatus*) regularly use M50 and M51.

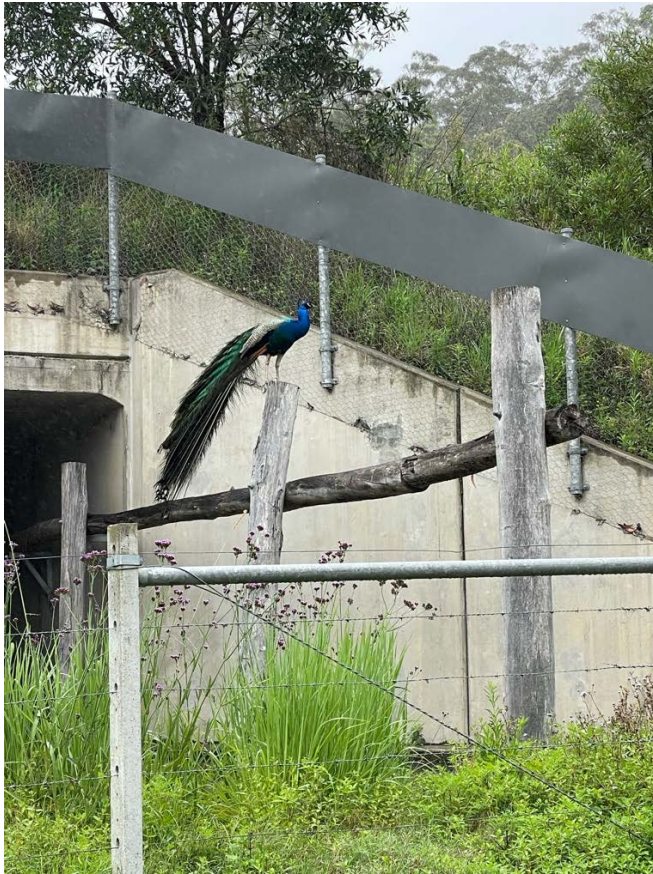
Plate 5: A male Indian peafowl at the entrance to underpass M50 at Laws Point. The five strand wire stock fence in the foreground extends across the underpass entrance on the west side.
