Woolgoolga to Ballina Pacific Highway Upgrade

Threatened Fish Monitoring Program Annual Report 2023

Year 3 Operational Phase Report

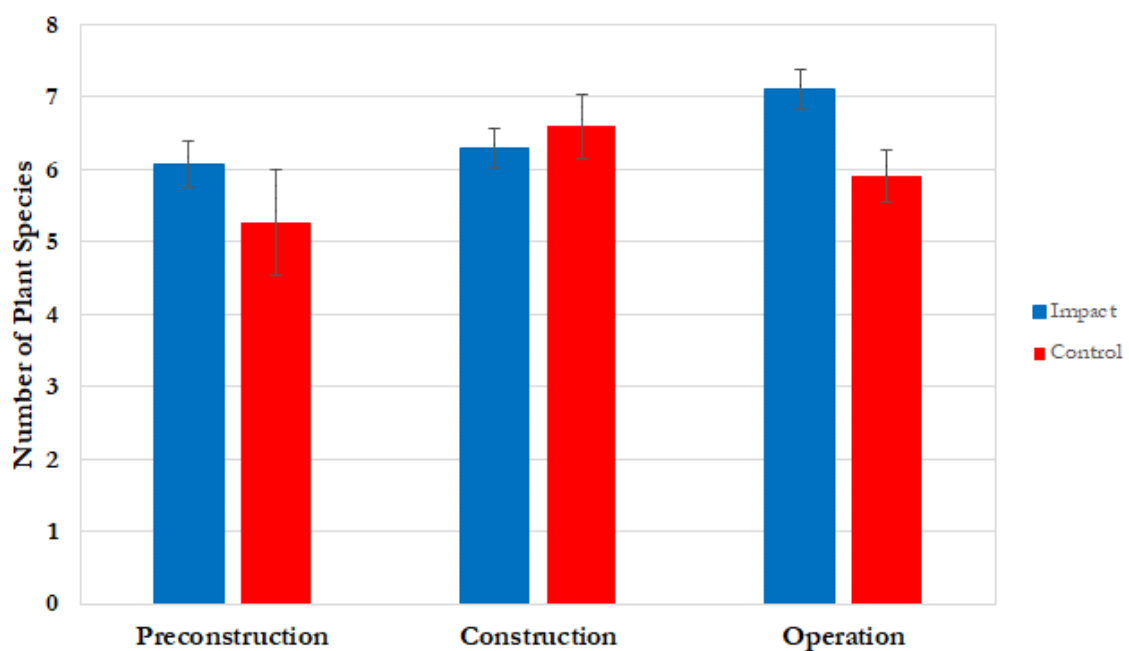
Aquatic plant diversity has been relatively stable at both control and impact sites over the three phases of monitoring. Although collection of an inventory of aquatic plant species was not designed as a quantitative measure, an assessment of the diversity of species observed at each site has been undertaken for this final report. The results are presented in **Figure 3.5**. They indicate that the diversity of aquatic plants was similar at control and impact sites but that the diversity increased slightly at impact sites in the operational phase. This result indicates that aquatic plant diversity has not been negatively impacted at impact sites over the course of construction and that habitat rehabilitation measures undertaken may have led to an improvement in the diversity of aquatic plant species.

Figure 3.5 Mean \pm SE number of aquatic plant species observed at combined control and impact sites in pre-construction, construction and operational phase monitoring to date (pre-construction data from GeoLINK 2014, 2015a & 2015b)

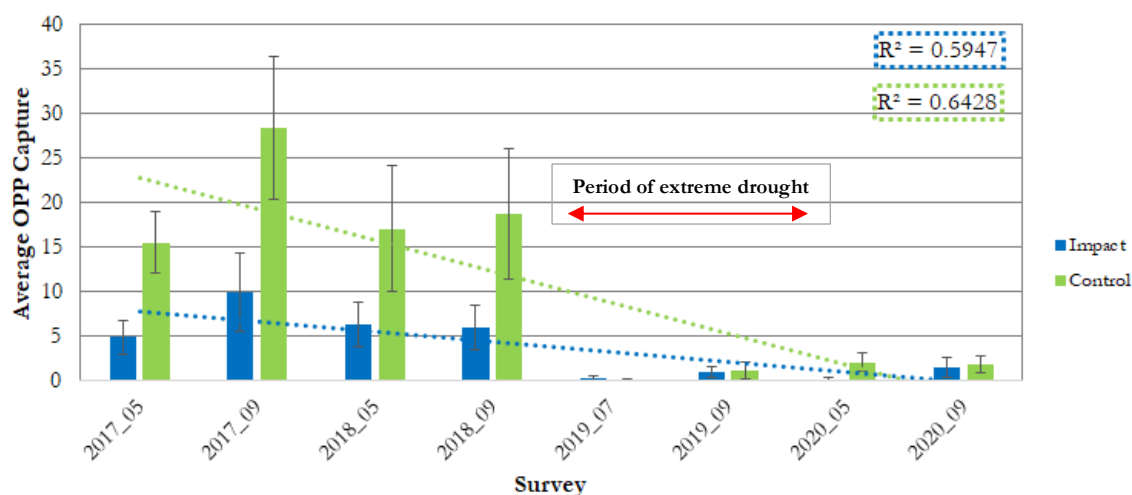
There has been a high degree of variability in the numbers of OPP captured at each site since monitoring began in 2013, at both the impact and control sites. Due to the opportunistic life cycle strategies and quick responses to stochastic environmental factors displayed by OPP (Knight *et al.* 2012) it is expected that surveys conducted at different times would yield different results depending upon favourable or unfavourable breeding and dispersal conditions. A comparison of average OPP capture at impact and control sites in the pre-construction, construction and operational (to date) phases of monitoring shows an increase in the average capture at control sites and a decrease in the average capture at impact sites (**Figure 3.5**). However, these unfavourable results are unlikely to be related to the W2B upgrade in any large part. As discussed in the previous annual Threatened Fish Monitoring Report (TfNSW 2022, **Figure 4.3**), trend analysis shows that throughout construction phase monitoring there was a trend towards reduced average per-site capture at both impact and control sites. During the operational phase to date trend analysis points to slightly increasing OPP captures per impact site and slightly decreasing OPP captures per control site, although there is a poor fit to the trend at control sites (**Figure 4.4**). Additionally, the observed increase in average capture at control sites between the pre-construction and construction phase monitoring is likely to be driven by the fact that no control sites were monitored during pre-construction monitoring in September 2013 after breeding and dispersal conditions had been very good. Pre-construction phase monitoring at control sites was only undertaken in September 2014, after a drought that resulted in very poor breeding and dispersal conditions and many dry sites, leading to very low numbers of OPP captures at both control and impact sites. This resulted in particularly low average captures at impact sites for the pre-construction phase monitoring, whereas impact sites were monitored during one very good and one poor year of captures over the pre-construction phase, resulting in improved average capture rates for that period.

Figure 4.1 Mean \pm SE OPP capture per site at impact and control sites during construction phase monitoring.
