Woolgoolga to Ballina Pacific Highway Upgrade

Threatened Frog Monitoring Annual Report 2021/22

Version 3.0

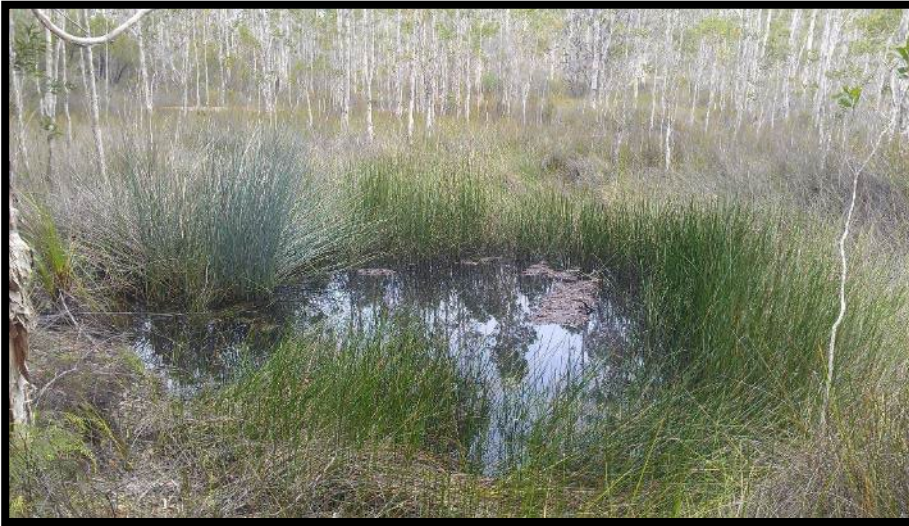
Plate 3-2. Wallum Sedge Frog habitat along the W2B corridor (adjacent ch. 148550).

The Wallum Sedge Frog is an "acid" frog confined to the coastal sandplain wallum swamps. Their life-cycle is adapted to the acidic pH (2.8-5.5) of these wetlands. Frogs are highest in abundance in relatively undisturbed wallum swamps. Breeding habitat is characterised by the presence of emergent sedges, with upright species such as *Baumea* spp. and *Schoenus* spp. preferred by adult frogs for perching. Frogs can be found in breeding habitat throughout the year

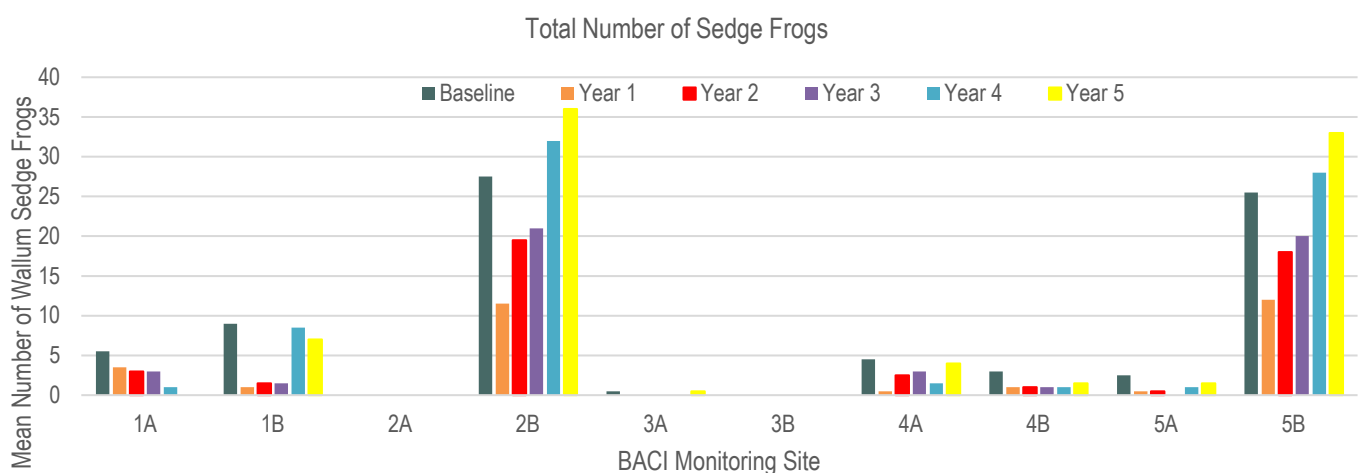
Figure 3-3. Total wallum sedge frog counts between the baseline survey and Years 1-5 with Year 5 being Operational Monitoring Year 1.

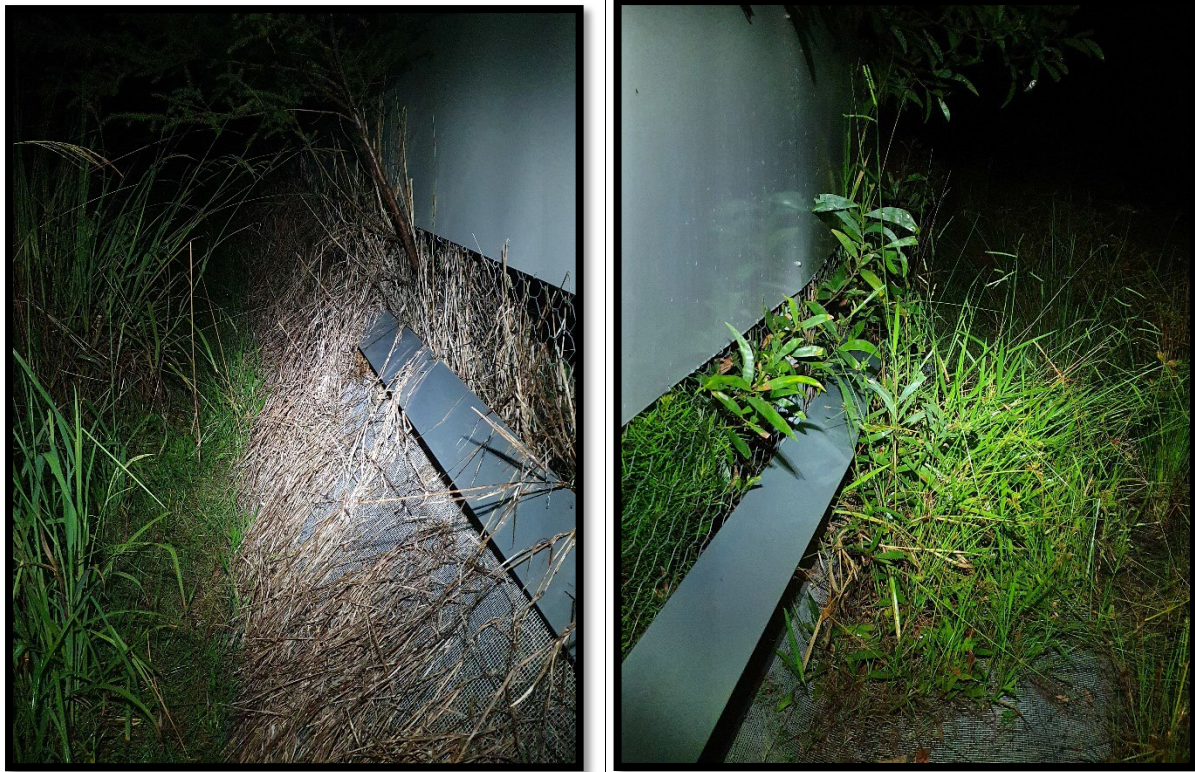
Plate 3-1. Evidence of herbicide treatment to contain or reduce the permeability of frog exclusion fence around ch. 140000 (left) and vegetation creating opportunities for frogs to move onto the roadway around ch.139000 (right).

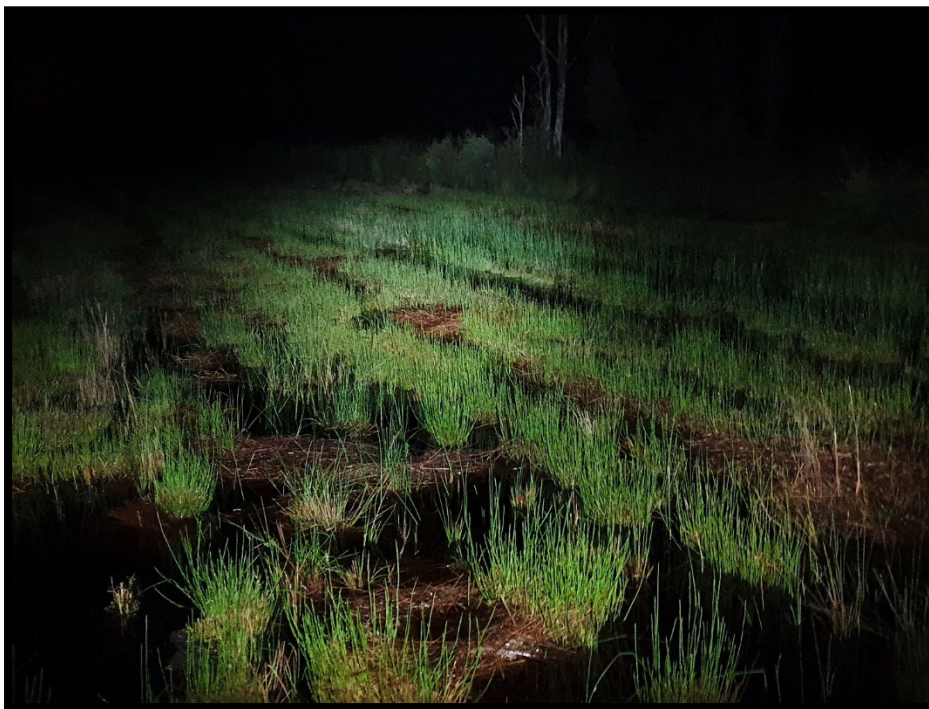
Plate 3-2. Part of the monitoring transect at Site 4B which is subject to periodic maintenance slashing (non project related).

Declines reported at Site 4 (Ballina Shire Council and Jali Land) and Site 5 (McDonalds and Broadwater National Park) probably represent normal population fluctuation from year to year. The increased decline at Site 4B is probably linked to the way surface water levels tend to fluctuate at this site, combined with some fires that have periodically burnt through this area and some mechanical intervention in the form of slashing sedges associated with a management trail (Plate 3-2). Meanwhile, fluctuating surface water levels probably explain the reported decline at Site 5A (McDonalds). When this area floods, sedge frogs are likely to disperse over a broader area as described by Lewis and Goldingay (2005) and similarly, during dry periods there is often no surface water at the monitoring site when adult sedge frogs move back to the east in to Broadwater National Park.

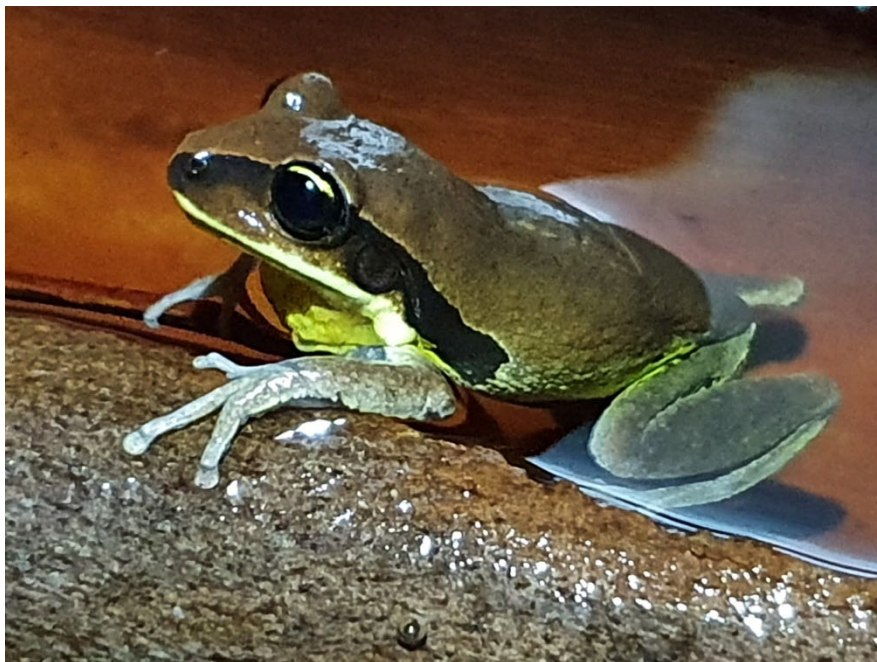
Plate 4-1. Green-thighed Frog from Bald Knob Tick Gate Road (Site 3A).

The Green-thighed Frog is a small to medium sized (max. 47 mm) hylid frog (Barker *et al.* 1995; Cogger 1995; Murphy and Turnbull 1999; Lemckert *et al.* 2006). It is a relatively distinct species with a prominent white upper lip, armpits and groin marked in lime green or yellowish in some instances but always with black markings (Barker *et al.* 1995; Lemckert *et al.* 2006).

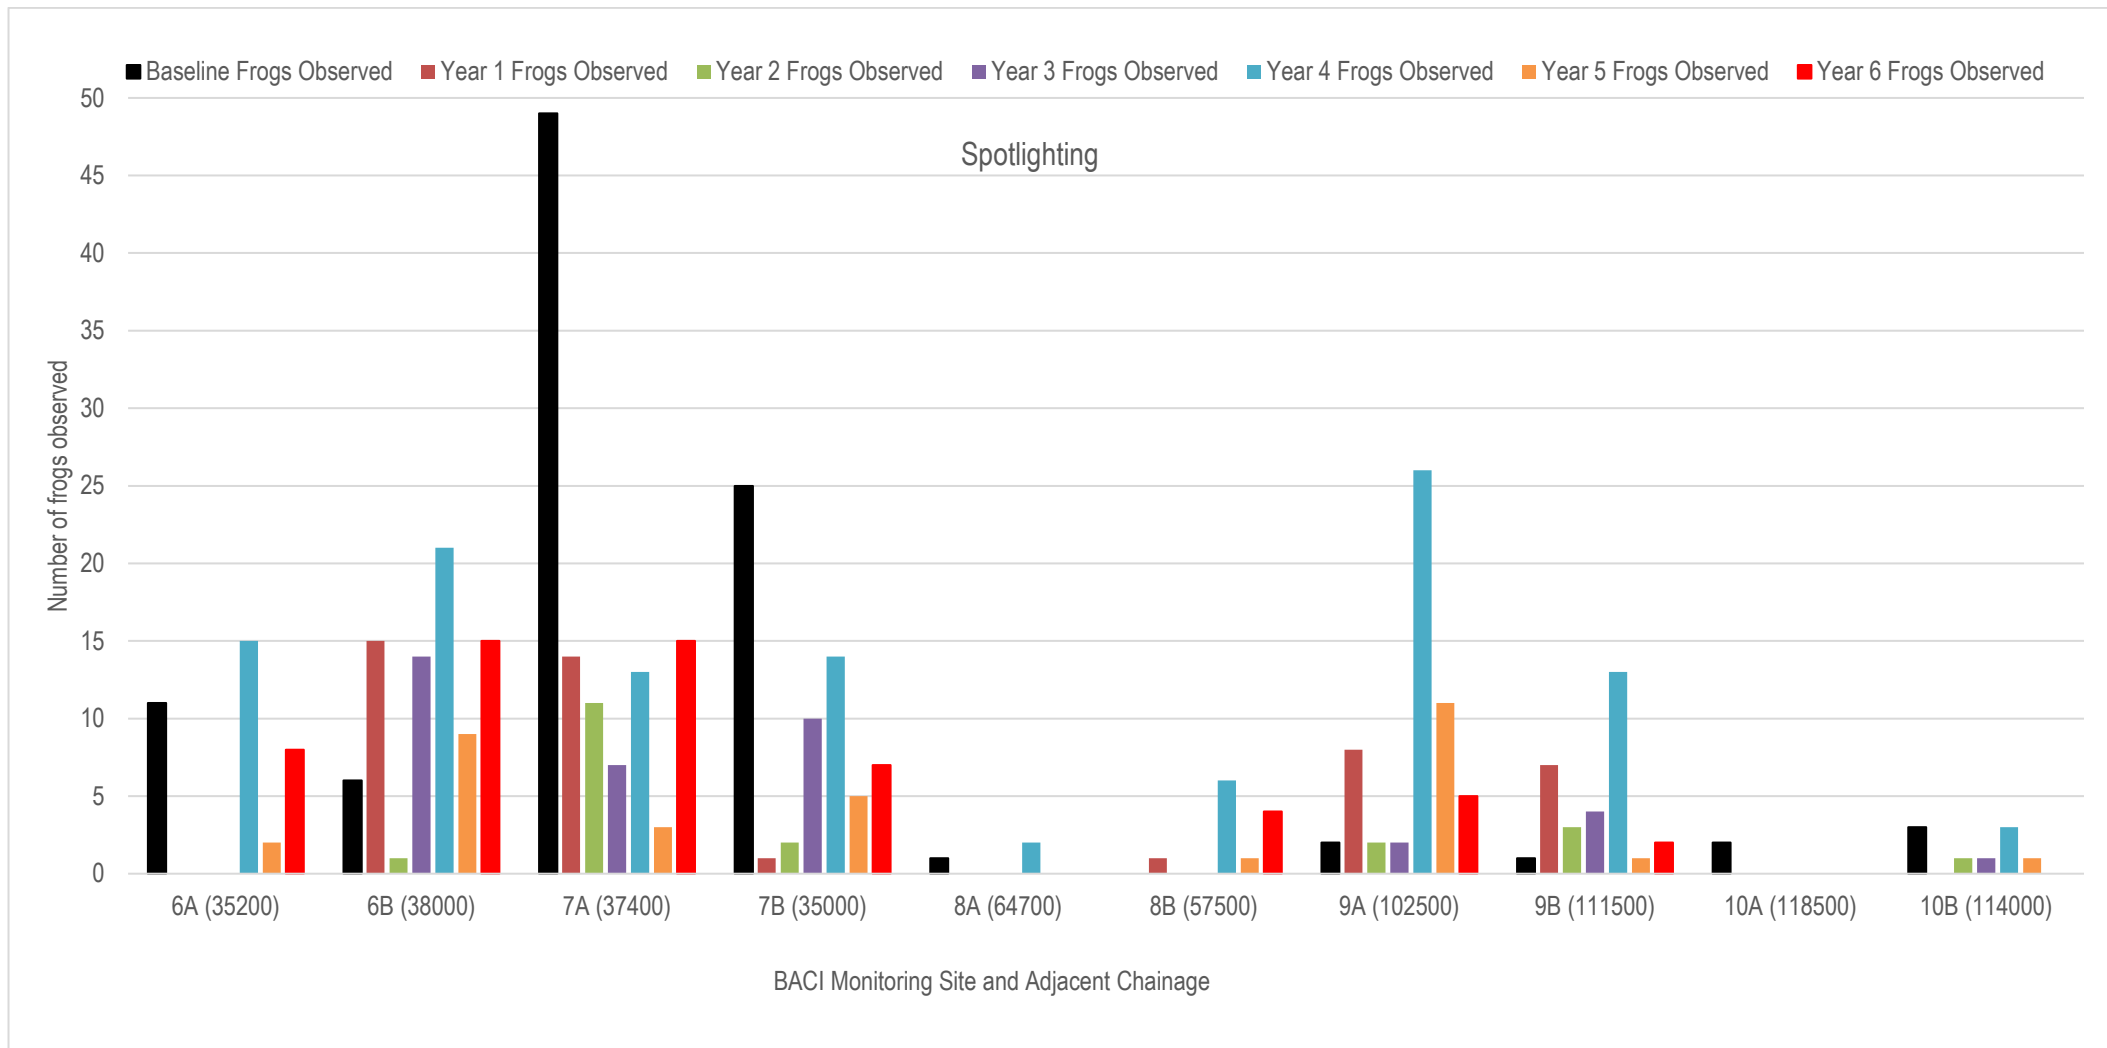
Figure 4-4. The number of Green-thighed Frogs spotlighted between the baseline survey, construction and operational monitoring in Years 1-6 at Sites 6-10.

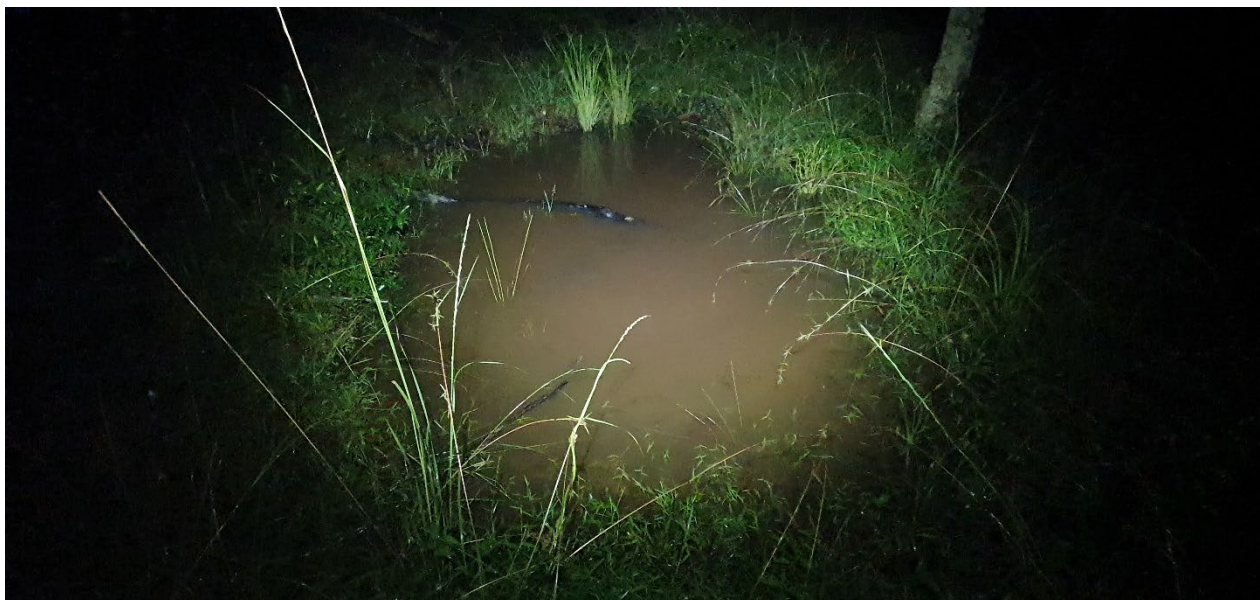
Plate 4-1. Constructed ponds at Site 7A (ch.37330) in late February 2022.

A follow up survey on the 17th March found the ponds contained 50-80% of their capacity over the past 20 days although there had been around 50 mm of rainfall in the week leading up to the pond monitoring. Another inspection on the 5th

April found the ponds were almost full with between 80-100% capacity, again due to ongoing rainfall including close to 100mm of rainfall in the week leading up to the inspection. A final inspection was performed on the 16th April where all ponds still contained water to varying degrees, measured at this time at 30-80% some 50 days after the stage 1 surveys. Inspections around the pond edge found metamorphs of both Bleating Tree Frog and Broad-palmed Frog and a number of tadpoles belonging to the same species.

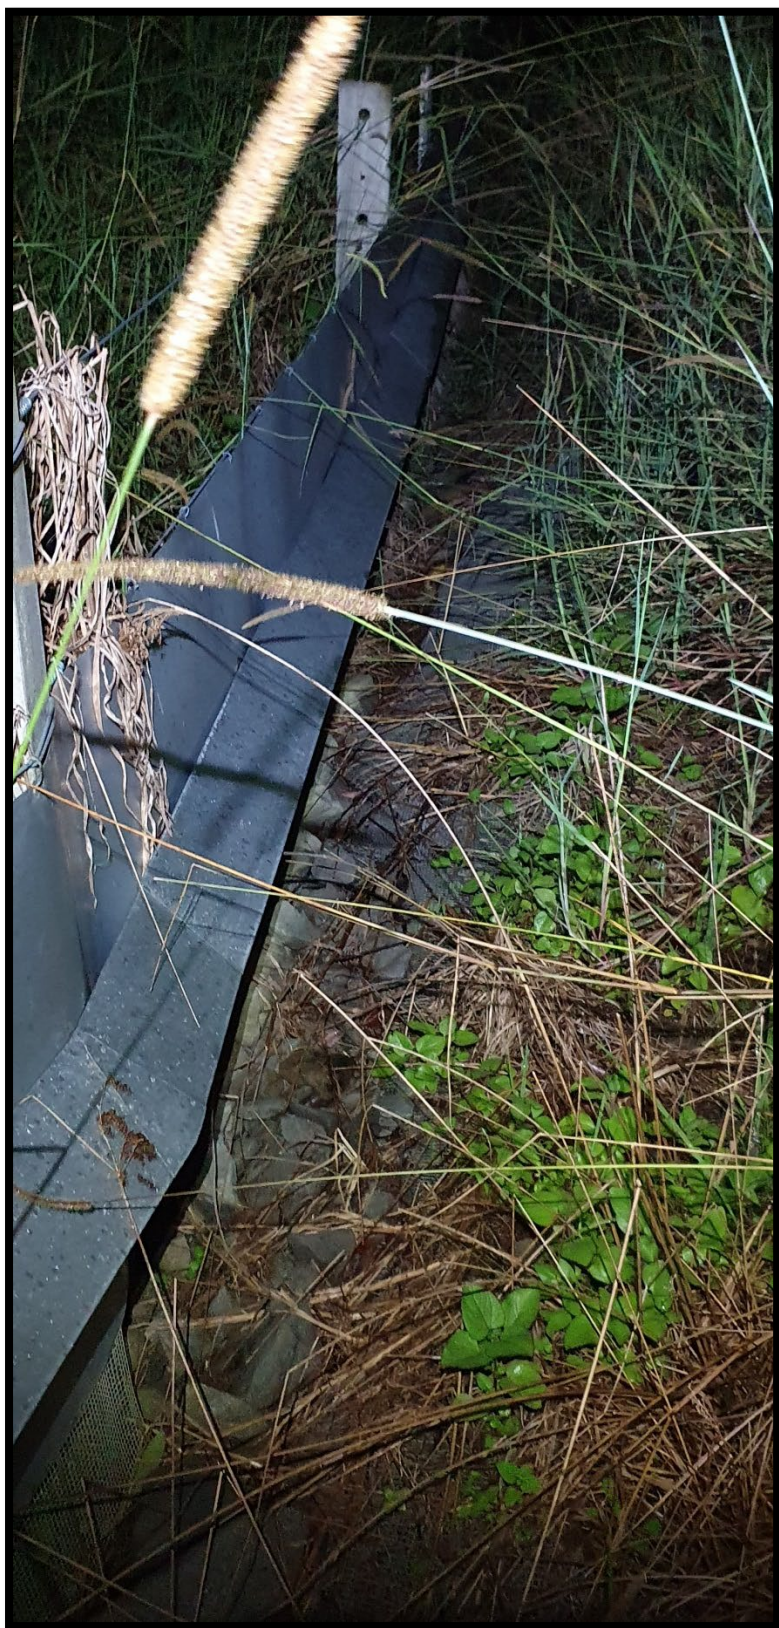
Plate 4-2. Example of maintenance being performed along frog exclusion fencing at Site 9A Jackybulbin ch.101250.

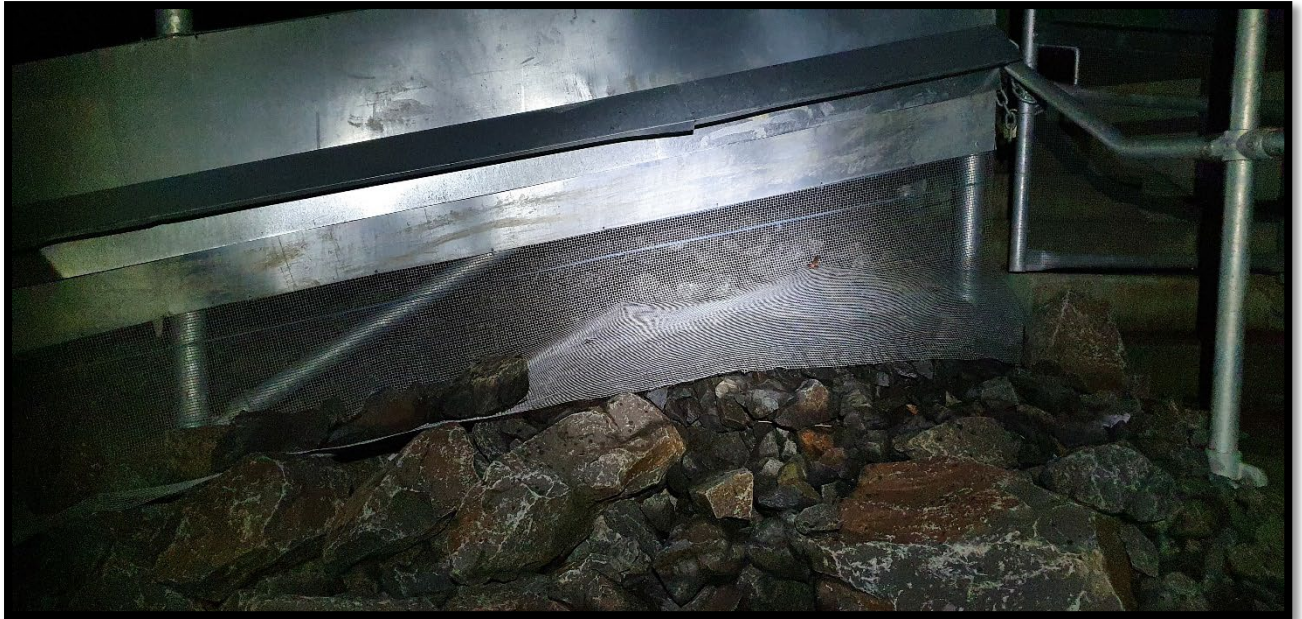
Plate 4-3. Example of return flap wash out or holes beneath the mesh within 50 m of installed ponds at ch.118500 Site 10 A (Tabbimoble).

Permanent frog exclusion fence surveys tied into this connectivity monitoring found no Green-thighed Frogs on the carriageway side of the fence, although a number of potential breach points were observed at Site's 6A, 7A, 9A and 10A (Plate 4-3).
