Woolgoolga to Ballina Pacific Highway upgrade

**Construction and Operational Monitoring of
In-situ Threatened Flora Species (non-
rainforest)**

Annual Report 2019

Woolgoolga to Ballina Pacific Highway Upgrade
In-situ Threatened Flora (non-rainforest flora) Annual Monitoring Report 2019

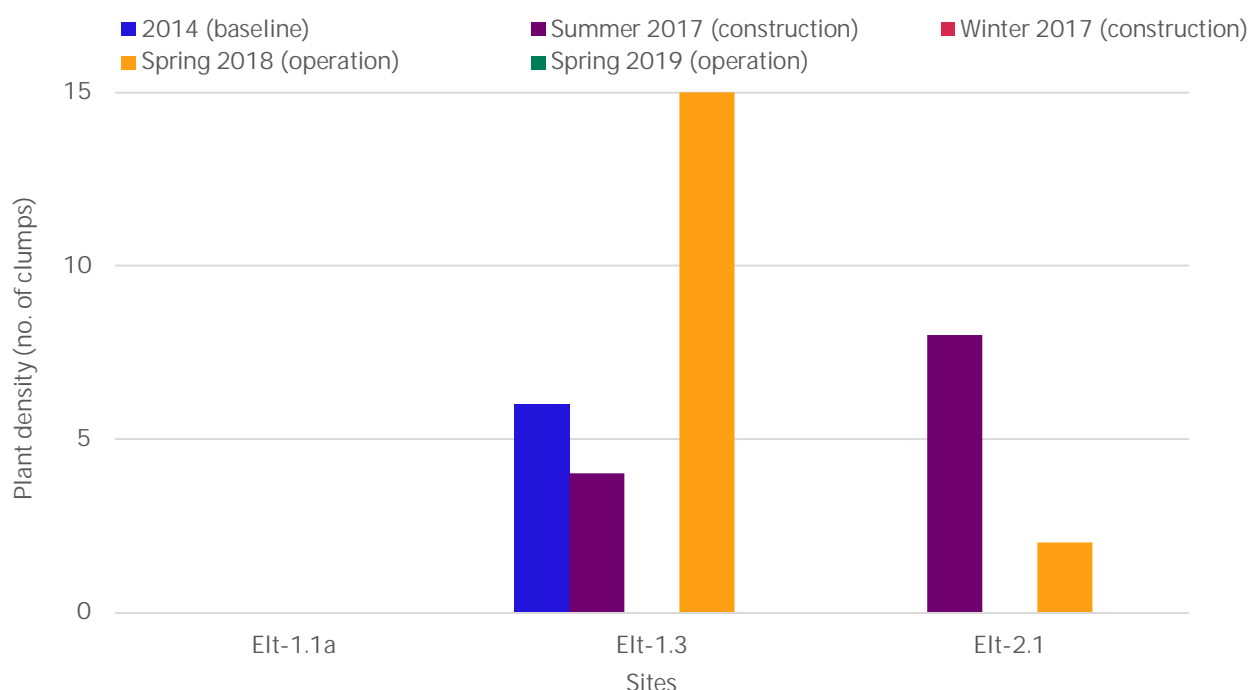
Searches for *E. tetraquetra* at sites Elt-1.1a (chainage: 5700), Elt-1.3 (chainage: 6600) and Elt-2.1 (chainage:14700) were undertaken on 2 and 3 October 2019. No plants were identified at any of the three plots during in 2019. Refer to Figure 3-1.

Sediment transport through the adjacent culvert has ceased considerably at site Elt-2.1 since 2017 and numerous native shrubs have established. The mean mid-storey cover has continually increased over the years and a reduction in weed cover abundance has been observed. The basin within site Elt-1.3 continues to hold sediment run-off from exposed soils, however the flow of sediment did not appear to be transported into habitat for threatened plants. Native macrophyte vegetation has re-established at the site and is capable of filtering sediment deposition. Weed cover abundance continues to remain low.

No plants have been observed at Elt1.1a since its establishment in 2017 due to the original Elt1.1 being set up during baseline monitoring within the approved clearing boundary. An increase in grass cover (40 percent) and decrease in reed cover (30 percent) since 2017 was observed at site Elt-1.1a, possibly due to lower water levels. Sitting water was a grey colour, possibly leached from introduced rock situated around adjacent basin.

Figure 3-1 Number of clumps *Eleocharis tetraquetra* observed over five survey periods at three active in-situ monitoring sites (Elt-1.1a, Elt-1.3 and Elt-2.1). No baseline data exists for Elt-1.1a as the original site (Elt-1.1) was located within the approved construction boundary.

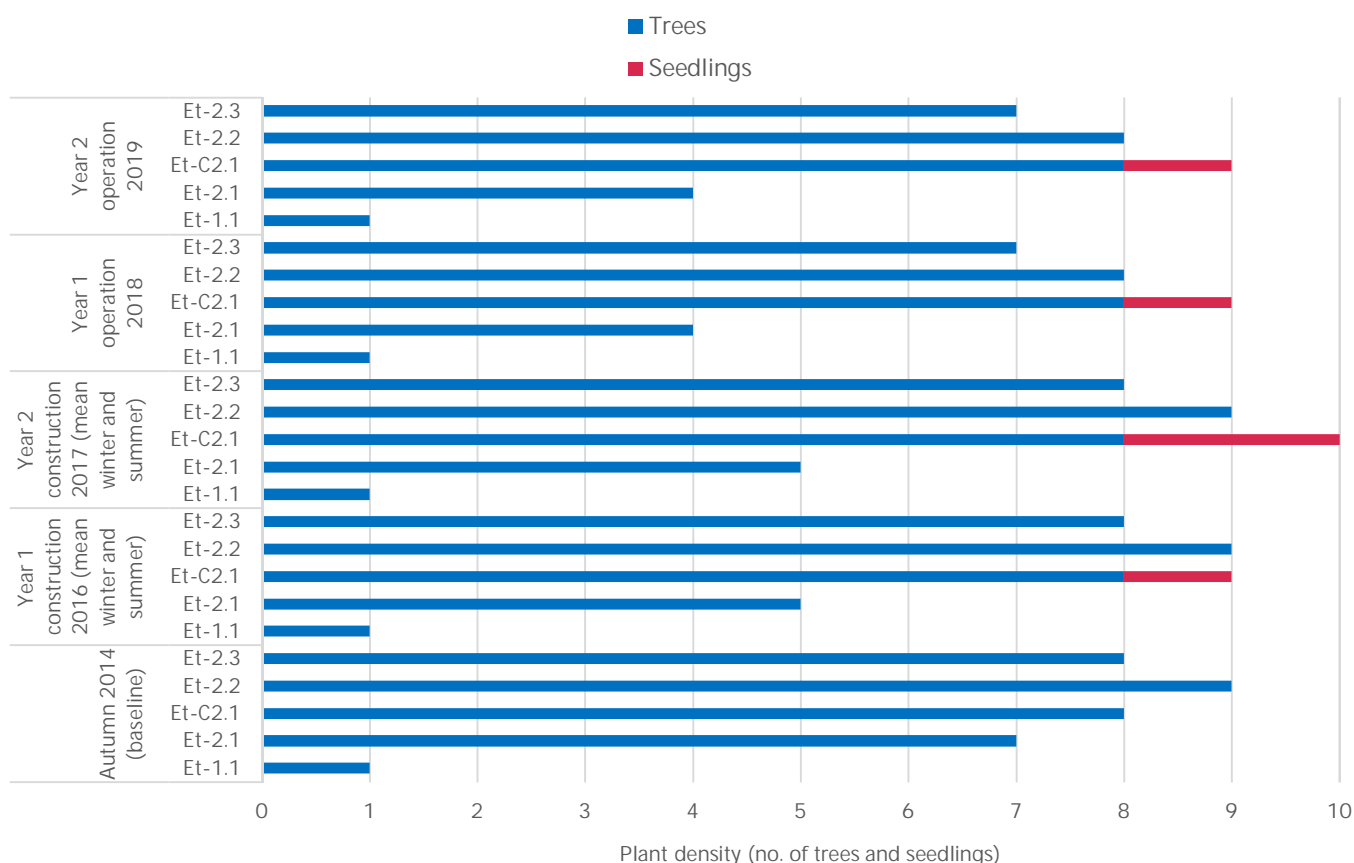
All sites were searched on 1, 2 and 3 October 2019. All sites (chainage:9200-28400) demonstrated no change from 2018. Et-2.1 and Et-2.3 Reasons for previous observations of mortality at some of the sites in 2018 (Et-2.1, Et-2.2 and Et-2.3) are unknown and unlikely related to the project, however dieback of both small and large branches, and one trunk, was detected in winter 2016 monitoring period as well as small branch dieback at site Et-2.1 in the baseline monitoring event. *E. tetrapleura* recruitment has been evident at control site Et-C2.1, with two seedlings occurring since baseline monitoring in 2014, though recorded mortality of one in 2018. Refer to Figure 3-2 for changes in tree abundance over seven monitoring events.

Run-off is affecting site Et-2.3 (also observed during construction phase) and continues to wash away top soil within the plot. The drainage pipe initially diverting water to site during construction has been removed, however flow of water from the constructed embankment adjacent to the site is evident during high rainfall. The loss of top soil may impact on the success of seedlings to establish.

Figure 3-2 Number of *Eucalyptus tetrapleura* trees and seedlings observed over seven monitoring events (mean results for 2016 (n=2) and 2017(n=2)) at four in-situ sites and one control site.

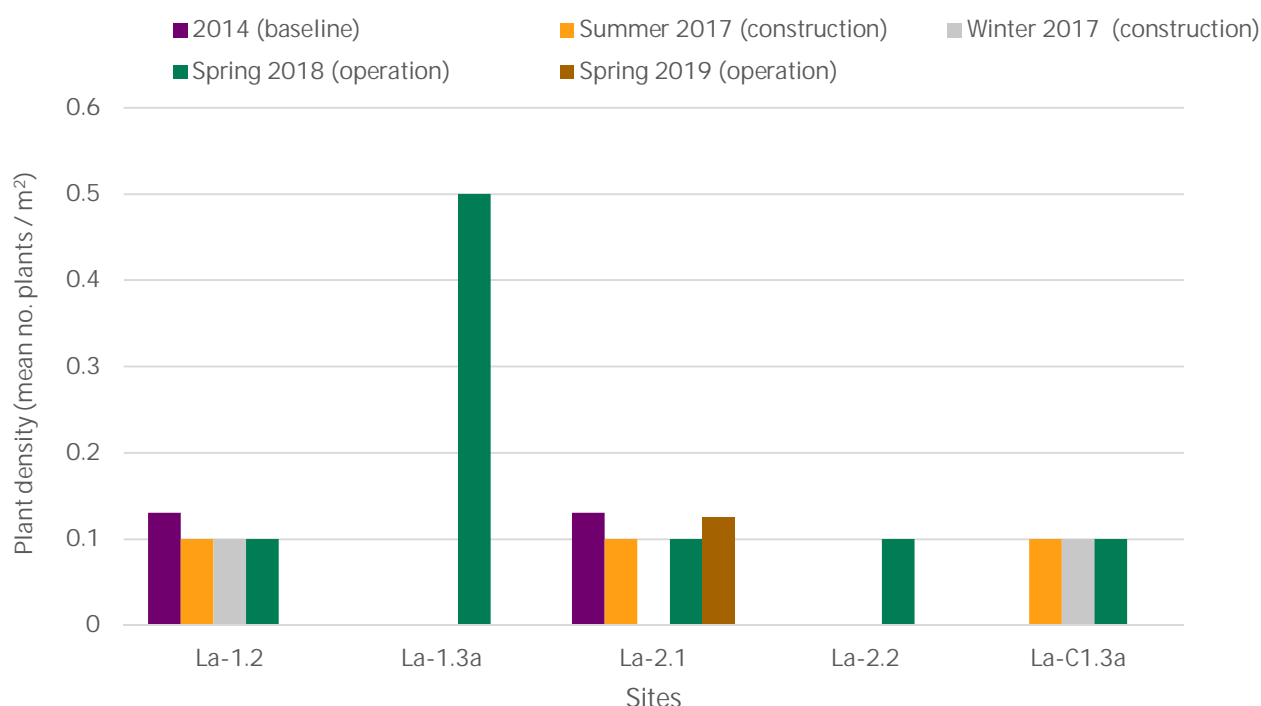
All accessible *Lindernia alsinoides* sites; La-1.2 (chainage:6600), La-2.1 (chainage:22400) and La-C1.3a, were searched on 2 and 3 October 2019. Plants were only recorded at La-2.1, with no large change from 2018 except for a possible slight reduction in the area of occupancy while maintaining the same number of plants (hence the increase in plant density shown in Figure 3-3).

Figure 3-3 Density (mean number of plants / m²) of *Lindernia alsinoides* observed over five monitoring events at four in-situ sites and one control site. Data only exists for La-1.3a and La-2.2 from 2018 onwards when these sites were established.

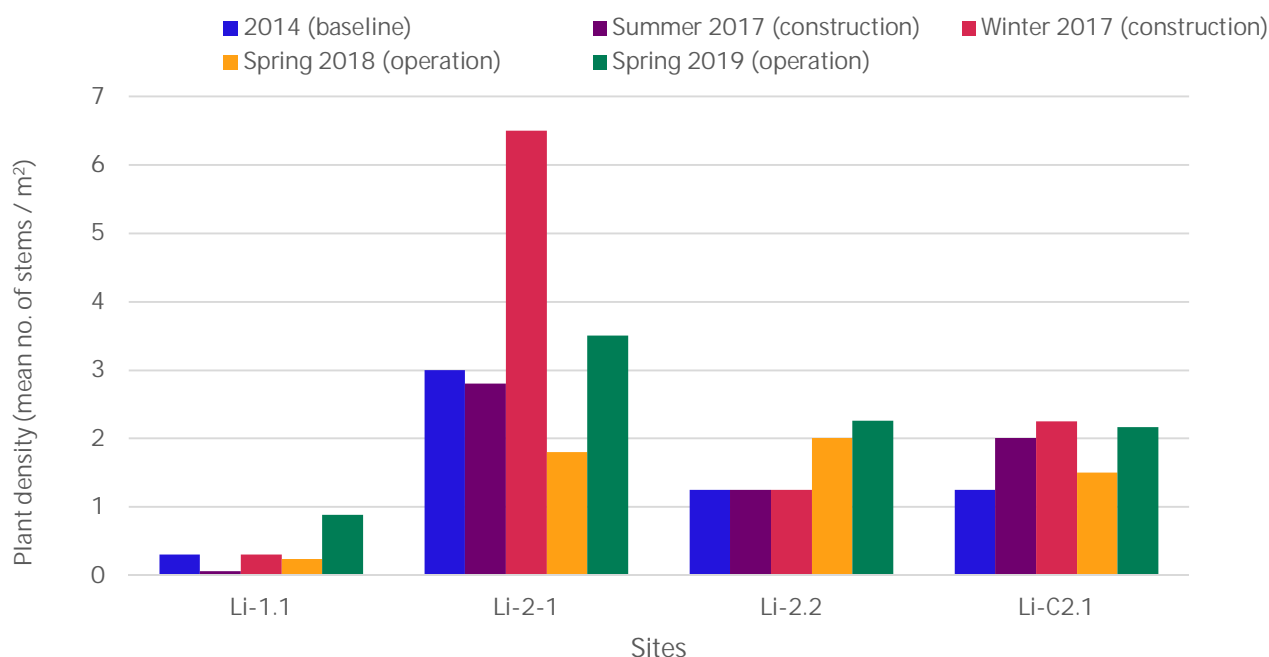
All active sites in Sections 1 and 2 (chainage:5000-17500) were surveyed during the operational phase on 2 and 3 October 2019. There were no large changes in *L. incisa* mean cover, though cover did increase slightly at all sites. All fern fronds were in mostly good health showing new growth, particularly at site Li-2.1 (refer to Photograph 3). Minor dieback (yellowing of fronds) and possible drought stress (wilting) of some *L. incisa* was observed across all sites. Figure 3-4 shows changes in plant density (mean percent cover) over the five monitoring events.

Figure 3-4 Density (mean no. of stems / m²) of *Lindsaea incisa* observed over five monitoring events at three in-situ sites and one control site.

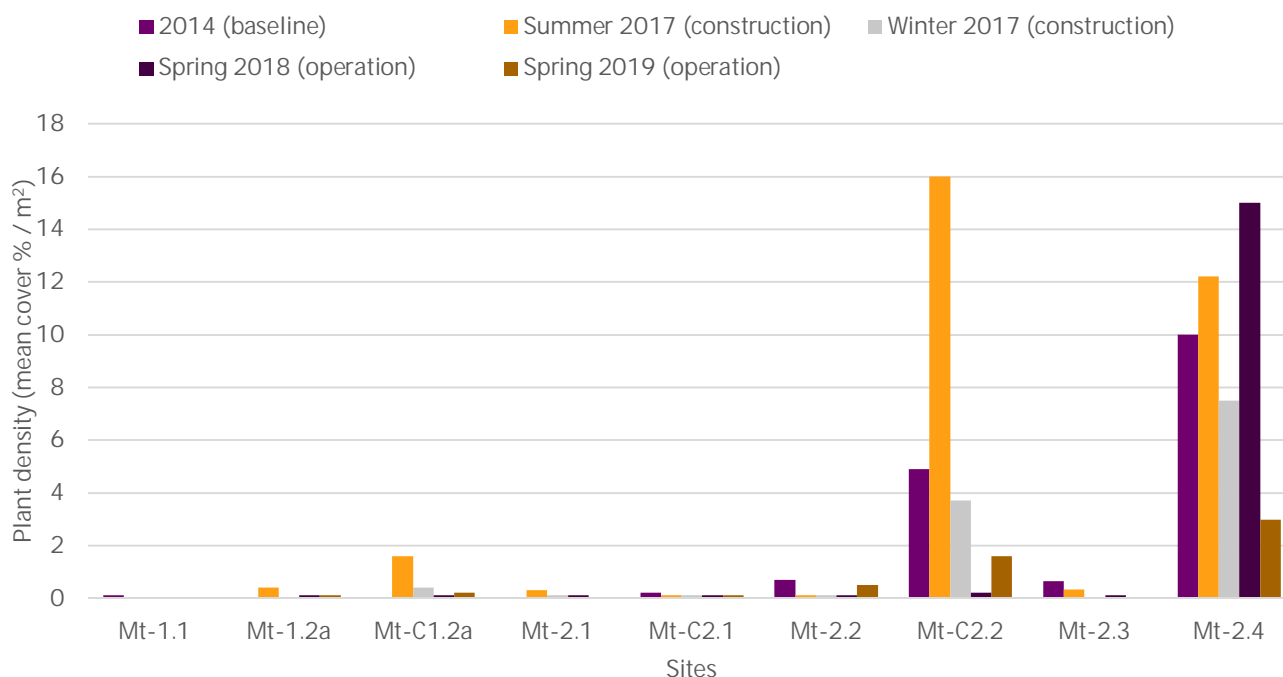
Grey sediment-laden water (possibly leached from introduced rock) observed in waterway during construction phase is still present during project operation at site Mt-1.2a but doesn't appear to be affecting *M. triglochinoides* plants.

Figure 3-5 Density (mean cover % / m²) of *Maundia triglochinos* observed over five monitoring events at six in-situ sites and three control sites

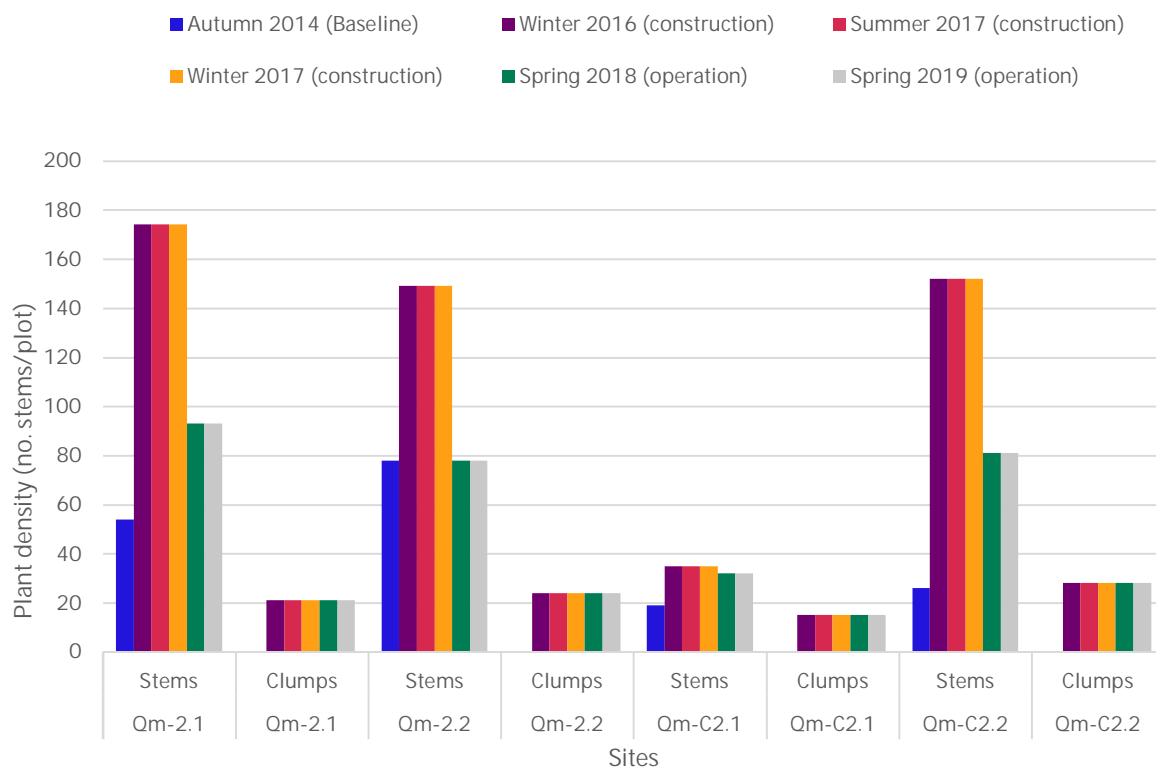
The abundance of *Quassia* sp. Moonee Creek clumps and stems did not change from 2018 at sites, both in-situ and control. Most plants remain in very good health, though yellowing leaves and dieback were observed. Leaf dieback was particularly high at Mt-2.1, with plants exhibiting missing leaves, insect damage and a white coverage on the stems of some plants, possibly a fungus (see Picture 5 and 6). It is unknown if this is affecting the growth of the plants. However, the number of plants at Qm-2.1 remained the same at 93 stems. None of the plants had flower or fruit. The *Quassia* sp. seedlings observed in 2018 growing in mulch on the cleared edge up hill adjacent to in-situ site Qm-2.2 continued to grow healthily. Refer to Figure 3-6 for changes in tree abundance over six monitoring events.

Figure 3-6 Clumps and stems counts of Quassia sp. Moonee Creek over six monitoring events (baseline, construction and operation) at two in-situ sites and two control sites. Only stem data was collected during baseline surveys.

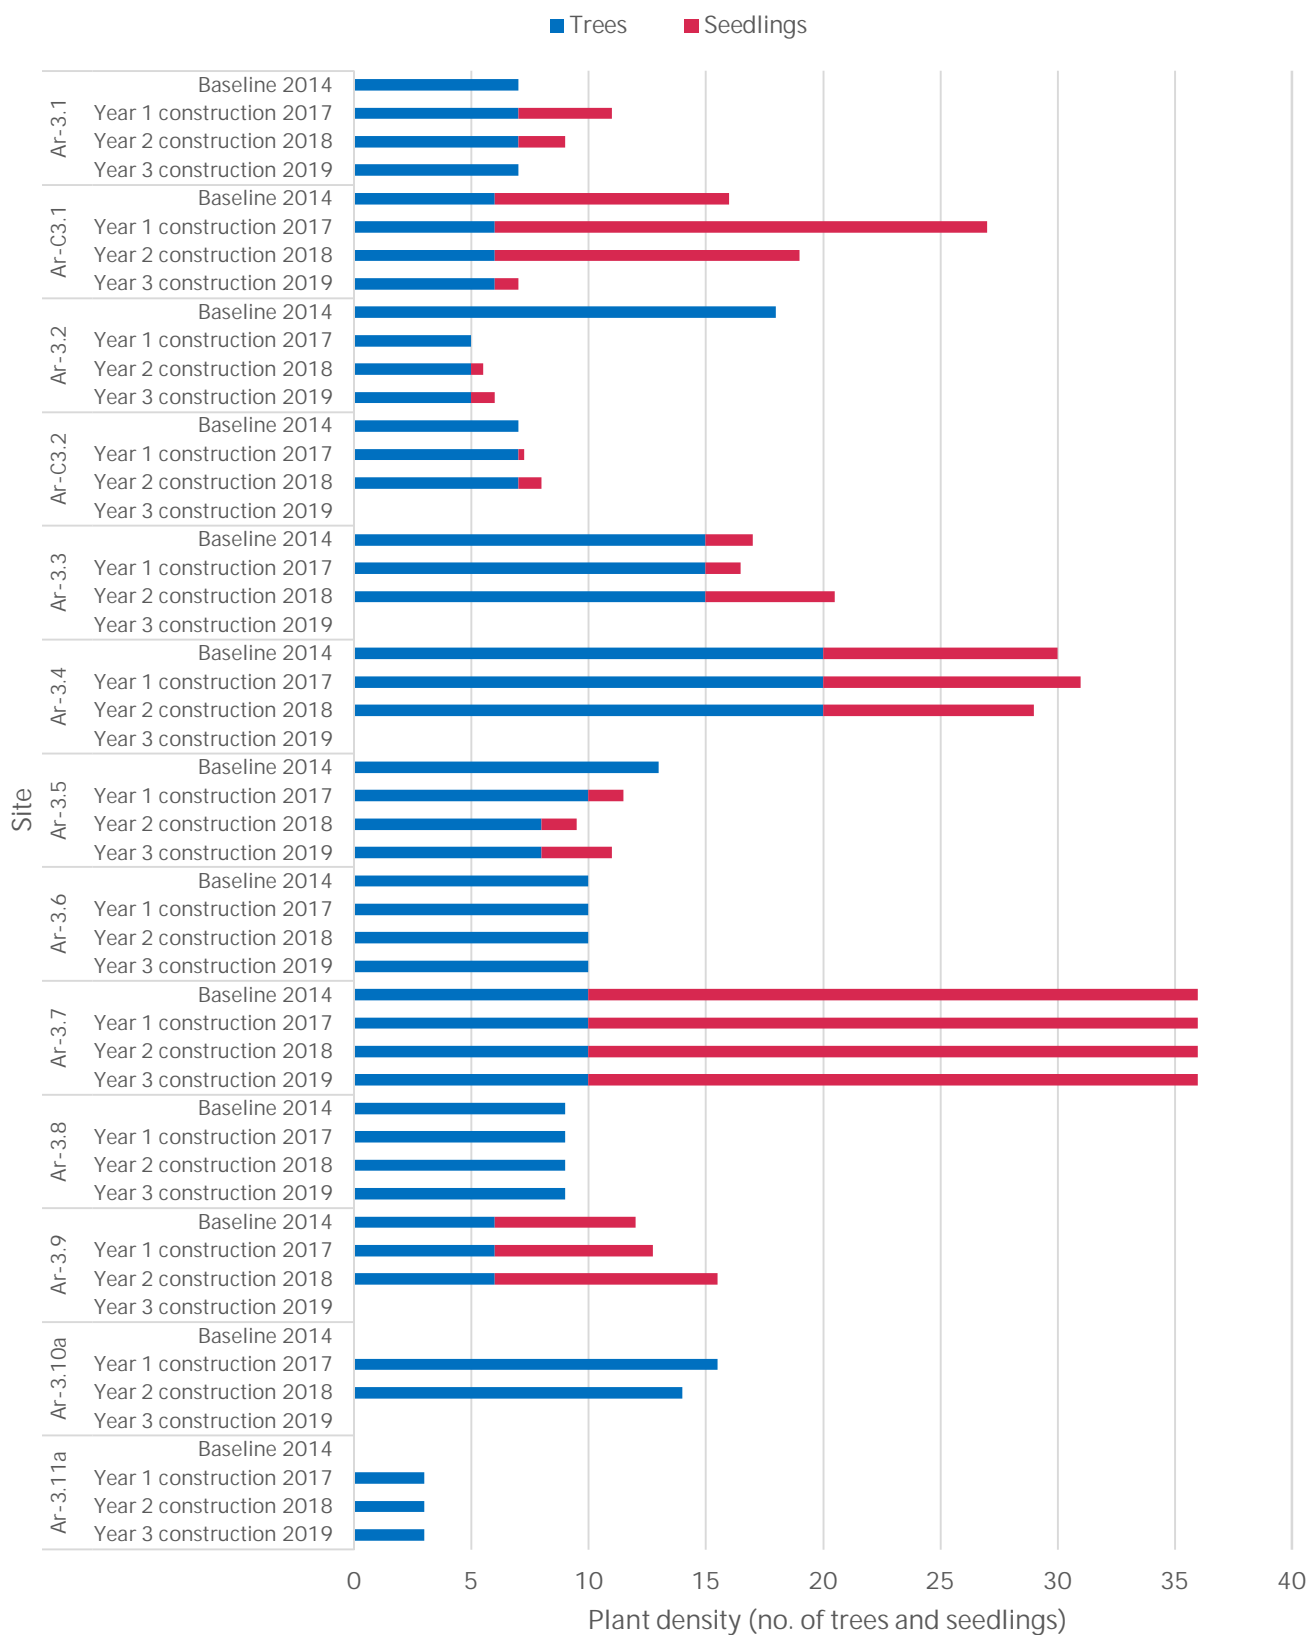
Year 3 construction monitoring of *A. robur* found no change in the abundance of mature trees and seedlings at both in-situ and control sites from spring 2018 surveys. Changes in the abundance of seedlings shown in Figure 3-7 from 2018 to 2019 are due to differences observed between autumn and spring surveys in 2018, which effected the annual average. Five sites (Ar-C3.2, Ar-3.3, Ar-3.4, Ar-3.9 and Ar-3.10a) were not able to be surveyed in spring 2019 due to access restrictions and construction activities. High boundary fencing is now in place round all these sites so the potential for direct impact is very unlikely. Considering the limited change observed at these sites in the past, no project-related indirect impacts are considered likely to have occurred.

Heat related plant stress and/or plant dieback continues to be evident (since Year 1 construction monitoring) at sites Ar-3.4 and Ar-3.7. Plant species affected include *A. robur* seedlings, *Xanthorrhoea* sp., *Duboisia myoporoides*, *Banksia oblongifolia*, *Pteridium esculentum* and *Alphitonia excelsa*. Dieback of *Xanthorrhoea* sp. and *B. oblongifolia* at Ar-3.7 is suspected to be caused by the epidemic infection of the root-rot fungus Cinnamon Fungus (*Phytophthora cinnamomic*), but this would need to be confirmed (refer to Photograph 7). Most sites with mature *A. robur* trees generally show some level of dieback in branches, and it is unknown whether minor tree dieback and seedling mortality at site Ar-3.7 is associated with the potential pathogen. Low average annual rainfall in the region has resulted in very dry conditions effecting many species (Photograph 7).

Figure 3-7 Number of *A. robur* trees and seedlings observed over eight monitoring events (2014 [n=1], mean results for 2017 [n=4], mean results for 2018 [n=2] and 2019 [n=1] at eleven in-situ sites and two control sites).

No baseline data exists for sites Ar-3.10a and Ar-3.11a that were established in 2017. Some sites were not able to be surveyed in 2019 due to access restrictions (high fencing) and construction activities.

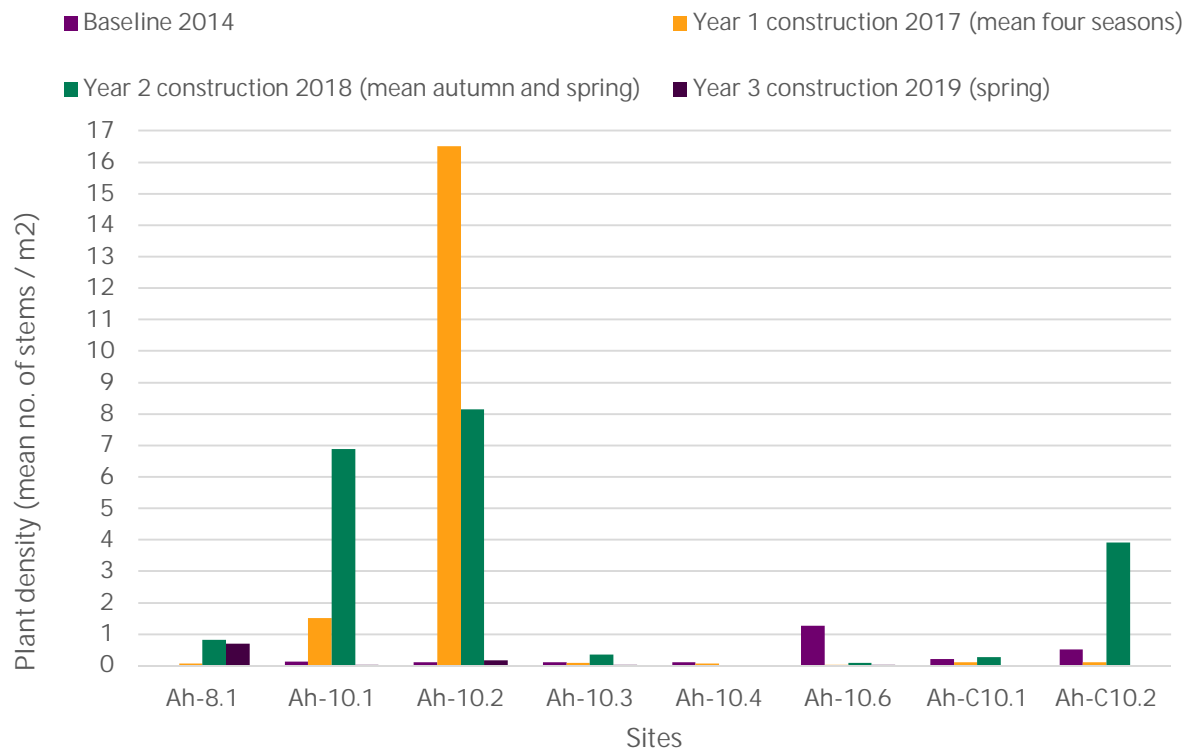
Arthraxon hispidus was detected at five sites and absent from four (Ah-10.4, Ah-10.5, Ah-C10.1, Ah-C10.2) from the 2019 surveys. The average number of stems per square metre in each plot was lower than 2018 at all sites where *Arthraxon hispidus* was present. All plants observed were small, mostly less than 5 cm, and appeared to have only just started shooting (see photograph 9). No flowering plants were observed. Large dead plants with seeds from the previous season were observed at some sites (Ah-C10.2) where it appeared that no plants had begun to grow yet in spring 2019. *Arthraxon hispidus* is an annual species that naturally dies back each year and the abundance of plants observed at the sites surveyed as part of this monitoring program have fluctuated since baseline surveys (refer

Figure 3-8). These observations in 2019 are considered primarily the result of drought conditions (Woodburn recorded 25 percent of the annual average in 2019 and only 0.2mm between May and December, refer Figure 2-3).

Competition with other plants continues to be a threat to *Arthraxon hispidus*. This is primarily by exotic species such as *Ageratum houstonianum* and *Commelina benghalensis* forming dense groundcover. This is particularly evident at sites Ah-C10.2 and Ah-10.4, where it appears *Arthraxon hispidus* plants are being out-competed. Similarly, this is also happening at Ah-C10.1 with the native grass *Leersia hexandra*. This is most likely occurring as the wetland around the upper reaches of Saltwater Creek is slowly drying out, a product of drought conditions in 2018-19. Though this problem may also be exacerbated by the removal of cattle from these properties, which have been previously managed through grazing. Cattle removal has occurred in some locations during the construction period. Table 3-1 shows the change in weed cover and number of weed species for all sites over all monitoring periods. This impact is not project related.

Figure 3-8 Mean number of stems / m2 in each plot over seven monitoring events for seven in-situ sites and two control sites

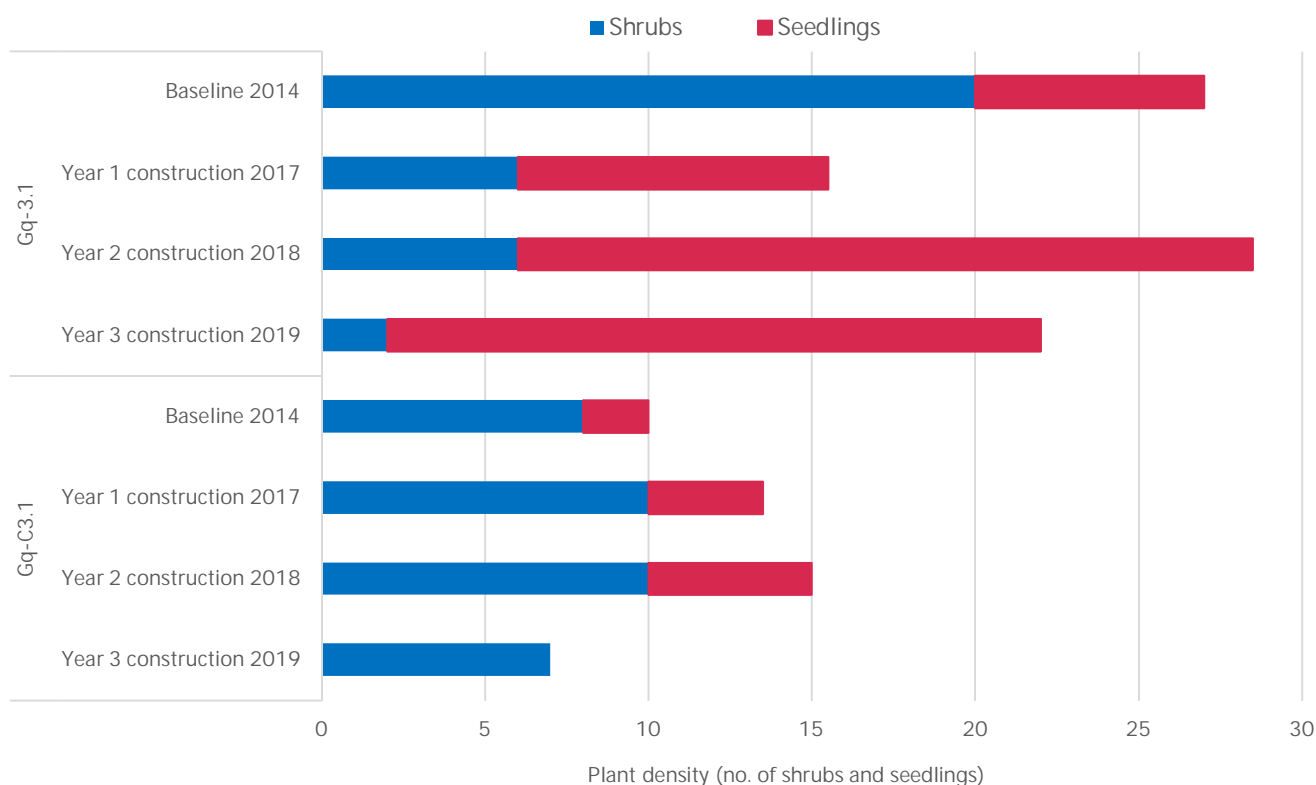
Dieback was also recorded at Gq-C3.1, Previously Gq-C3.1 remained unchanged since November 2017 with 10 adults and five seedlings. During 2019 surveys only seven adult plants were identified. Cover of leaf litter was recorded at 65 percent, nearly three times previous measurements, giving evidence that many different species have died back in the dry conditions.

Figure 3-9 Number of *G. quadricauda* shrubs and seedlings observed over eight monitoring events (2014 [n=1], mean results for 2017 [n=4], mean results for 2018 [n=2] and 2019 [n=1] at in-situ and control site).

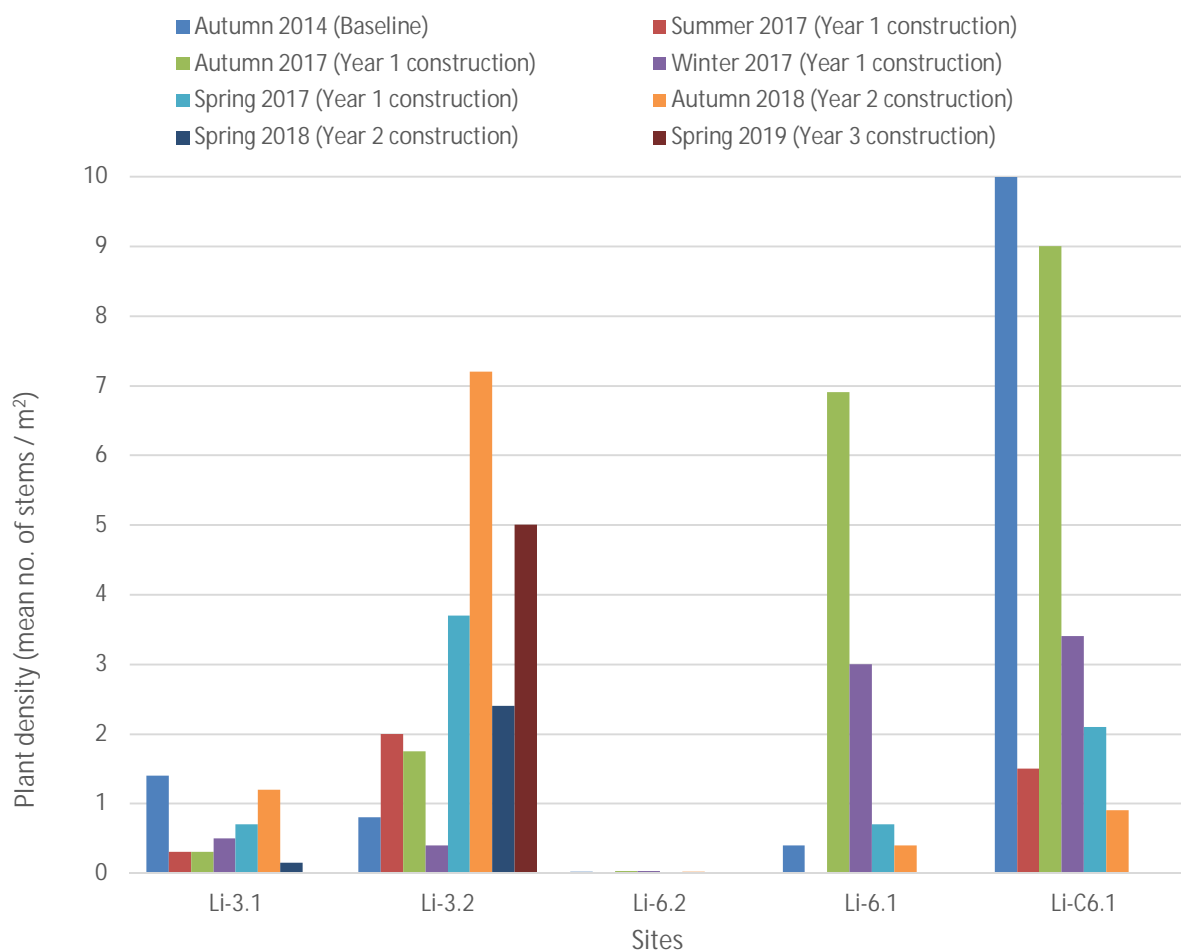
No plants were observed at any of the monitoring locations in Section 6 during 2019 surveys. This follows from 2018 where *L. incisa* was absent at in-situ site Li-6.2 and control site Li-C6.1, and ferns were scarce and in bad health at in-situ site Li-6.1. These observations are expected to be a result of lower than average rainfall in the region in both 2018 and 2019. The dry and unfavourable conditions were evidenced by wilted and dying *L. microphylla* observed along the track near in-situ site Li-6.1 (refer to Photograph 13). During spring 2018 surveys, healthy *L. incisa* ferns were observed along edge of track adjacent to in-situ sites Li-6.1 and Li-6.2 where ferns are exposed to track runoff, however no plants were identified anywhere in habitat surrounding these sites in 2019. This species is likely to be sensitive to the very low rainfall trends and these observations are unlikely to be a project-related impact.

Figure 3-10 Density (mean no. of stems / m²) of *Lindsaea incisa* observed over eight monitoring events at four in-situ sites and one control site.

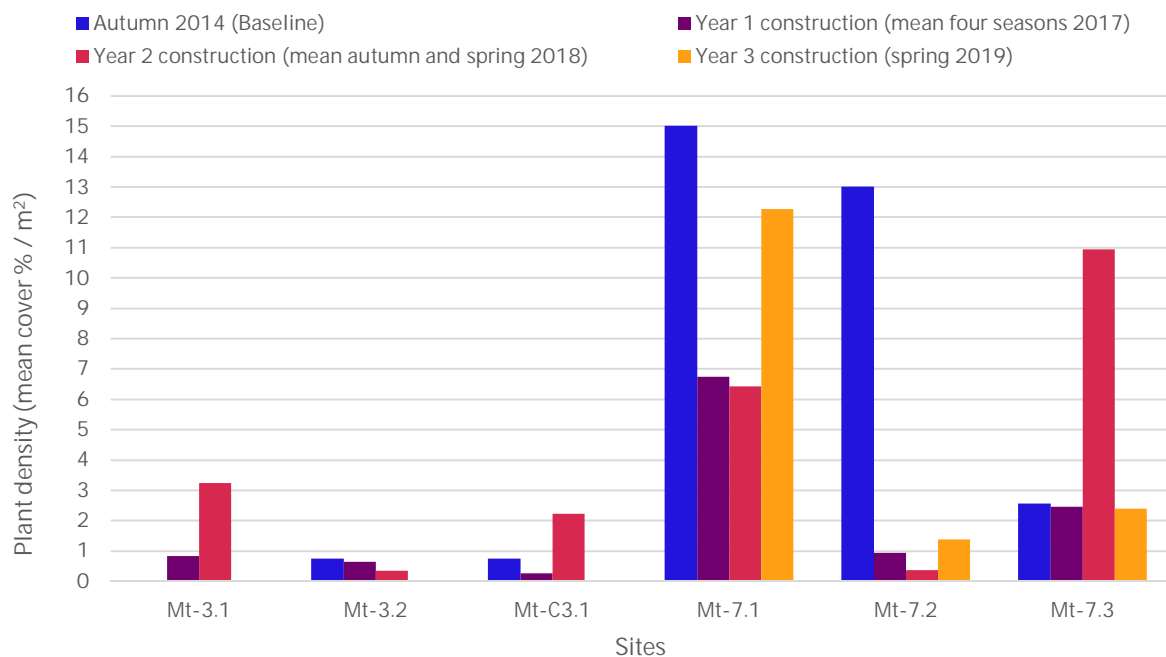
of the annual average in 2019 and only 0.2mm between May and December, refer Figure 2-3). As above-ground plant parts have dieback, presumably *M. triglochinoides* continue to exist only as tubers in the soil until sufficient water returns.

Figure 3-11 Density (mean cover % / m²) of *Maundia triglochinos* observed over eight monitoring events at five in-situ sites and one control site.

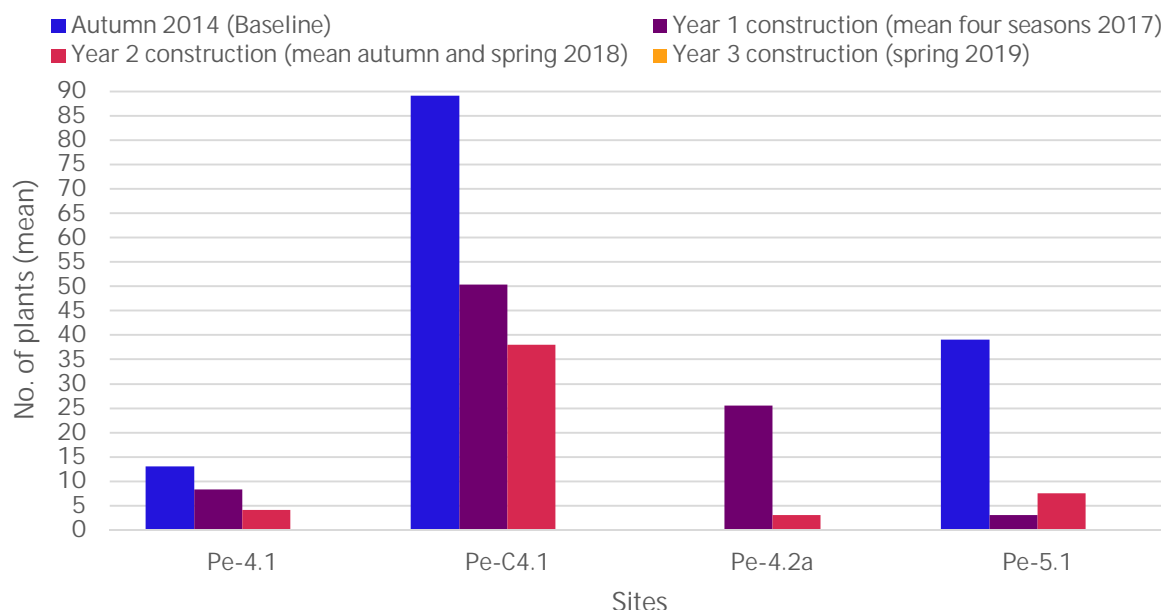
These changes are most likely directly related to the lower than average annual rainfall the region has experienced in three of the last five years, as opposed above average annual rainfall in the four years prior to baseline surveys (refer Figure 2-4). Particularly low rainfall in Year 3 construction monitoring (Grafton Research Station received 31 percent of the historical annual average in 2019 – refer Figure 2-2) resulted in the eventual drying out of standing water at all four monitoring sites.

These declines are not project related. Refer to Figure 3-12 for a summary of results.

Figure 3-12 Mean number of *Persicaria elatior* plants over eight monitoring events (baseline and construction) at three in-situ sites and one control site. No baseline data exists for site Pe-4.2a as it was added in 2017.
