Pacific Highway Upgrade: Woolgoolga to Ballina, Sections 1 and 2

Microbat and Nest box Monitoring –
Operational Phase, (2020-2021)

Sandpiper Ecological

8 November 2021

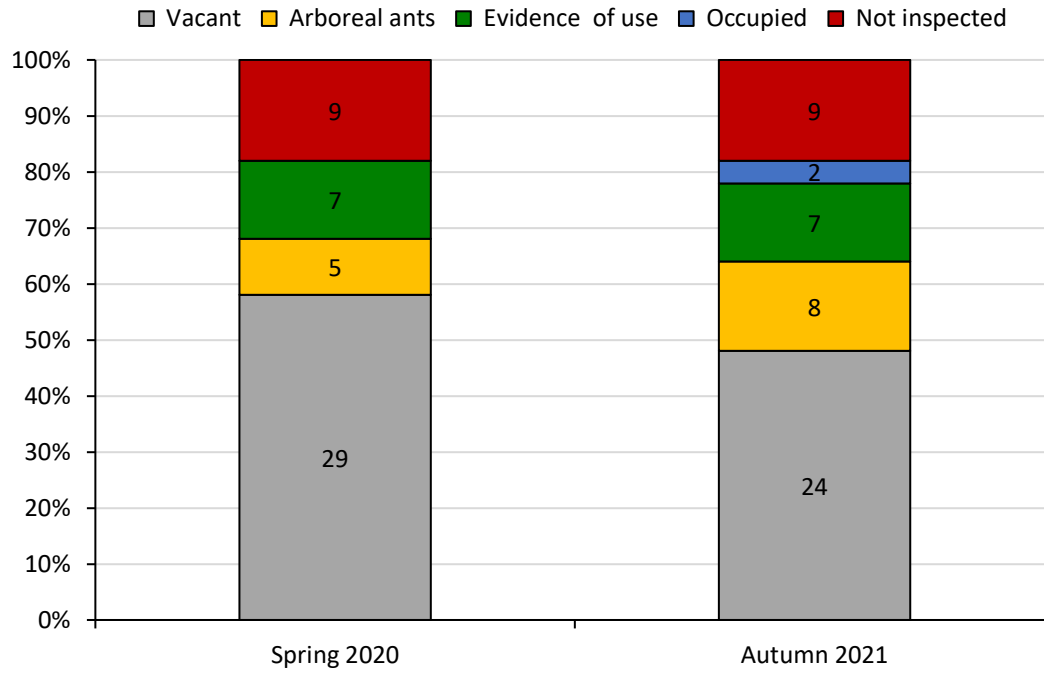
Figure 12: Number and proportion of hollowed used by vertebrate fauna (occupied or evidence of use), arboreal ants, unused (vacant) and boxes not inspected (due to damage or missing) during operational phase monitoring (spring and autumn) at HC2G/WC2G (Section 2), 2020-2021

Vacancy rates decreased from 67.4% (29 hollows) in spring to 55.8% (24 hollows) in autumn (Figure 11). Additionally, nine hollows were not inspected during either sample (Figure 11) due to destruction from bush fires ($n=7$, Plate 2) and two were not found. These are either duplicates in the dataset (i.e. there were two #710 and 714) or were burnt (see Appendix C, Table C1).

During inspections, epicormic growth was removed around several hollows (five during spring 2020 and three during autumn 2021) to facilitate passage for fauna (plate 2, see Appendix D). Arboreal ants were also present in relatively high abundance occupying five hollows during spring and eight during autumn (Figure 12).
